NERC Lessons Learned

Misoperation of 87N Transformer
Ground Differential Relays Causing
Loss of Load

Protracted Fault in a Transmission Substation

Loss of Automatic Generation Control
During Routine Update

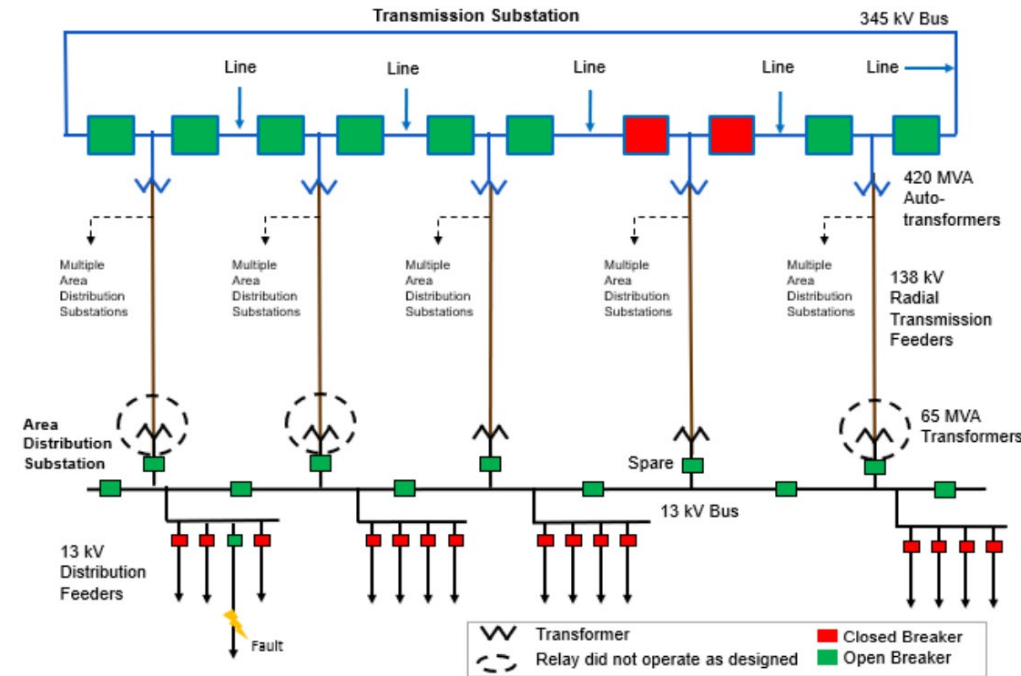
Figure 1: One-line Diagram of Transmission and Area Substations [1]

- 345 kV ring bus with 4 in-service XFMRs (1 standby)
- 13 kV feeder fault
- (3) 87N neutral/ground diff relays misoperated clearing the XFMRs
- Remaining XFMR overloaded before standby could be switched in
- (1) 345 kV path stayed in service
- Loss of load

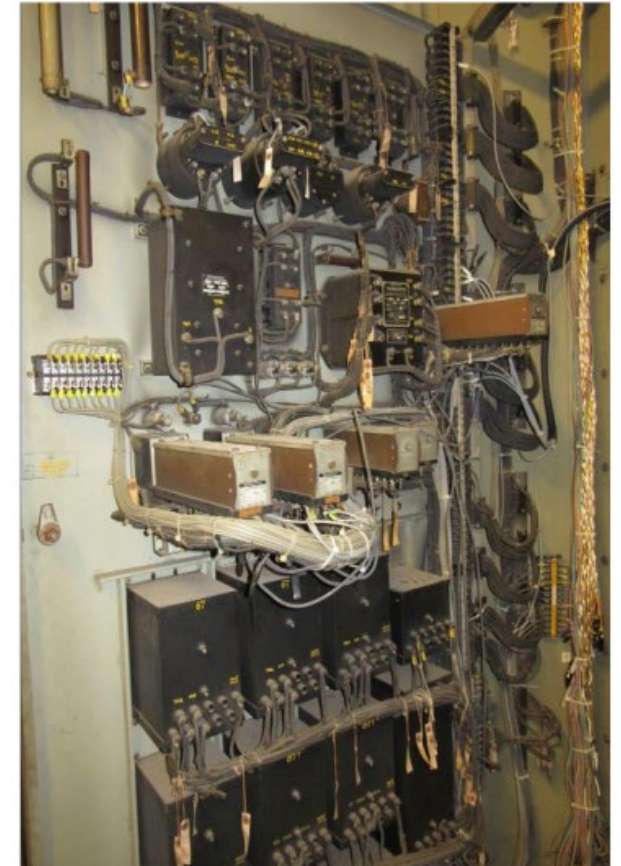
Figure 2: Wiring in Rear of Relay Panel [1]

- 87N relays misoperated from open or missing connection between the 13 kV transformer CTs and the neutral auxiliary CT that supplies each 87N relay
- Missing connection unbalances the differential configuration
- Missing neutral connection occurred during a 13 kV breaker retrofit program
- Original overall schematic not used
- Separate crew found issue later on 4th XFMR

- Missing wiring was corrected
- Process developed to redraw AC circuits with templates
- Standardization of commissioning testing for substation equipment and relay protection systems
- Provide feedback to supervision and engineering when problems are encountered

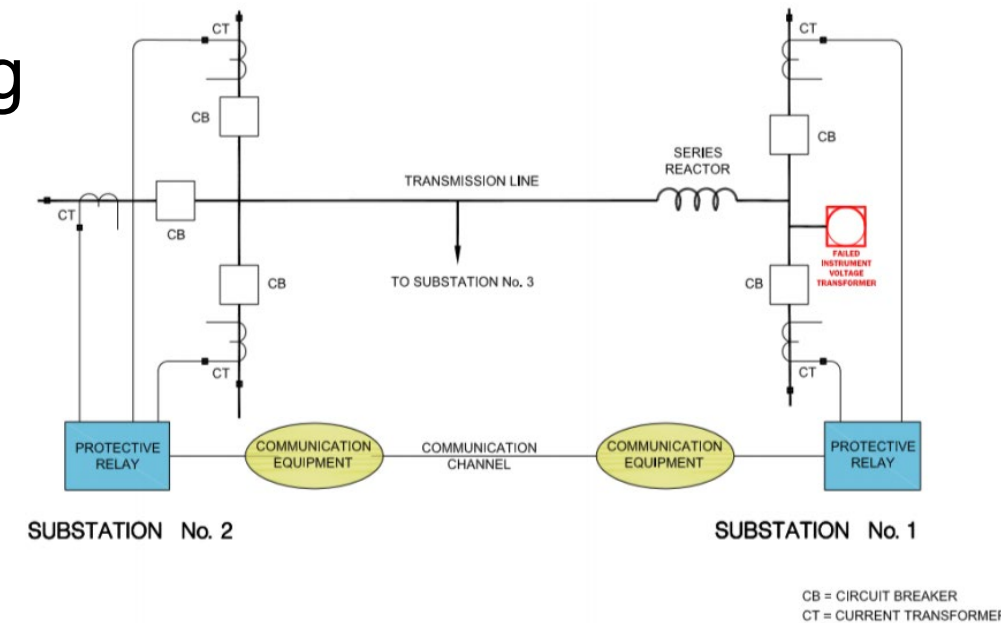
Figure 4: One Line Diagram of Faulted Circuit and Line Differential Protection [2]

- Single-phase-to-ground fault on CCVT
- Output temporarily isolated but coupling capacitors remained connected
- Communications equipment shut down because of an electrical transient associated with the fault
- Loss of communications prevented the line differential relaying from properly detecting the fault
- Remote back-up relays slow to detect fault for multiple reasons

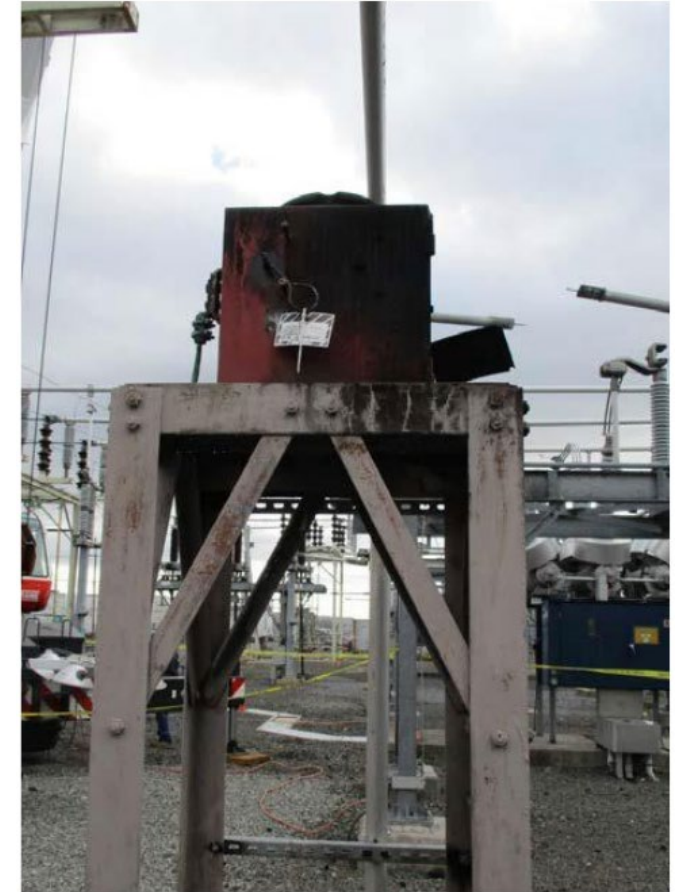
Figure 5: Failed C Phase CCPD [2]

- Fault was not cleared by either the primary or the back-up relay protection
- Four multiplexers (with 8 power supplies) automatically shut down from transient
- Control scheme intended to protect the power supply from overloading
- Transient generated coupled into the 125V DC battery supply
- Continuity between two adjacent ground grids

- All damaged equipment replaced
- DC supply for multiplexers shortened
- Ground grids reinforced
- Extent of condition review conducted system-wide to replace power supplies modified to disable shutdown scheme
- Diversify primary and backup equipment
- Equipment out of service should be completely isolated
