# AEP Eastern System Pre-1930s Era Lattice Tower and Transmission Line System

**SRRTEP-Western Committee**

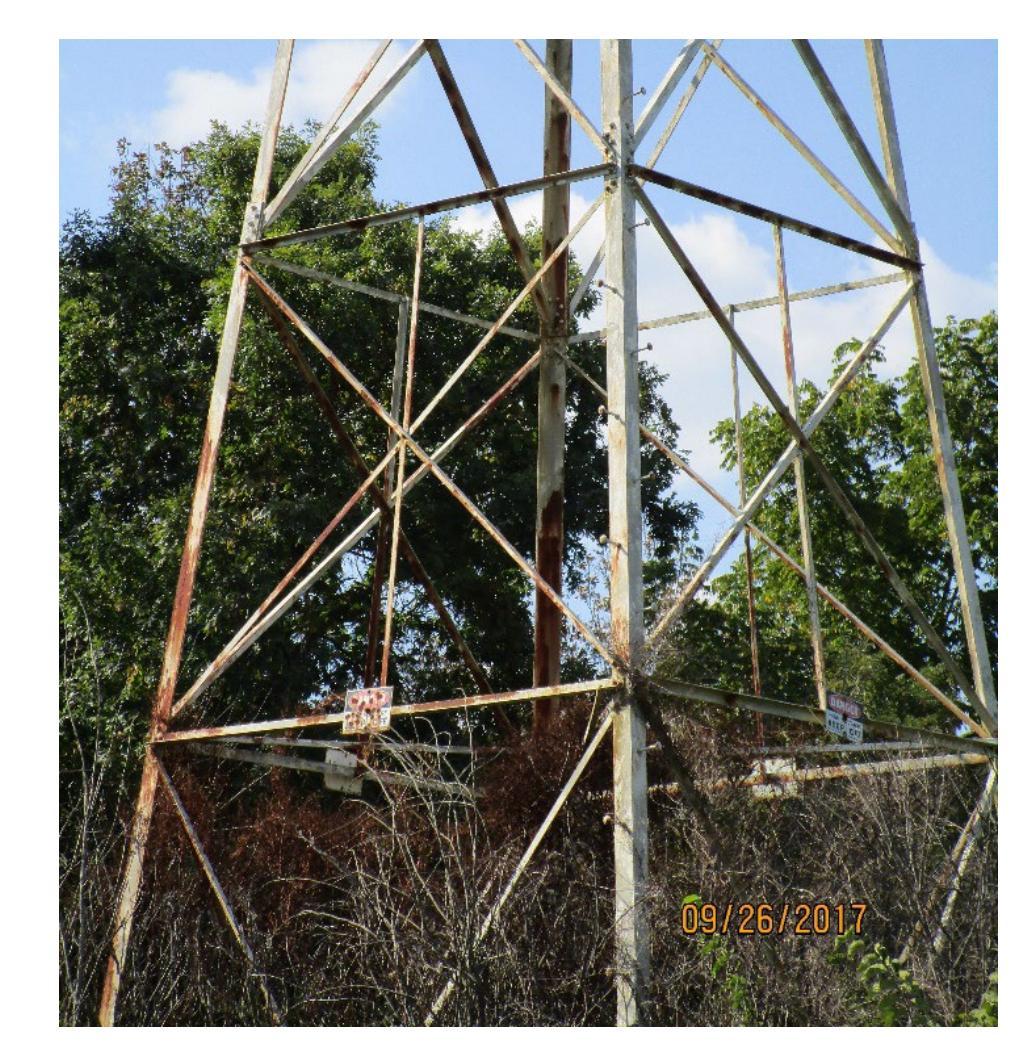
### **Tower Conditions**

- The towers consist of galvanized steel
- Conditions vary with environmental exposure
- Typical life of galvanizing is 70 years
- The towers are all supported by steel grillage foundations buried in the ground
- The tower leg is subject to significant risk of corrosion where it enters the ground

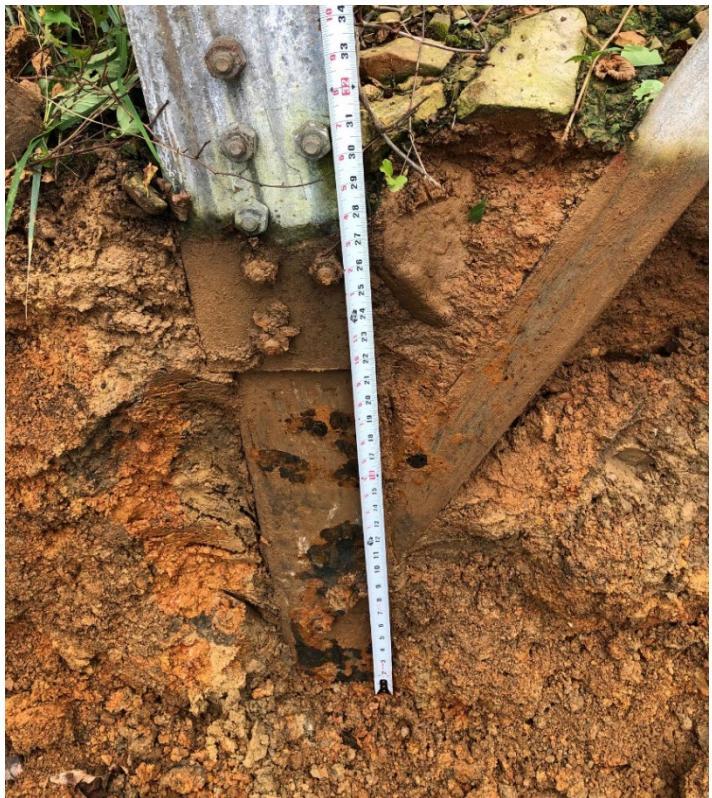
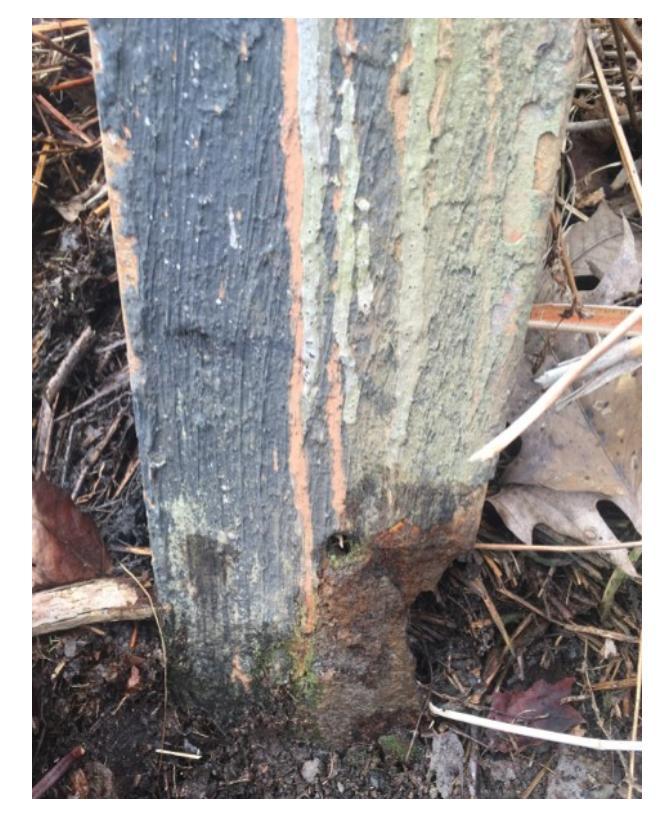
**Ground Line Corrosion**

- Tower legs have lost greater than 50% of section due to corrosion
- Subject to collapse

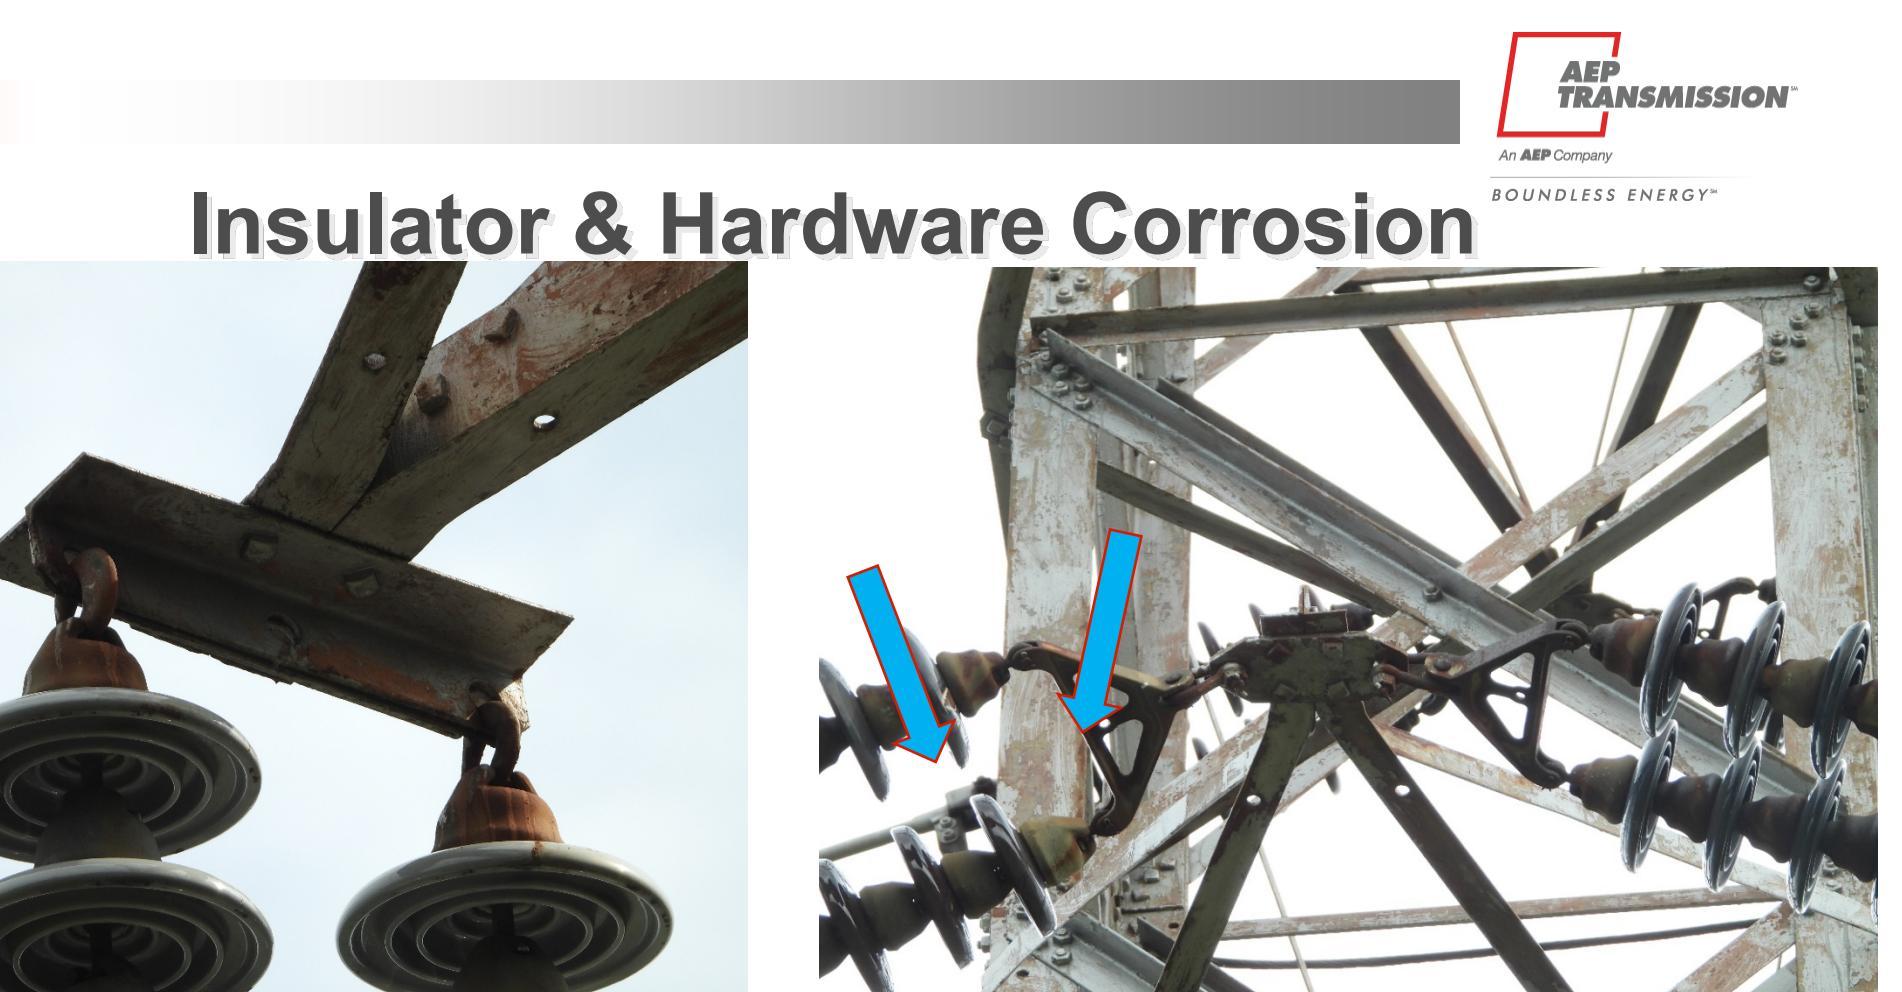
- Section Loss: The connecting elements including the tower attachment hole and the insulator hook have experienced serious section loss due to corrosion and wear. This loss of metal crosssection significantly reduces the capacity of the connection
- Corrosion: The insulator caps and connecting hardware have experienced heavy to complete loss
  of galvanizing. When the protective galvanized coating is gone or significantly compromised the
  bare steel corrodes at an accelerated rate

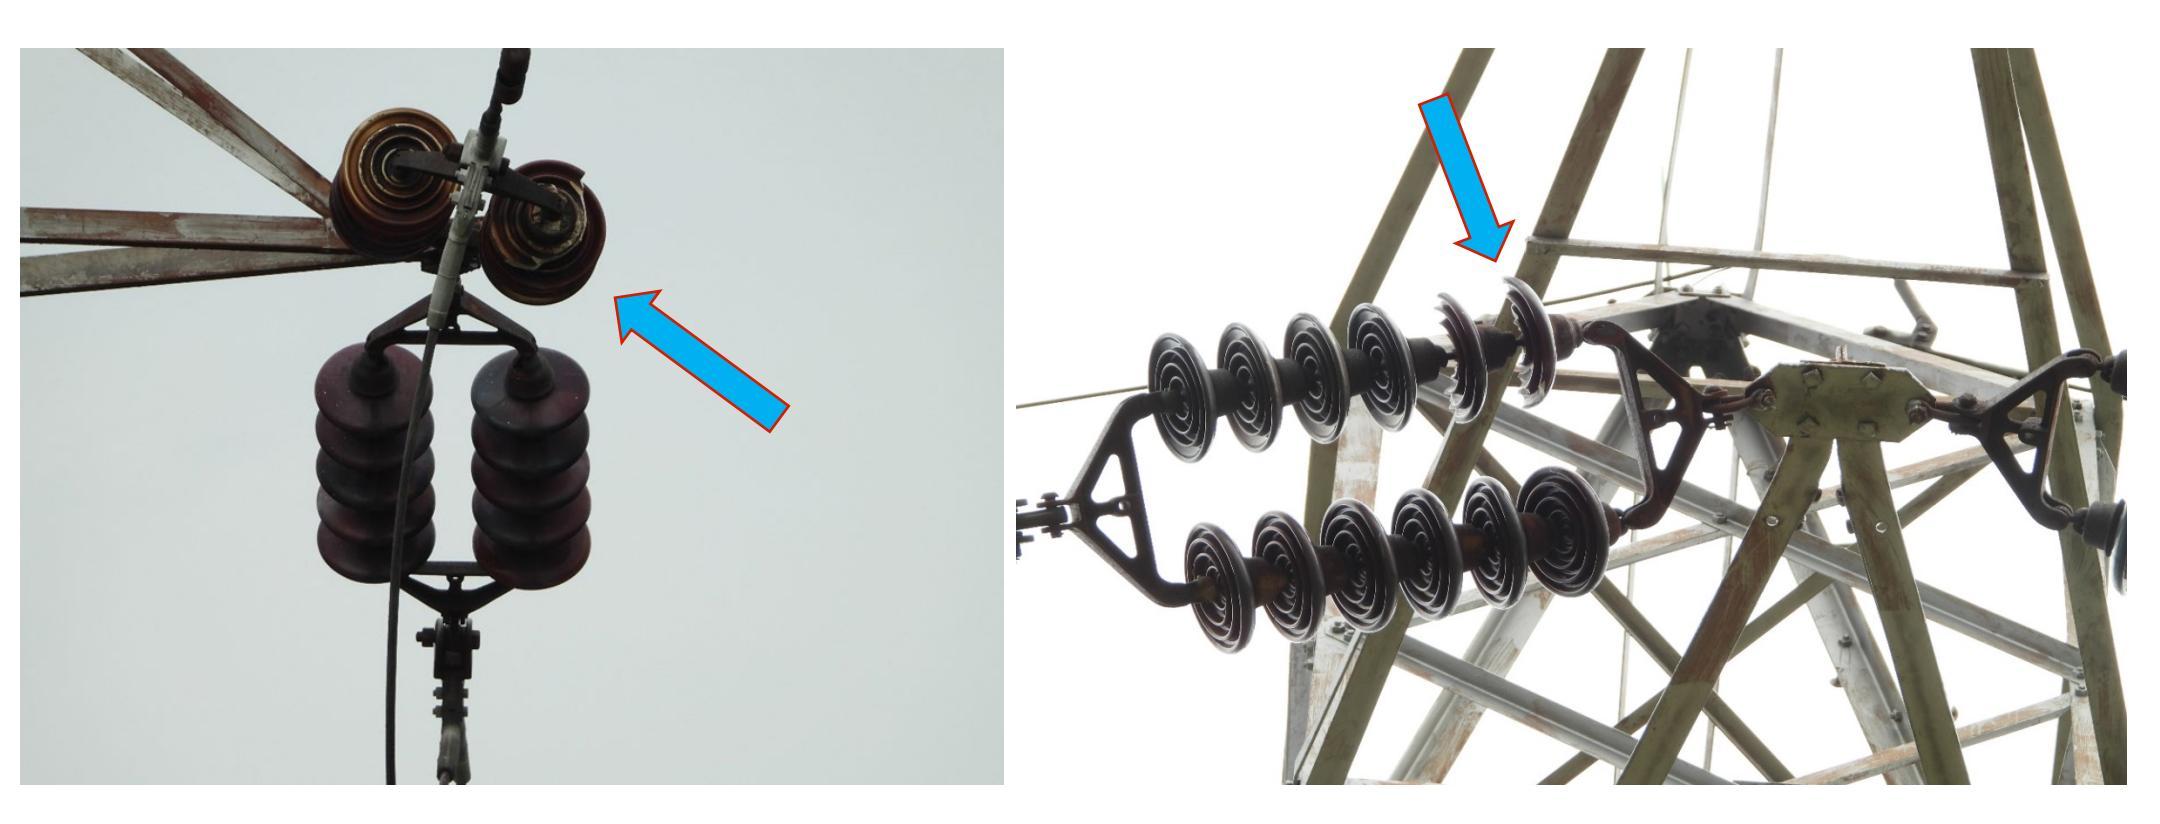
#### **Broken Insulators**

- Broken, cracked and otherwise damaged insulators lead to premature flashover causing permanent outages
- When the insulator assembly breaks, the wire falls to the ground potentially damaging other conductors, and present an increased public safety concern

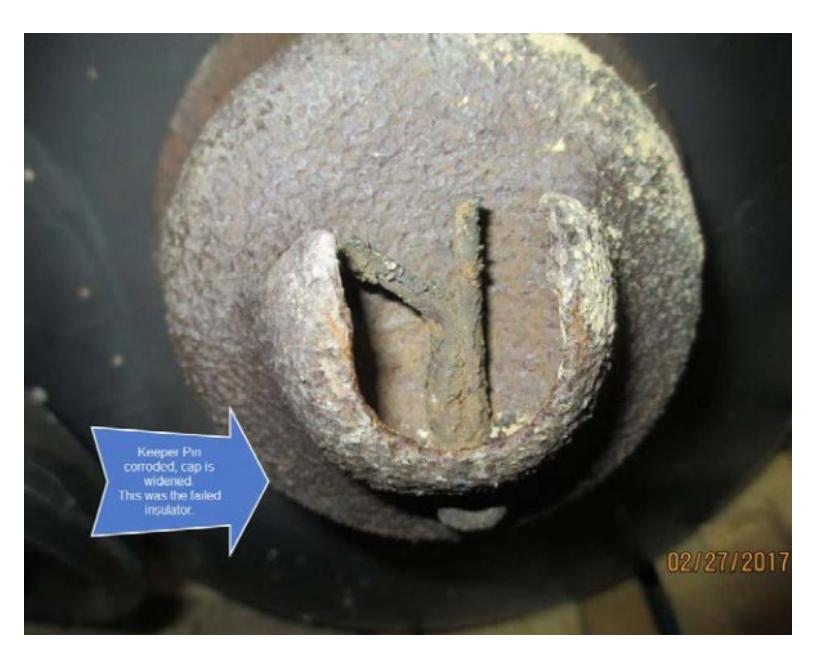
#### **Typical 1930s Lattice Line**

- Pitting and deterioration of base steel
- Corroded connecting pins will drop conductor when they fail

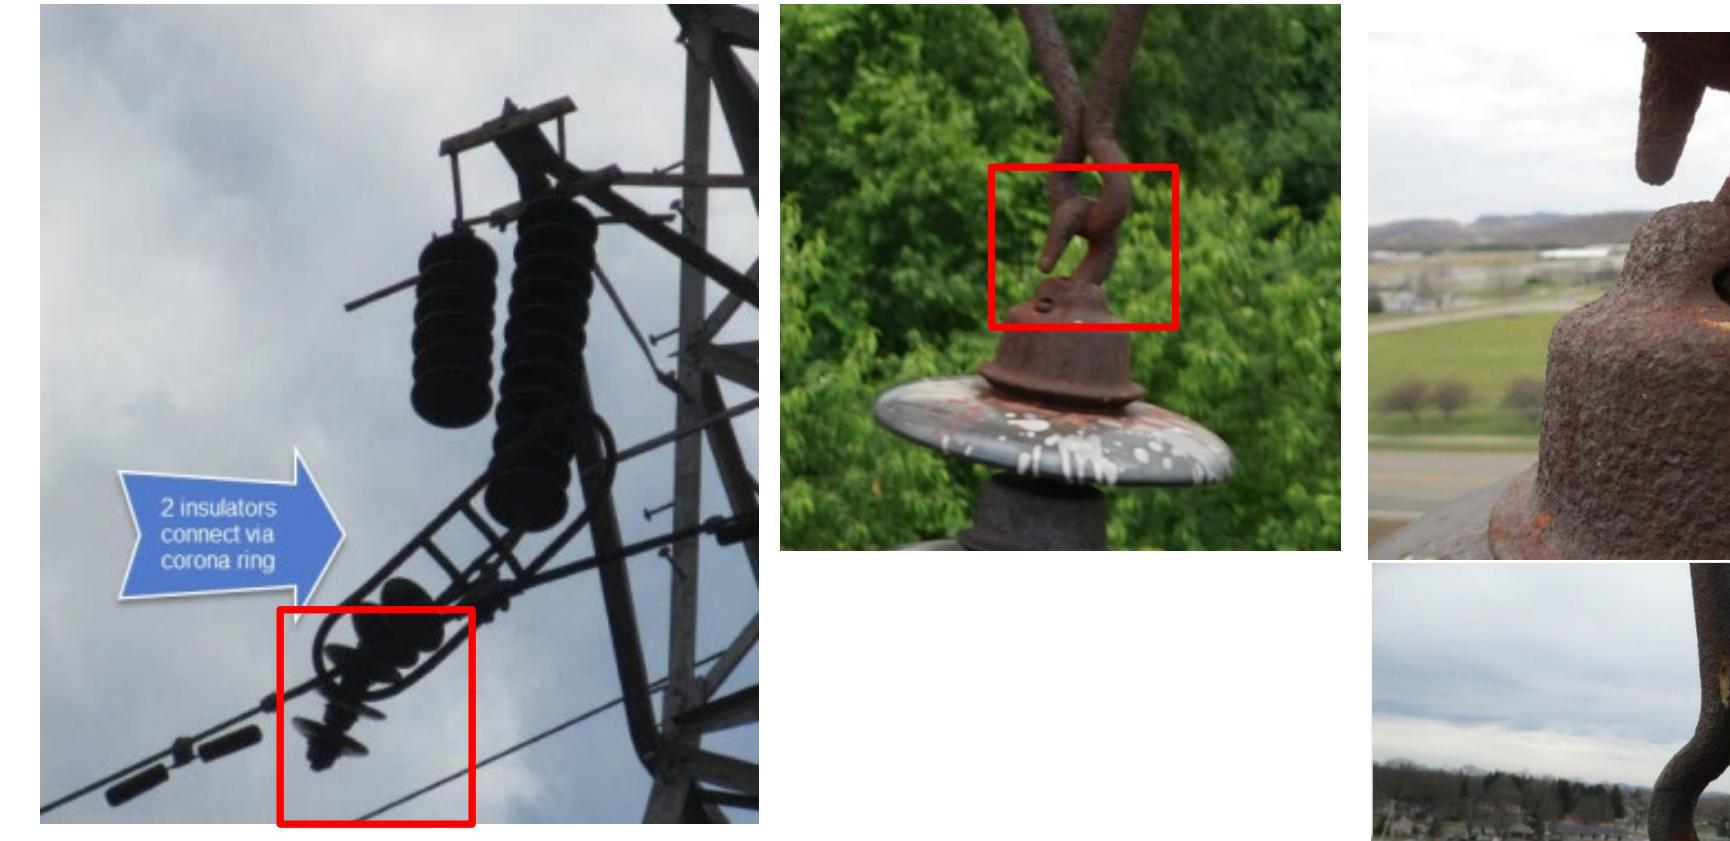
**Typical 1930s Lattice Line**

- Insulator failure due to corrosion and wear of connecting element
- Close up views of connections showing corrosion and loss of section

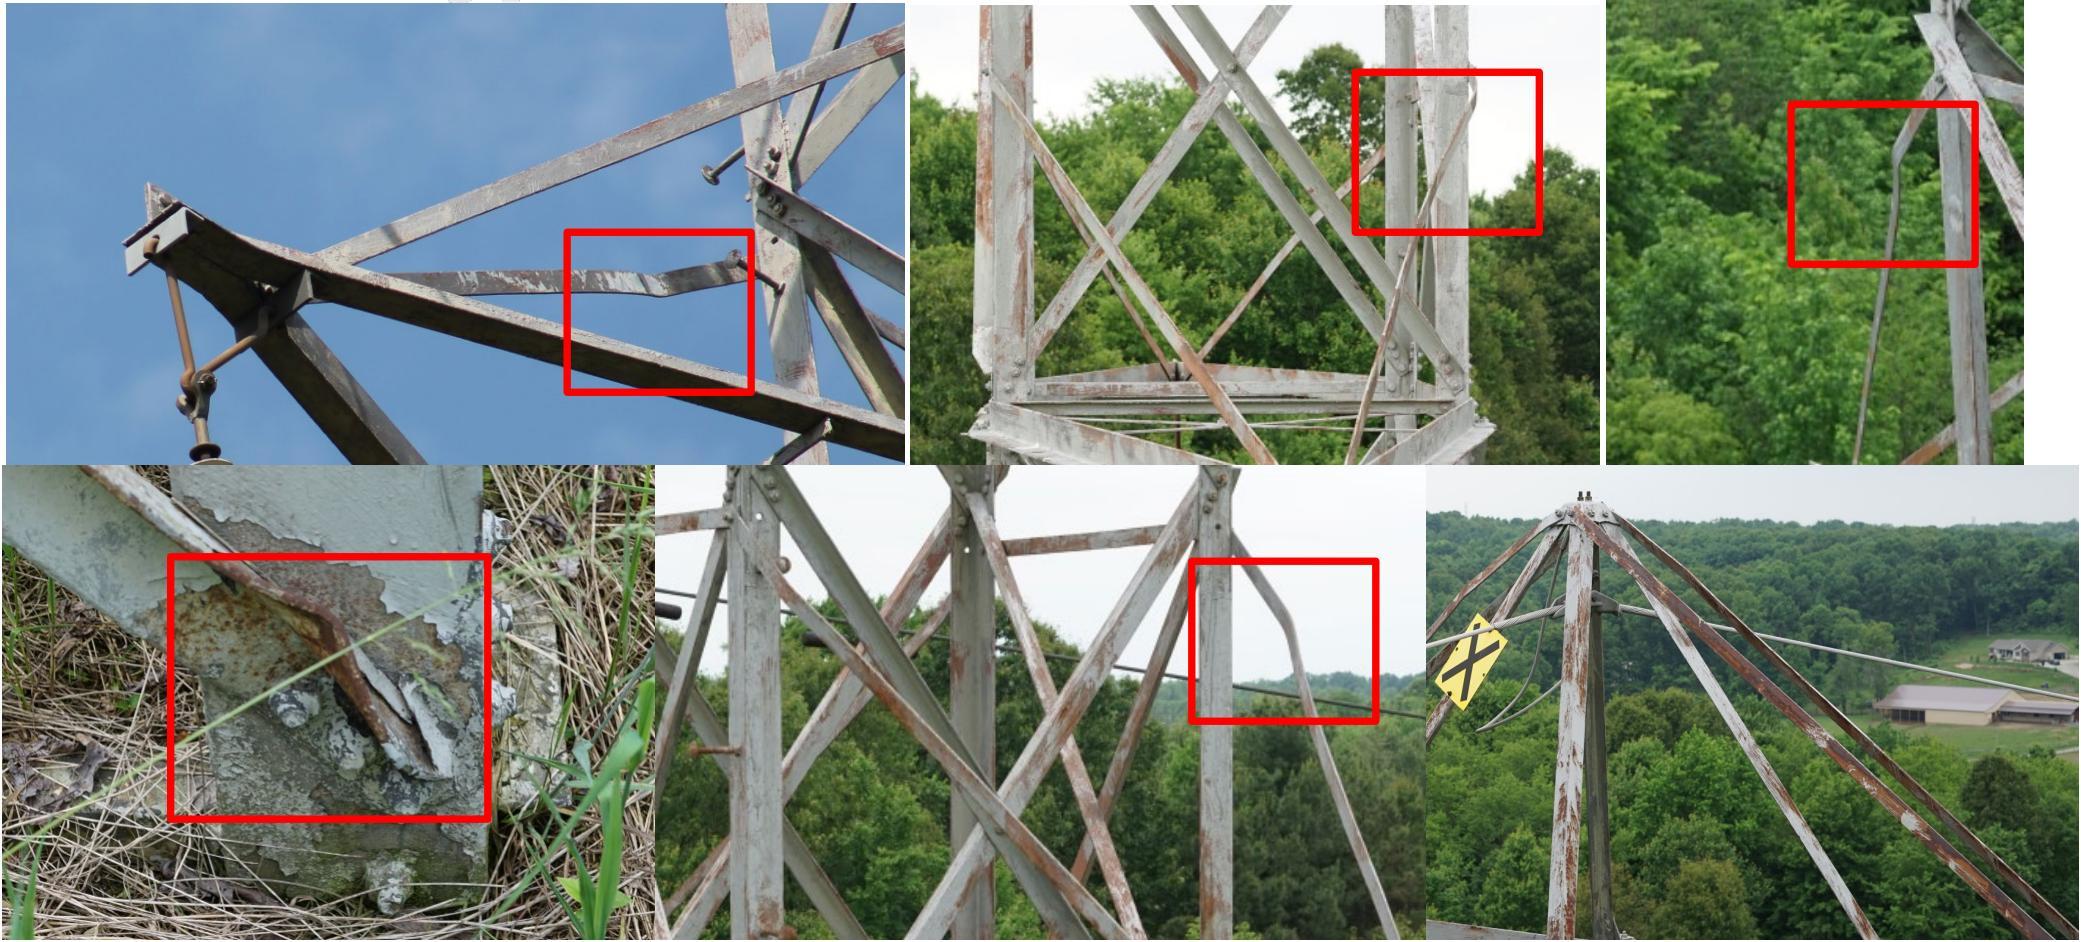
#### Typical 1930s Lattice Tower<sup>oundless energy</sup>

Tower members with corrosion and damage. Lattice tower structures have little structural redundancy. A failure of one member of the structure will impact the integrity of the structure and may cause the entire tower to collapse. 18

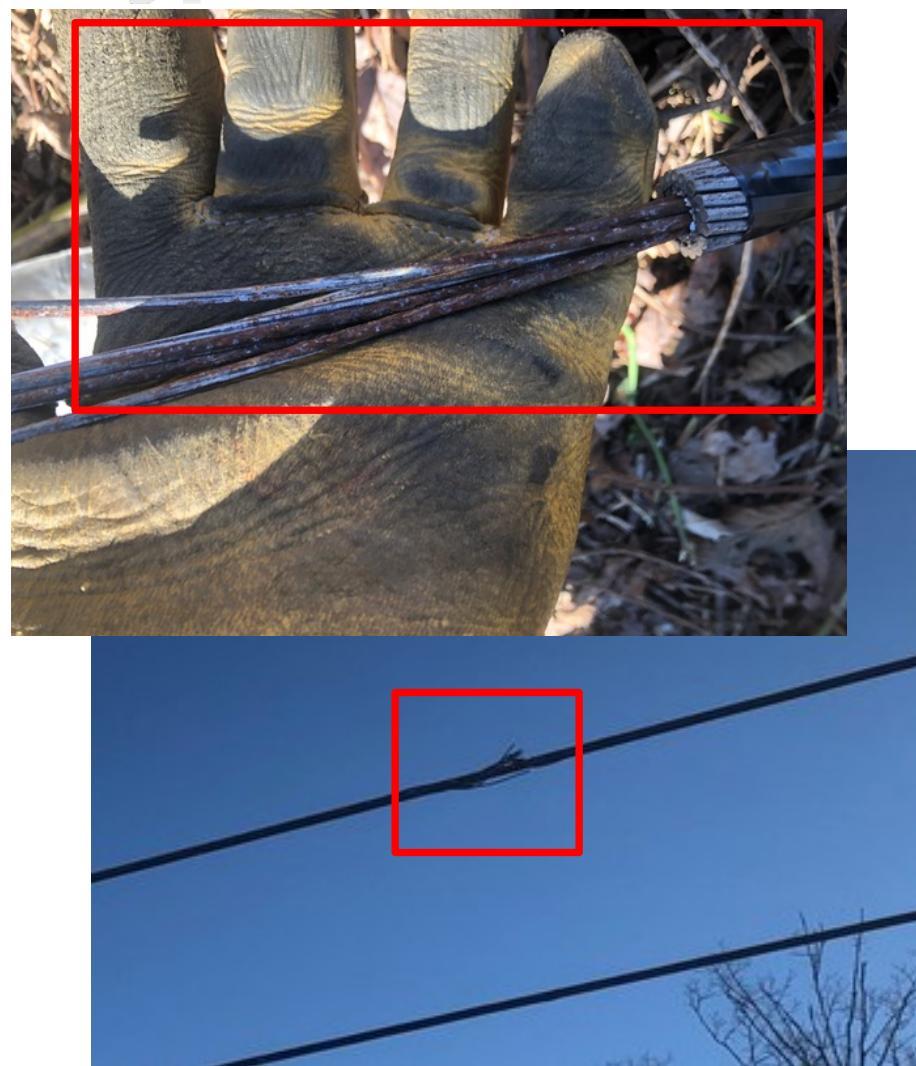
#### **Typical 1930s Era Steel Core Conductor**

- Significant deterioration exists
- Aluminum Conductor Steel Reinforced (ACSR) conductor consists of aluminum strands wrapped around a core of galvanized steel strands. The steel provides the structural strength. Like other steel elements the strands of the core have also lost the galvanized coating and steel section
- The degraded state results in significant loss of tensile strength and potential risk to the public if the conductor was to fail and fall to the ground

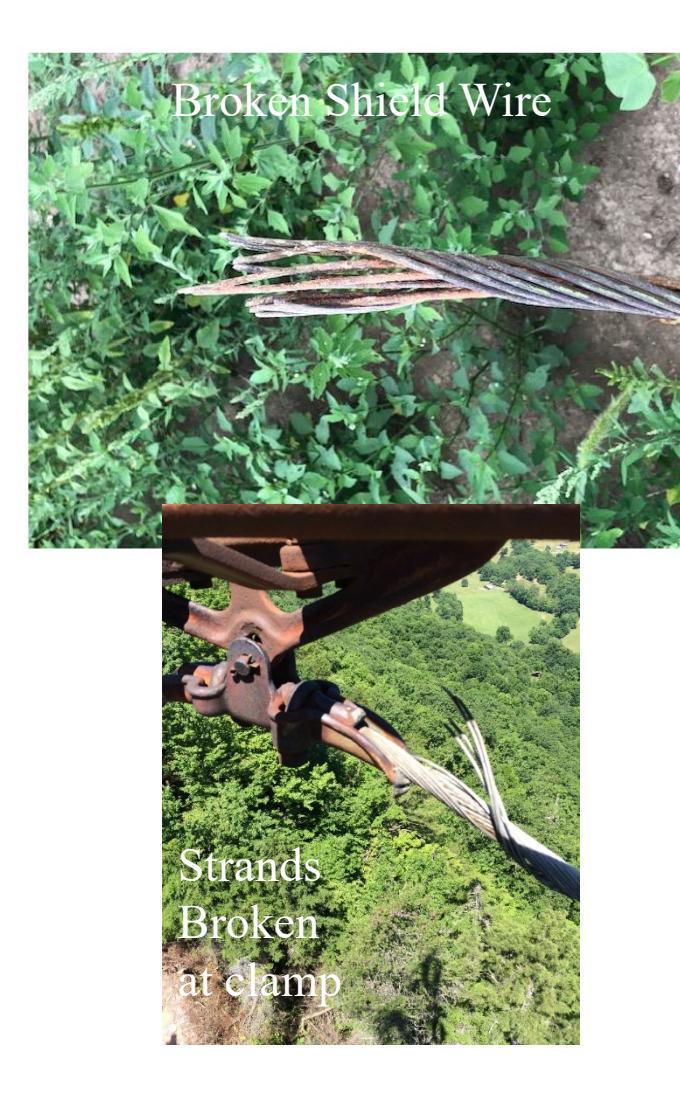
#### **Typical 1930s Era Steel Core Conductor**

- Conductor damage is usually not visible in a field inspection
- Specific conductor samples, from the belly of the sag (lowest point) and/or inside the clamps at the insulators, have confirmed significant corrosion
- During the restoration or construction activities, conductors often break at adjacent locations due to handling, introducing a potential safety risk and increase public safety concern
