Dominion's End of Life Criteria

Transmission Replacement Processes Senior Task
Force

May 23, 2016

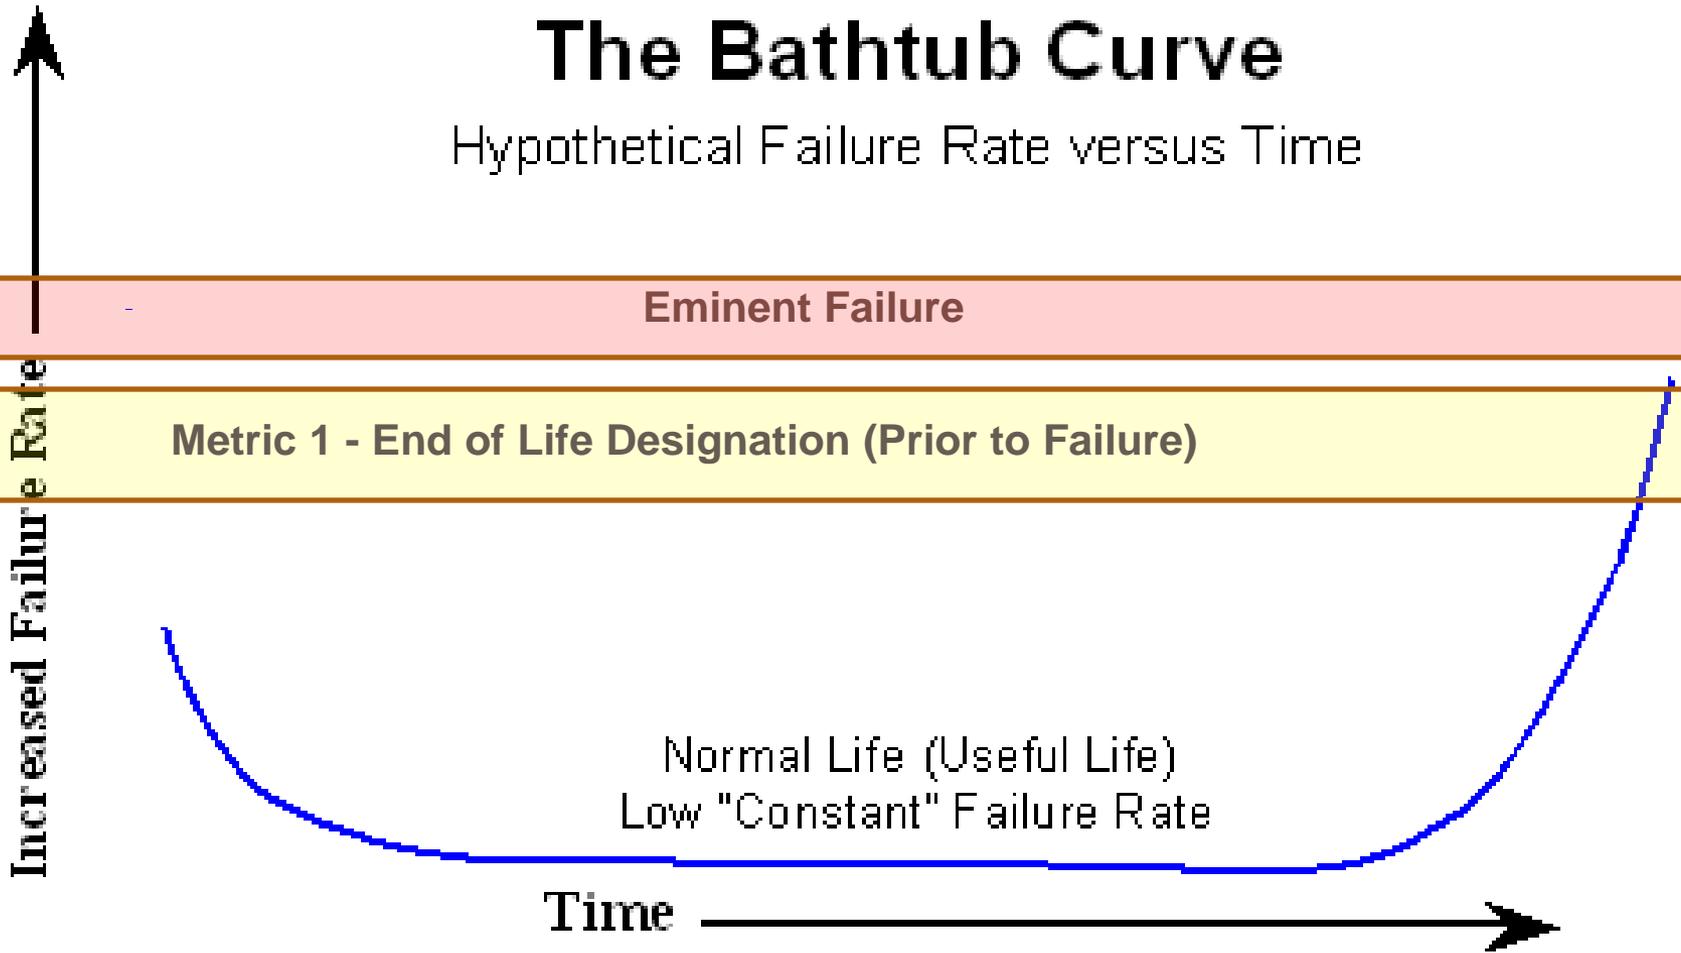
The Bathtub Curve

Hypothetical Failure Rate versus Time

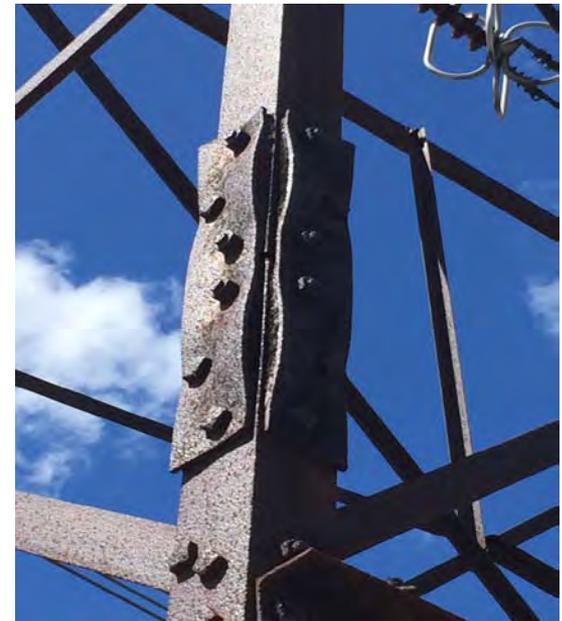
Patina layer not performing as expected.

- Joints collect moisture and develop large amounts of corrosion (pack out) build up over time and cause bolt failures and deformation of steel members.

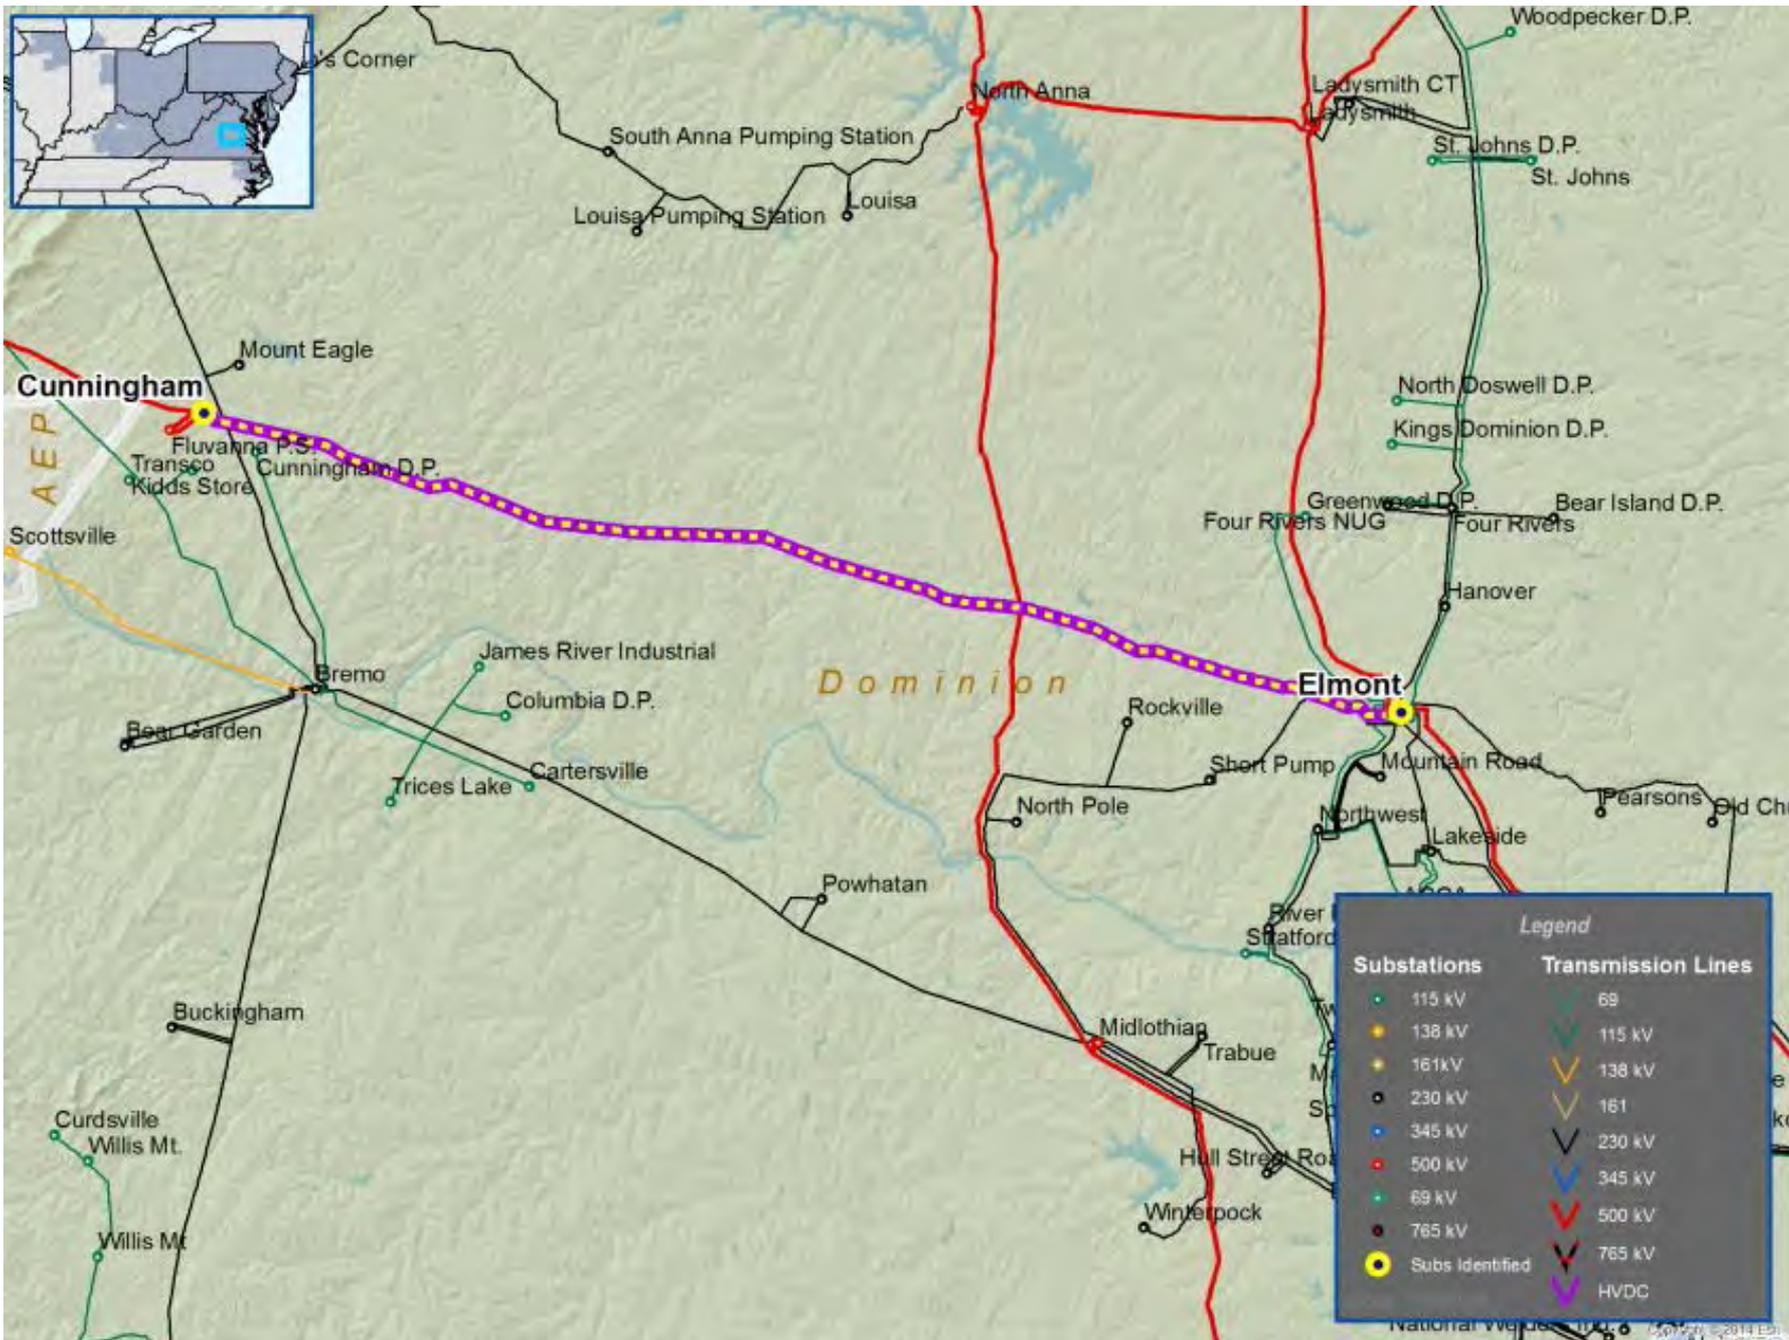
- Part of Dominion's "Original Loop" of 500 kV lines
- 1965 construction
- Approximately 51 miles in length
- Consists of 409 COR-TEN[®] steel towers

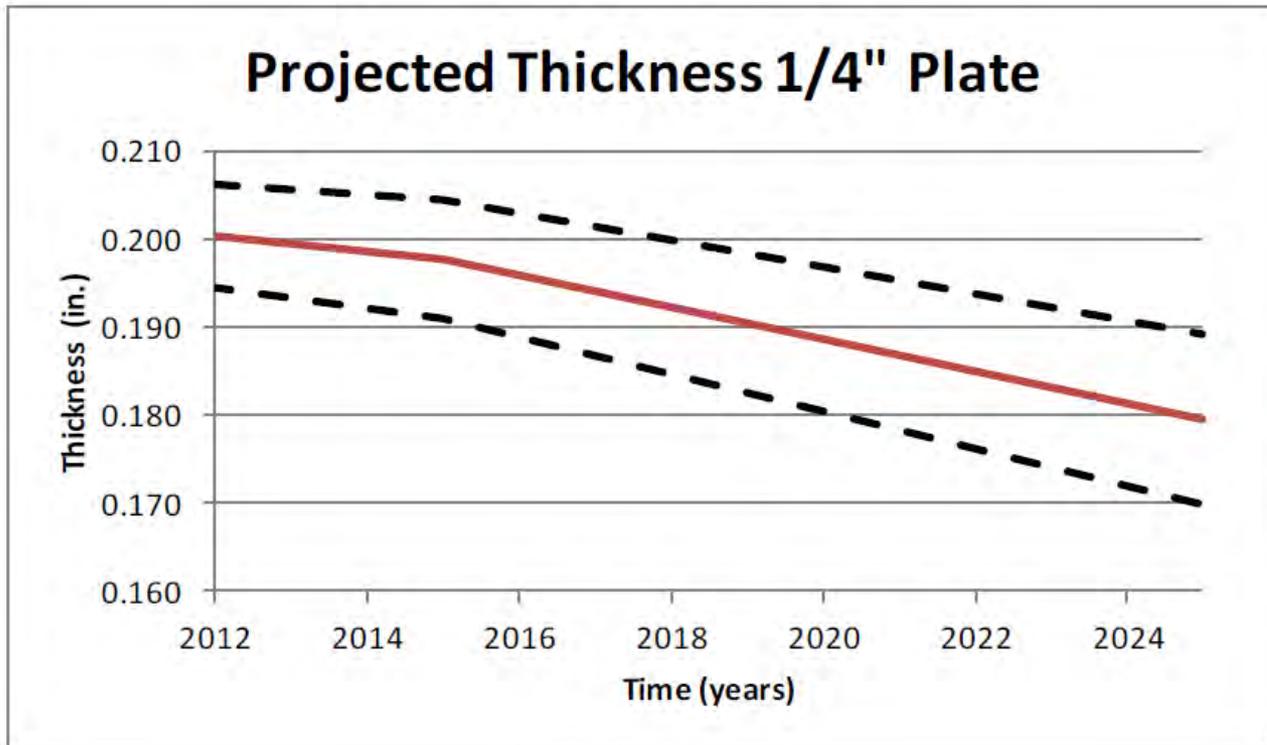
Figure 5-1. Projected plate thickness

- **Report validated Metric #1 of “End of Life” criteria for the Elmont to Cunningham line**
- Found that over 70% of the towers had some sort of rehabilitation package applied
- Found individual member strength has deteriorated and will continue
- Performed tower loading studies which indicated that stress on the tower legs is increasing as members continue to lose strength
- Supported the need to begin wholesale line replacement of the Elmont - Cunningham line with a target date of June 2018.
- Study also identified the priority of the remaining 500 kV original loop lines with a total projected completion of by 2023.

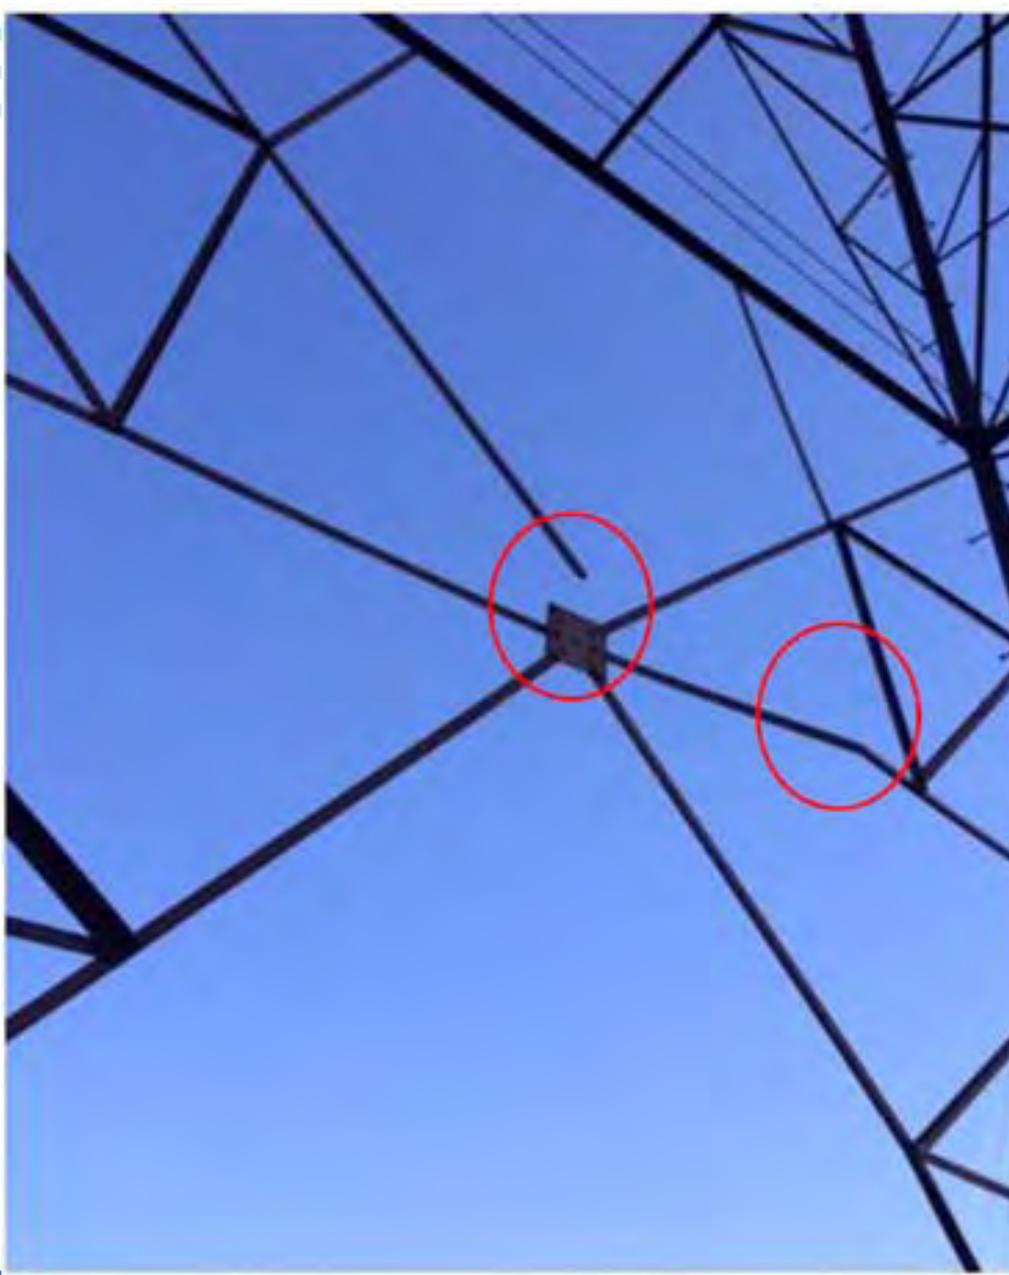
Wind Event

**Failed members caused by
deterioration of Plate Thickness**

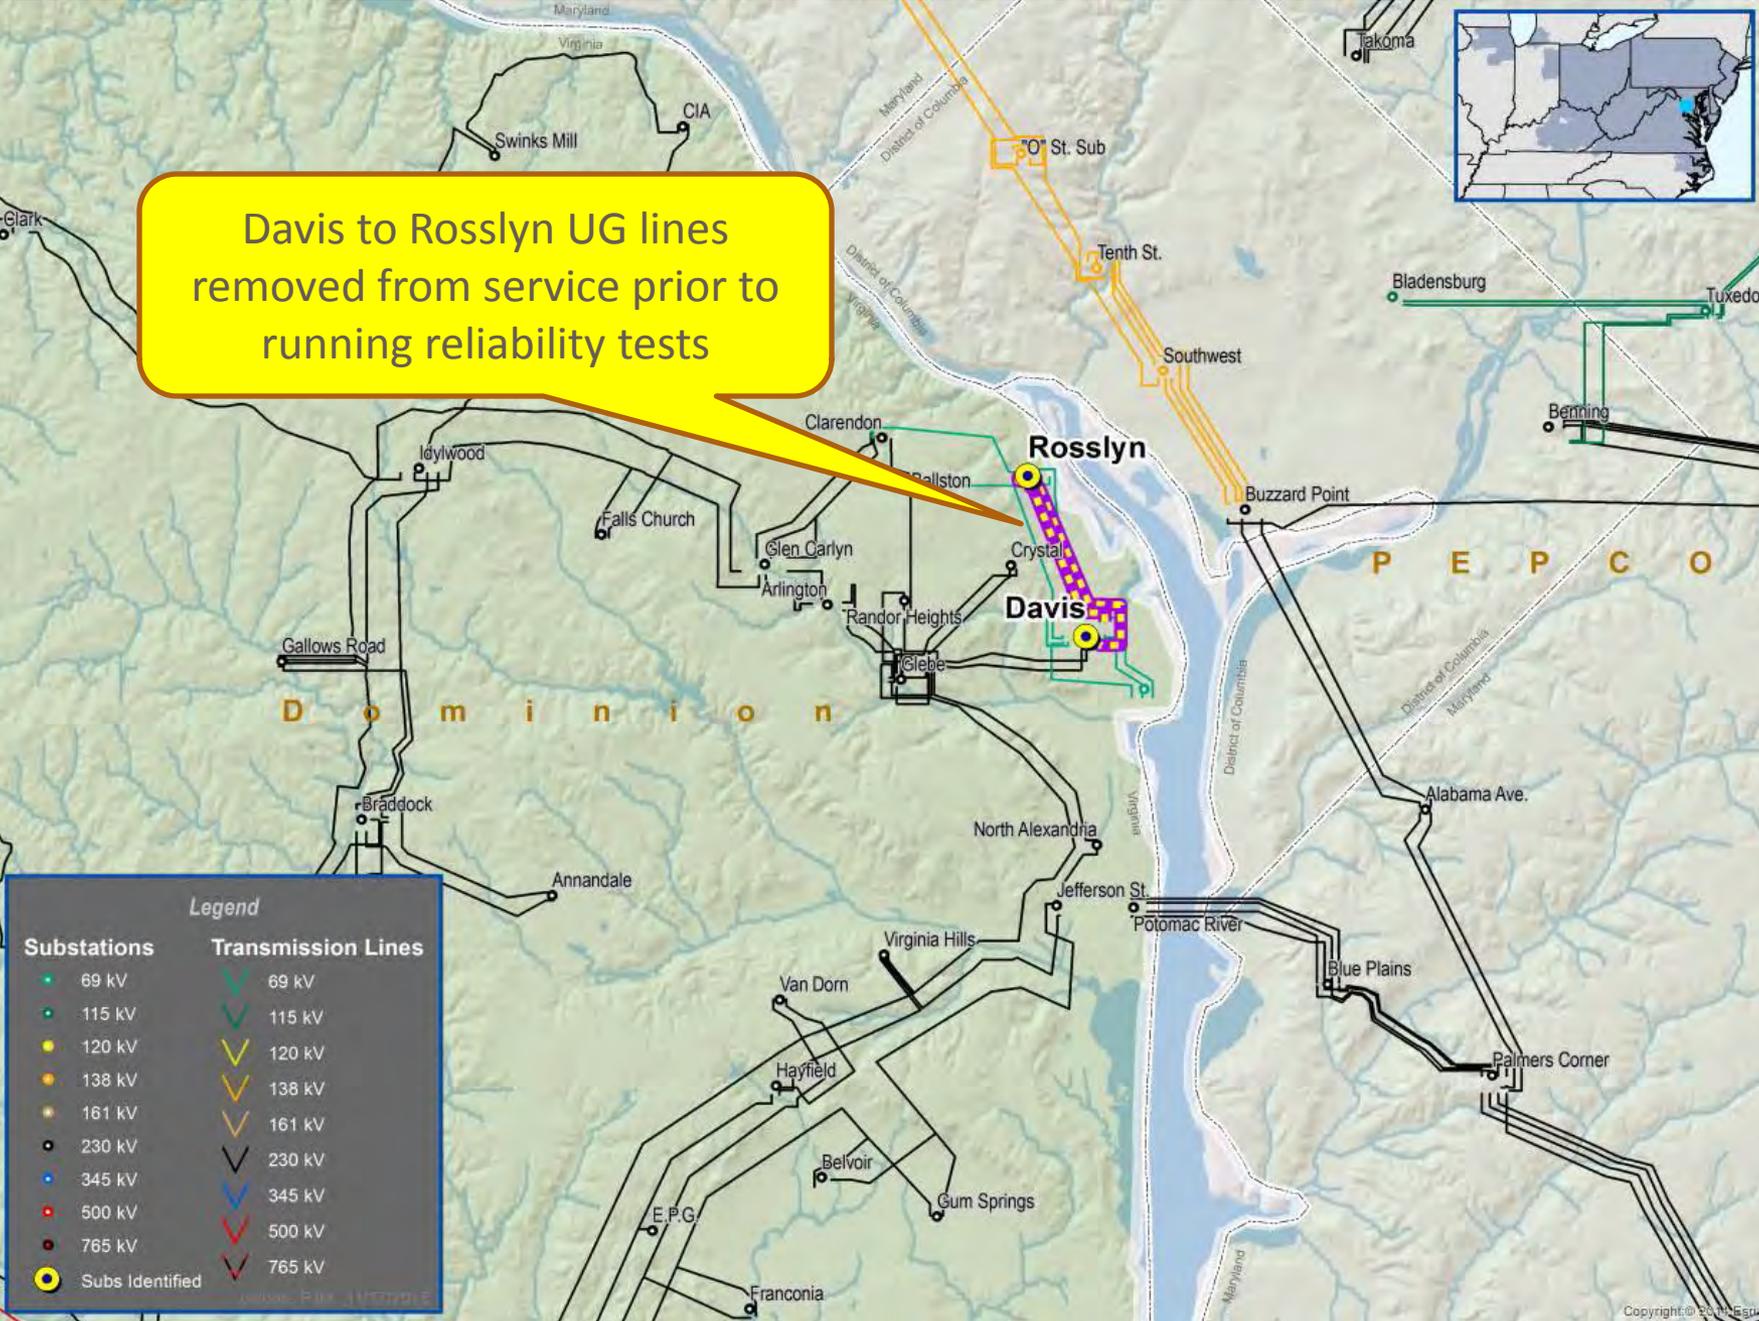
Davis to Rosslyn UG lines removed from service prior to running reliability tests

- System studies did not identify any issues that would result in a reduction of reliability for this area
 - No NERC, PJM, or Dominion criteria violations identified
