# AEP Eastern System Pre-1930s Era Lattice Tower and Transmission Line System

**SRRTEP-Western Committee**

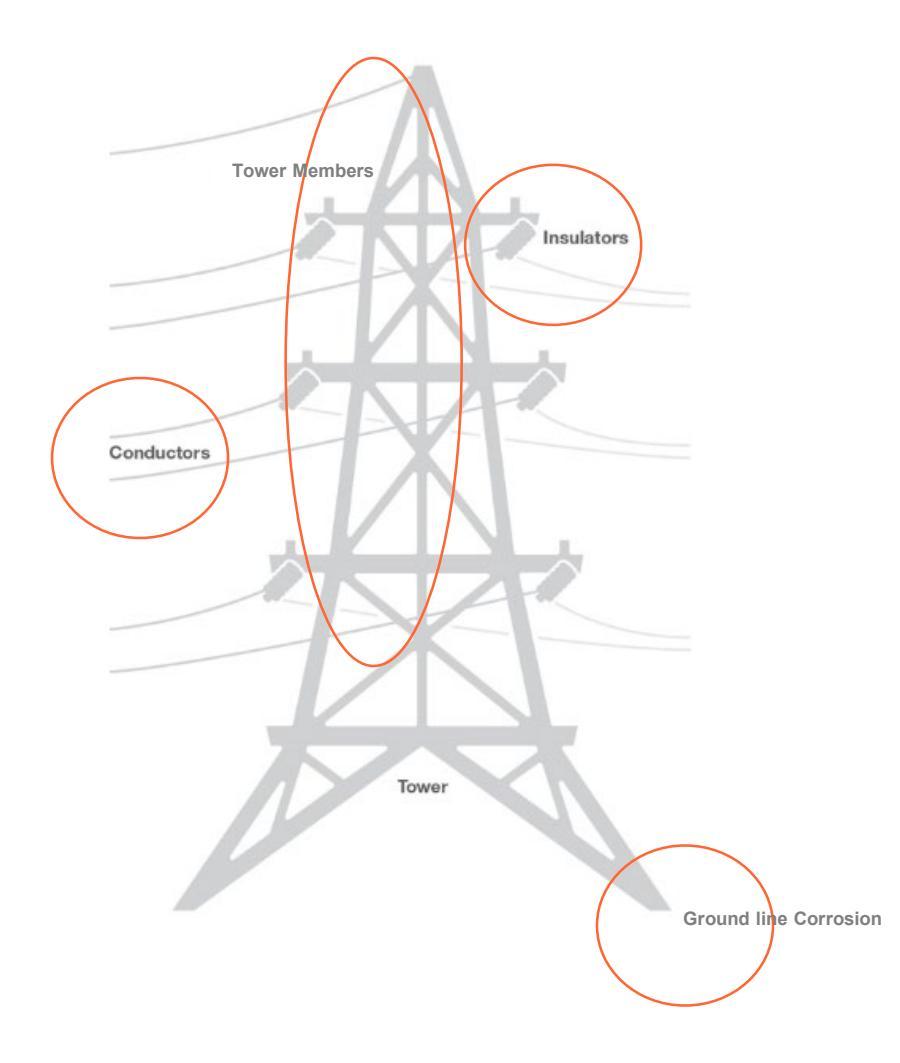
### **Conditions of System**

- The system is evaluated holistically, including an assessment of insulators, conductors, ground line corrosion and tower members
- The next 9 slides include photos of lattice tower components that represent the condition prevalent across AEP's pre-1930s era lattice transmission line network

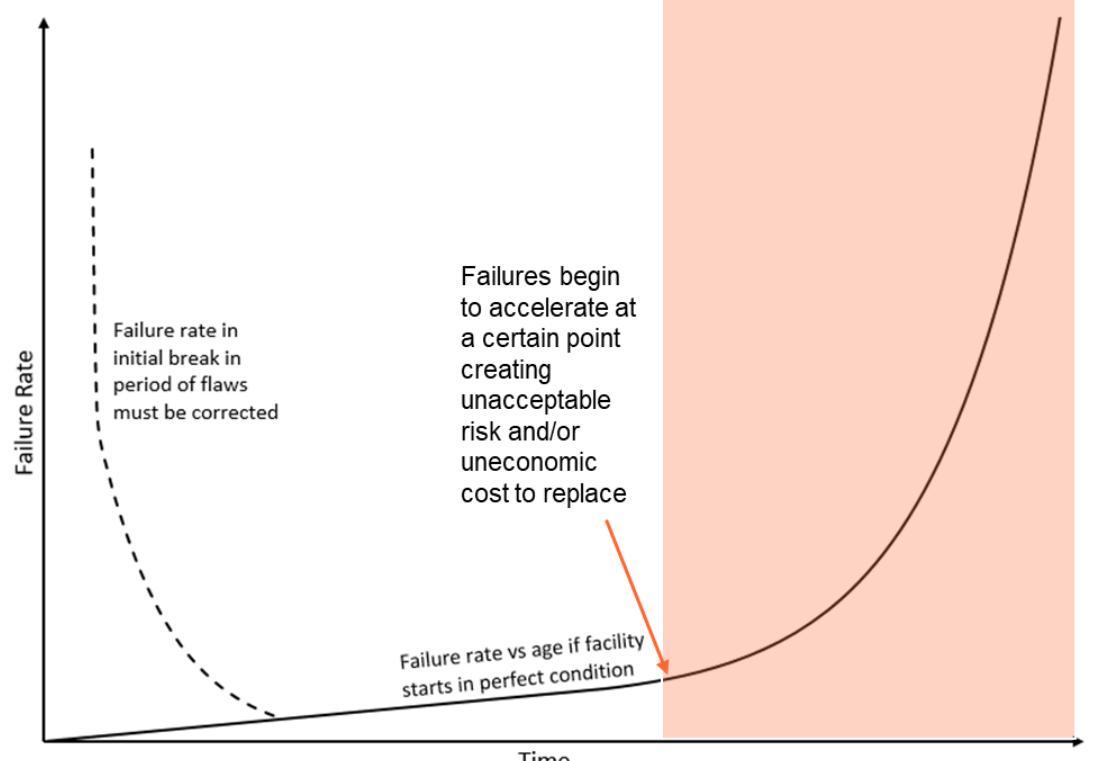
### **Effect of Age on Component Failure**

- All assets are made up of individual components
- Each component has a failure profile unique to its material

- All material behaves similarly in that failures increase dramatically at the end of life. This is known as the "bathtub curve"
- The timelines and rates vary by components and material. (e.g. wood crossarms fail sooner than wood poles; polymer insulators fail sooner than porcelain)

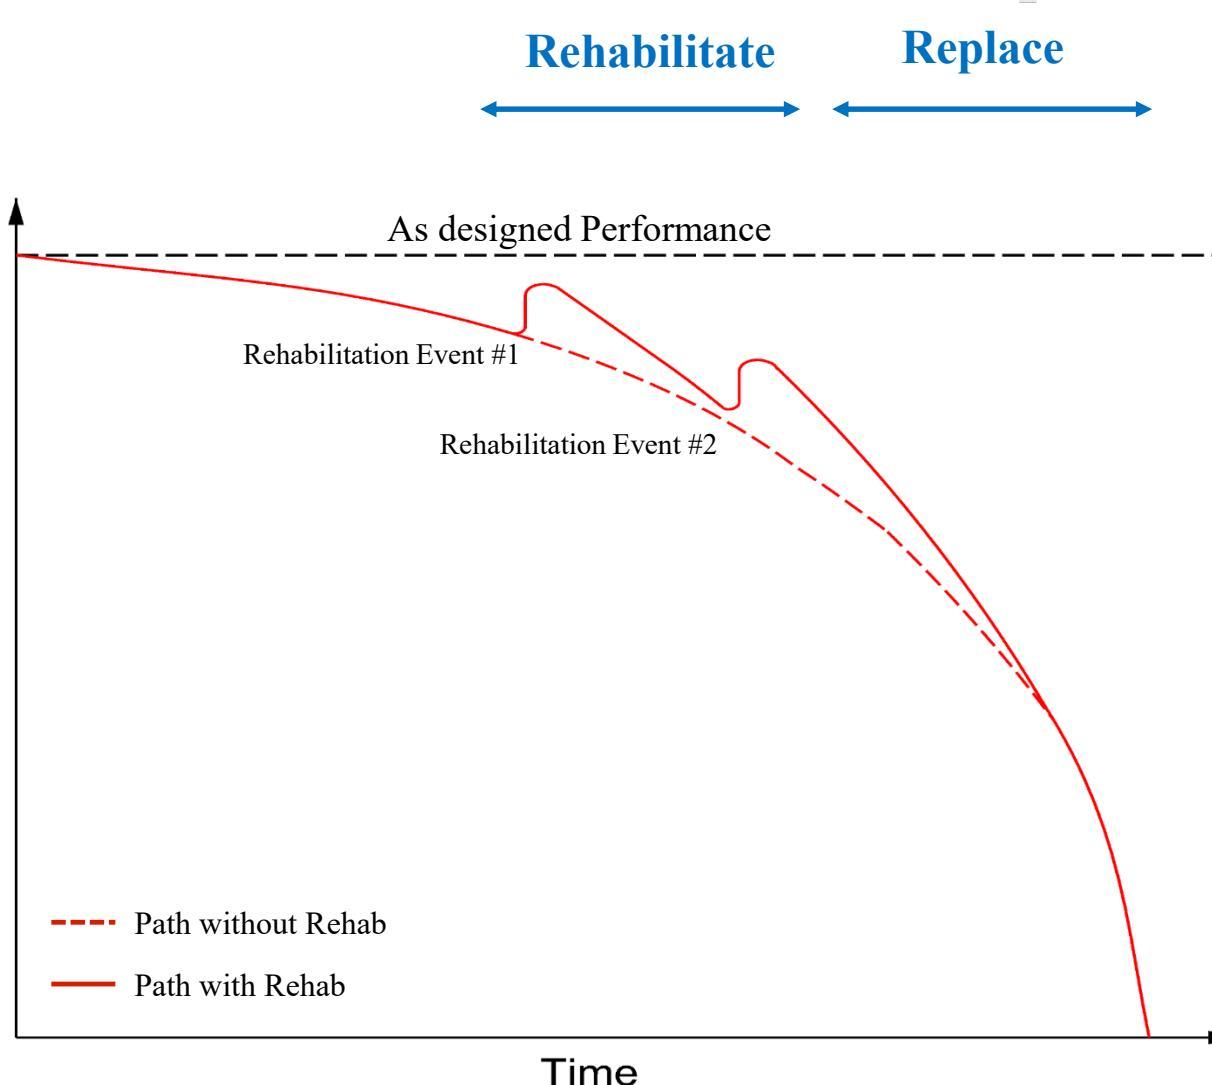
### **Asset Rehab or Replace Decision**

- The performance characteristics of an asset degrade with time due to deterioration of the individual component failures
- Improvements are gained through rehabilitation efforts
- At some stage maintenance and rehabilitation is no longer a cost effective method to restore reliability
- If the replacement decision is delayed too long the risk to reliability and the public becomes unacceptable
