Subregional RTEP Committee - Mid-Atlantic FirstEnergy Supplemental Projects

JCPL Transmission Zone M-3 Process EH Werner Substation

Need Number: JCPL-2023-037

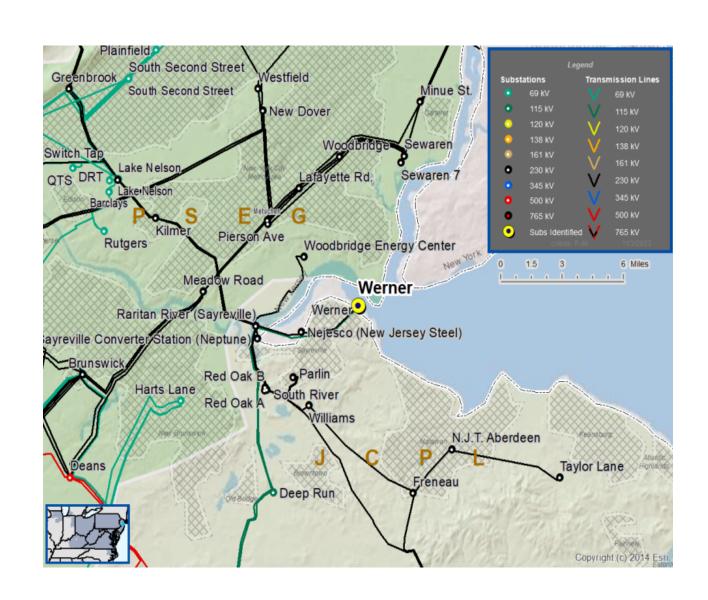
- The 115-34.5 kV No. 12 Transformer at Werner Substation was manufactured approximately 60 years ago and is approaching end of life.
 - Transformer is constructed with Type U bushings
 - Type U bushing designs have been documented to dramatically increase the risk of bushing failures.
- Existing TR Ratings:
 - 92 / 99 MVA (SN / SE)

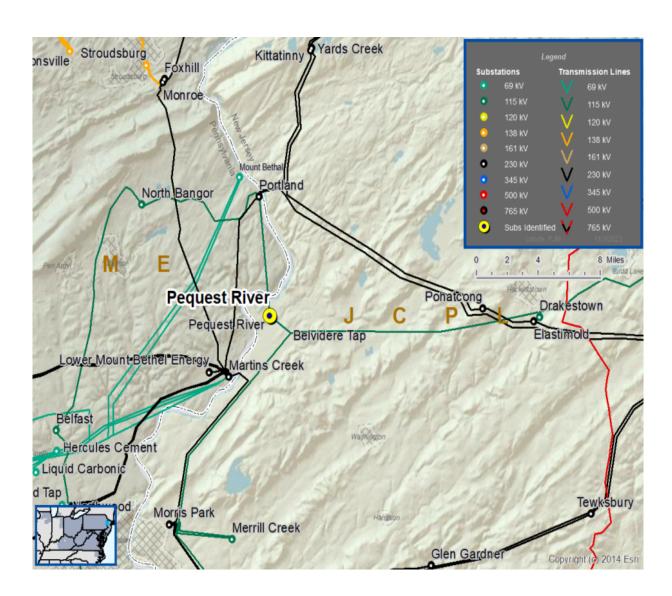
- The 115-34.5 kV No. 2 Transformer at Pequest River Substation was manufactured approximately 50 years ago and is approaching end of life.
 - Most recent DGA results showed elevated ethane gas levels compared with IEEE Standards
- Existing TR Ratings:
 - 65/69 MVA (SN/SE)

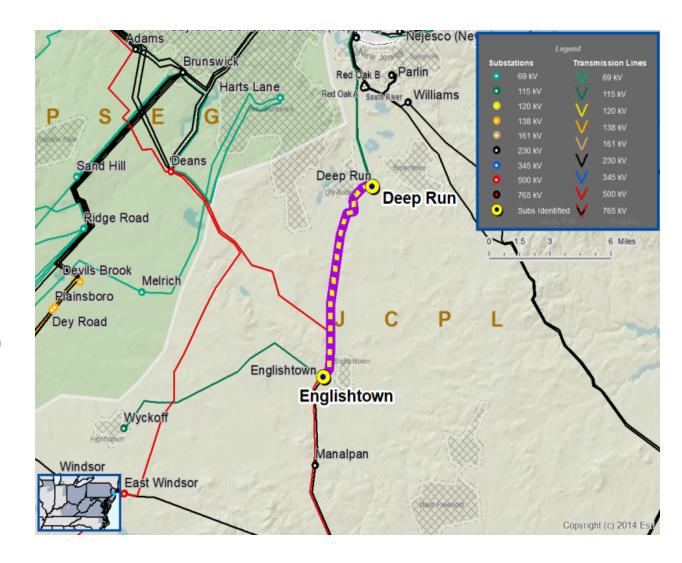
- Both Deep Run Englishtown 115 kV DRE1 and DRE2 lines have structures with an average age of 55+ years. Upon visual inspection, 88-91% fail inspection due to rot/decay and woodpecker damage.
- Line sections are exhibiting deterioration and increasing maintenance needs.
- Transmission line ratings are limited by terminal equipment.

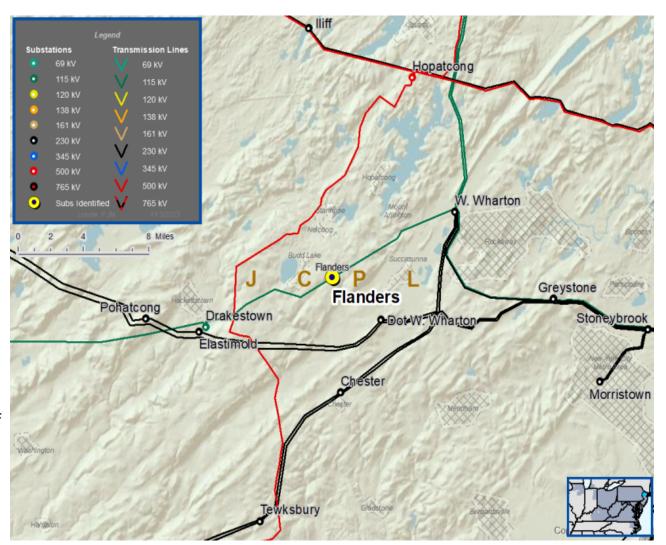
- The 115-34.5 kV No. 2 Transformer at Flanders Substation was manufactured approximately 70 years ago and is approaching end of life.
- High levels of moisture continue to develop in the transformer.
 - Moisture can reduce oil dielectric strength increasing risk of flashover and arcing.
- Existing TR Ratings:
 - 61 / 66 MVA (SN/SE)

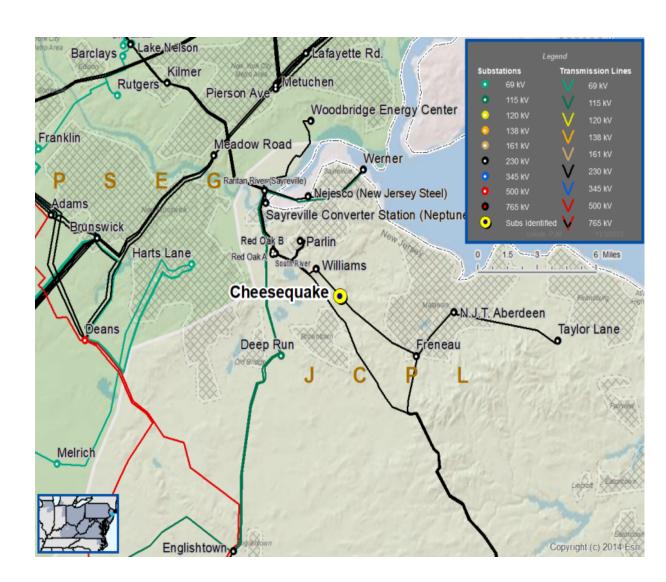
New Customer Connection - A customer requested 34.5 kV service for load of approximately 14 MVA; location is near Cheesequake Substation.

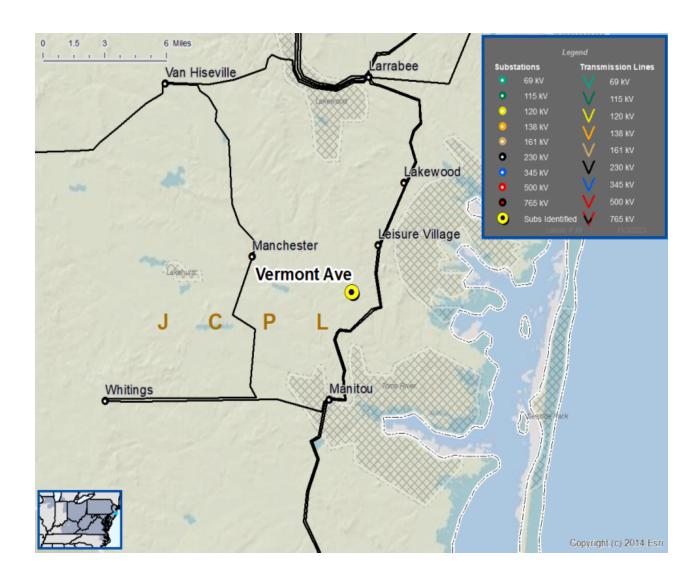
New Customer Connection - A customer requested 34.5 kV service for load of approximately 10 MVA; location is near Vermont Ave Substation.

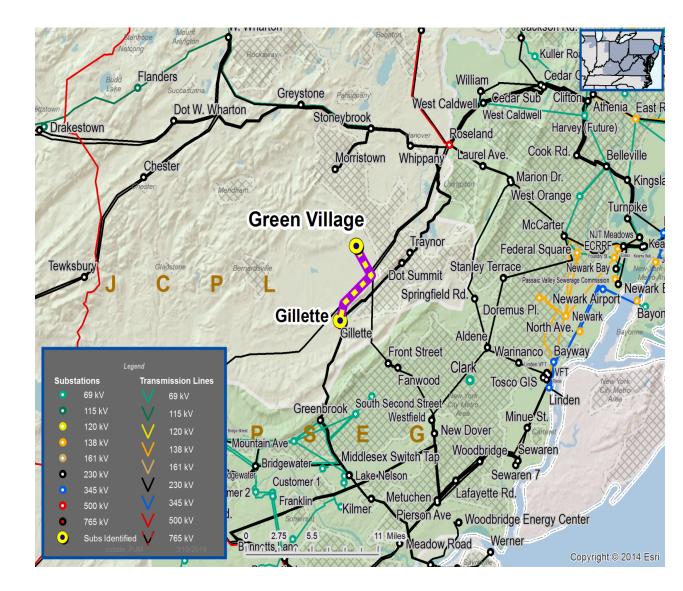
- Line sections are exhibiting deterioration, increasing maintenance needs. Transmission line is approaching end of life
- Transmission line ratings are limited by terminal equipment.

■ Rebuild the Gillette-Green Village 34.5kV E5 and J114 circuit (shared structures). Replace approximately 134 damaged poles. Install 5.7 miles of new conductor.

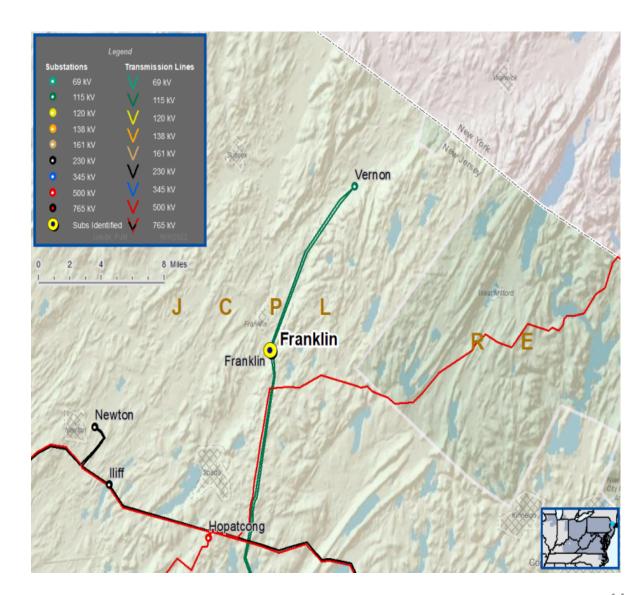
- The 115 34.5 kV No. 2 Transformer at Franklin Substation was installed 70 years ago and is approaching end of life.
- Ethane and Hydrogen gases have been exhibited as elevated compared to IEEE standards.
- Existing TR Ratings:
 - 61 / 66 MVA (SN / SLTE)

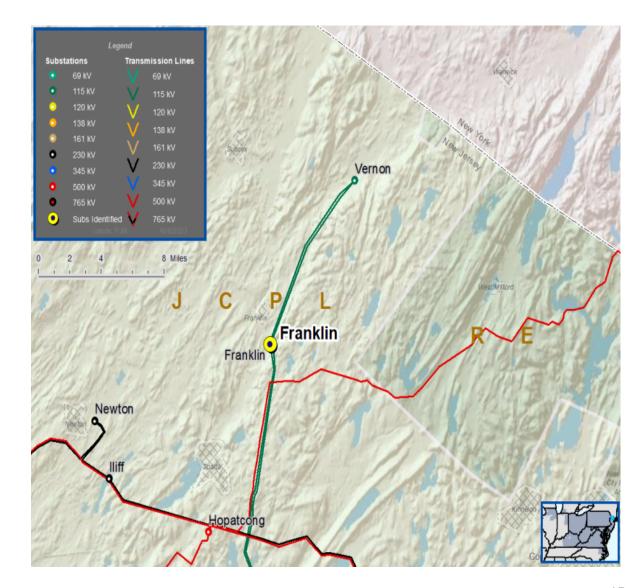
- Franklin Substation is configured as a straight bus with two 115 kV sources. Each 115 kV source is a tap connection on the Vernon West Wharton 115 kV lines
 - Franklin Substation serves approximately 67 MW of load and 4,464 customers.
 - Both existing Vernon West Wharton 115 kV Lines are 16.7 miles long. A fault anywhere on either line will cause an outage at Franklin and Vernon substations.

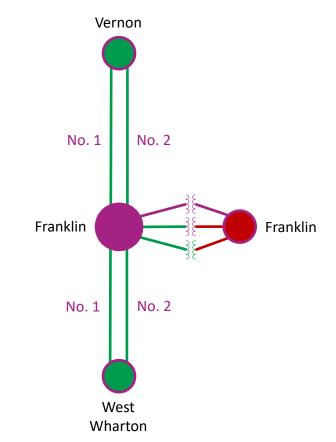
• Replace the existing 115-34.5 kV No. 2 transformer with a 90 MVA unit.

· Replace relaying at Franklin, Vernon, and West Wharton Substations

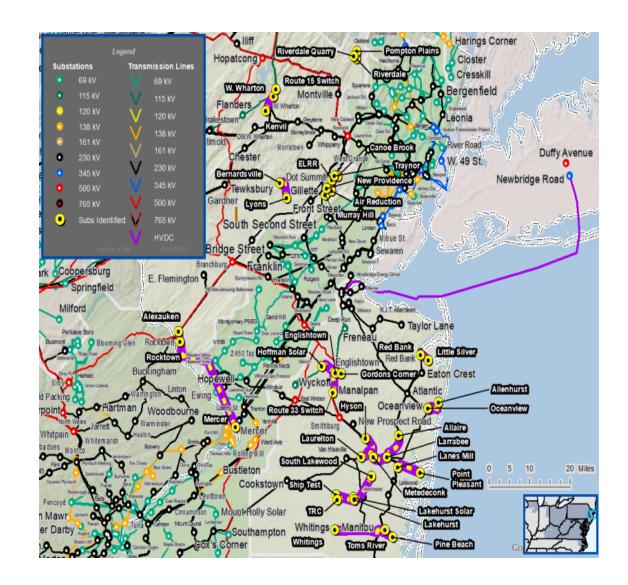
- There is a lack of automatic restoration of 34.5 kV lines following tripping events without the intervention of Transmission Operators.
- Manual restoration increases the risk of system constraints on adjacent facilities, especially for critical lines as identified by Transmission Operations.
- Obsolete electromechanical relay schemes. In many cases, the protection equipment cannot be repaired due to a lack of replacement parts and available expertise in the outdated technology.
- Proper operation of the protection scheme requires all the separate components perform adequately during a fault.
- · Transmission line ratings are limited by terminal equipment.
