Sub Regional RTEP Committee Western Region AEP

February 20, 2019

AEP Needs

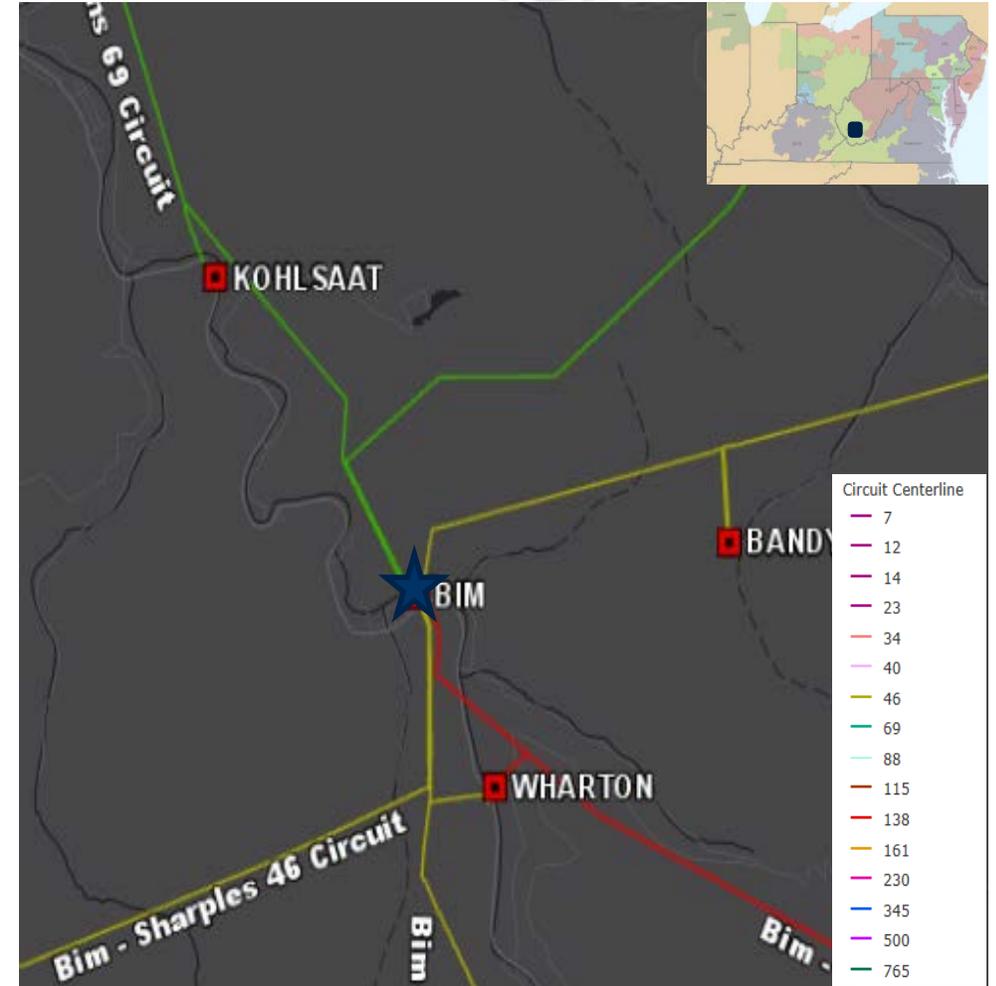
- Breaker "D"
 - 1967 FK oil type breaker without containment
 - Fault operations: 369, recommended 10 operations
- Cap Switchers "AA" and "BB"
 - SC-2030 type
 - No gas monitoring
 - Sister units have experienced numerous gas and interrupter failures

- Breakers "A", "B", "C", and "E"
 - 1967 FK oil type breakers without containment
 - Fault operations: CB A (85), CB B (14), CB C (131), CB E (63), recommended 10 operations

- Existing Gr. SW. MOAB configuration creates faults in the station; known safety hazard in legacy station designs
- Transformer Bank #1 138/69/46
 - Oil leaking at a steady rate
 - Deteriorating wooden crossties, obsolete arresters and bushings, LTC is not in adequate condition
 - Cooling system and controls need replaced
- GND Bank
 - Interfacial tension in all three units has been on the decline or at sustained low levels for around 15 years, indicating the development of sludge which can impede oil circulation/cooling
 - Rising/Sustained high moisture content has resulted in degrading/sustained low levels of dielectric strength
 - Obsolete arresters/bushings, deteriorating wooden crossties
 - Cooling system/controls need replaced

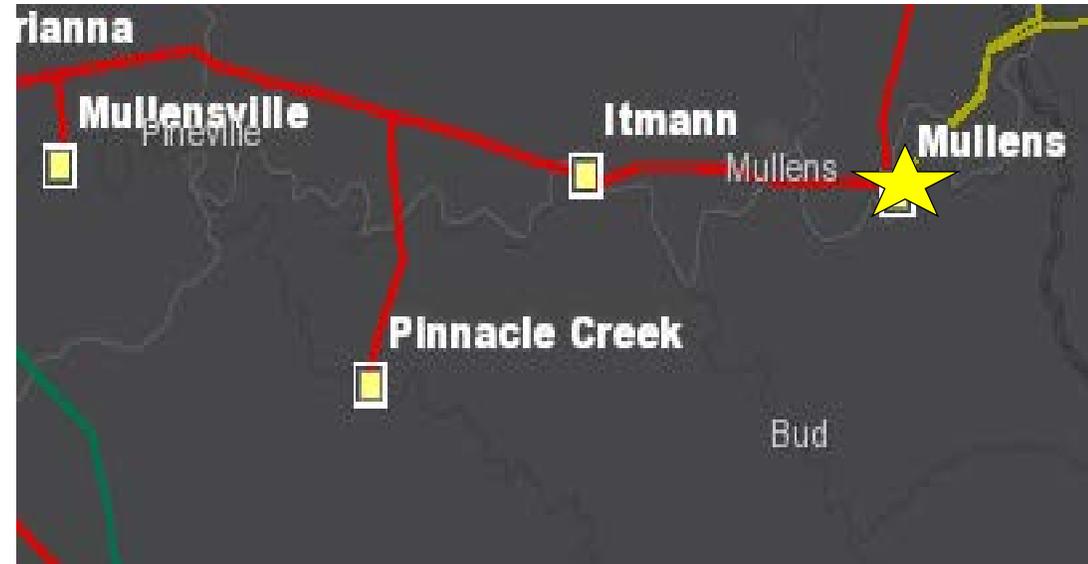
- Transformer Bank #4 138/46 kV
 - Short circuit strength breakdown caused by the amount of high energy electrical through fault events
 - Numerous gases are at the IEEE level 2 condition level with acetylene and ethylene being at the highest condition level 4, which negatively impacts the oil dielectric

- Existing Gr. SW. MOAB configuration on the 138/46 kV and 138/34.5 kV transformers create faults in the station; known safety hazard in legacy station designs

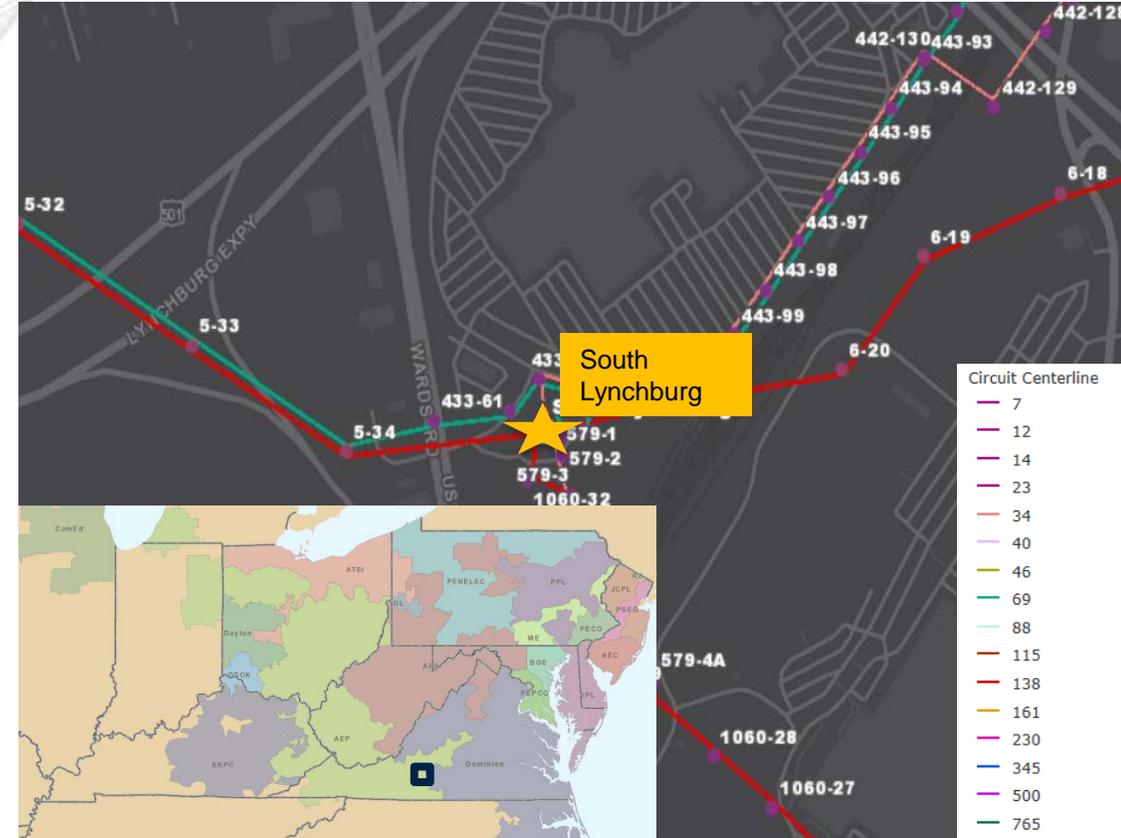
- The 1959 vintage 138/69/34.5 kV transformer #1 at South Lynchburg Substation has elevated levels of carbon dioxide which began increasing in 2004. Additionally, the interfacial tension is steadily decreasing and the oil power factor is steadily increasing indicating that the oil insulation is beginning to degrade as well. This data proves that the transformers insulation is aged and has degraded.

- 12 kV CBs P, L, K, N, M, and R are oil breakers
- Number of fault operations: P (44), L (42), K (152), N (132), M (34), R (135)
- 34.5 kV CB F has 31 fault operations

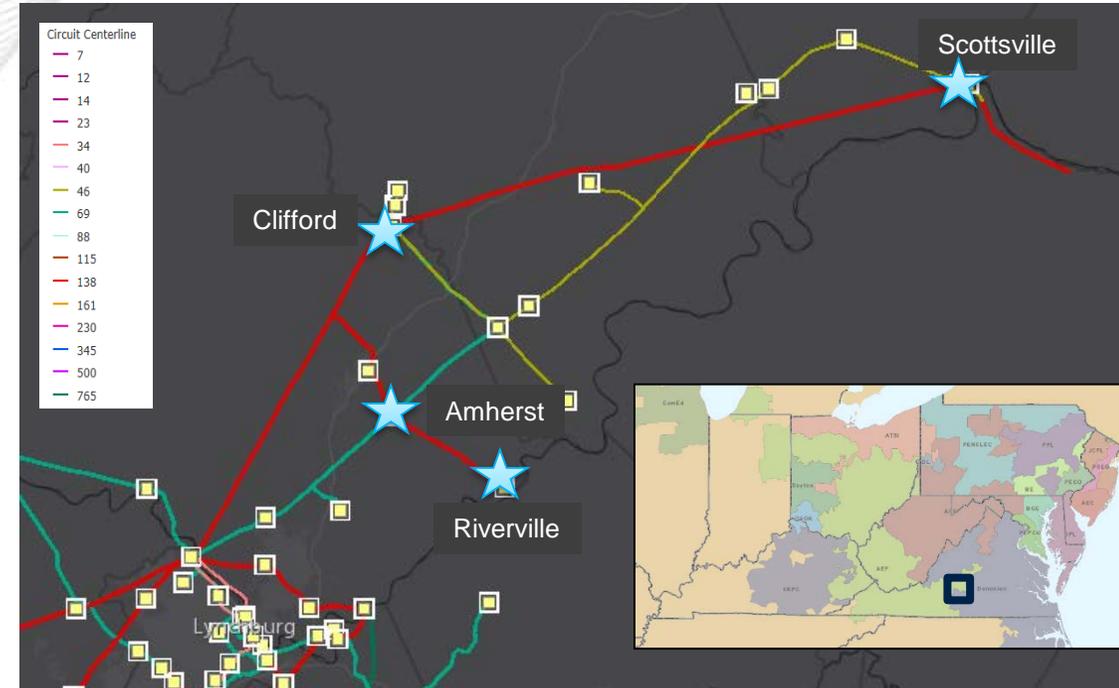
The Amherst-Clifford 69 kV circuit (13.9 mi.) consists primarily of 1960 wood pole structures with 4/0 ACSR overhead conductor and currently has 26 open conditions including rot top, woodpecker damage, split poles, broken insulators and damaged shield wire. Over the 2015-2018 time frame there were 5 momentary outages which occurred during lightning and wind events due to the lack of shield wire on half of the circuit, exposing it to a higher probability of forced momentary and permanent lightning induced outages.

The Clifford-Scottsville 46 kV circuit (45.5 mi.) consists primarily of 1926 wood pole structures with 4/0 ACSR overhead conductor and currently has 93 open conditions including rot top, rot heart and woodpecker/insect damage. Over the last recorded 3 year period, 6 permanent outages were observed. Also, only 16% of the line has shielding, mainly on the tap sections.

Riverville station serves a large industrial customer (Grief Brothers Corporation) consisting of approximately 45 MW from a radial 138 kV line served from Boxwood S.S. located between Clifford and Reusens. This radial line is approximately 9.2 miles long, leaving a large amount of load exposed to a variety of single contingency events.

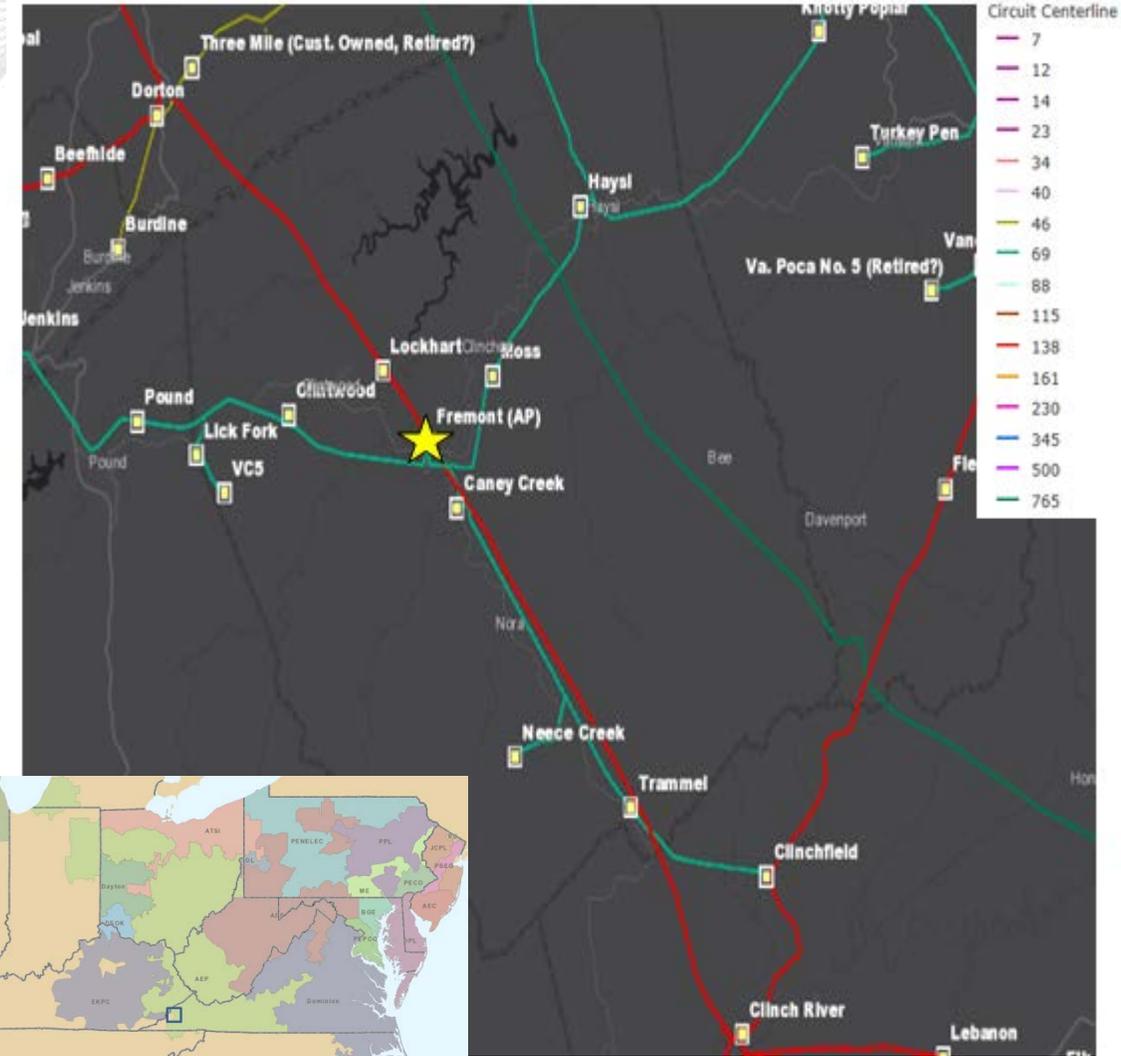
The 138/12 kV Transformer #3 at Fremont station is 1971 vintage and is showing dielectric breakdown (insulation), accessory damage (bushings), and short circuit breakdown (due to through faults).

138/69 kV Transformers #1 and #2 at Fremont station are 1957 vintage and show significant signs of dielectric breakdown (insulation), accessory damage (bushings), and short circuit breakdown (due to through faults).

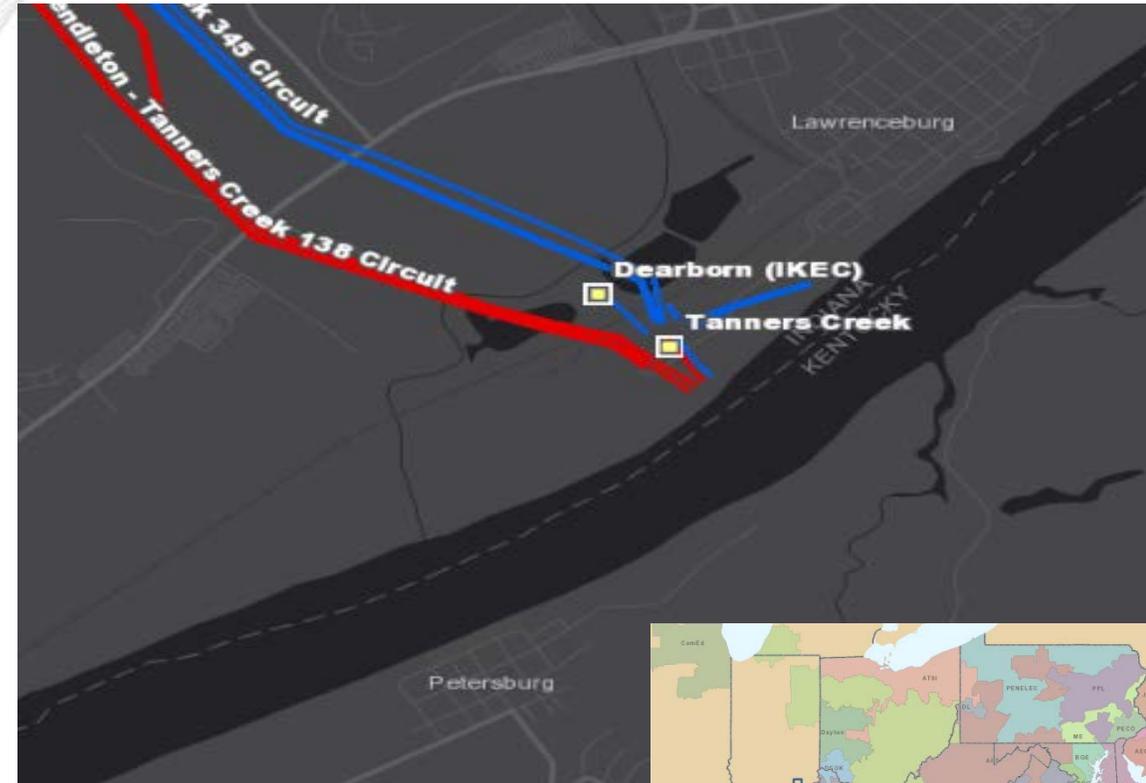
- Tanners Creek
 - Currently a line fault on the Dearborn circuit causes 5 EHV breakers to open. This is above the AEP max of 4 and must be addressed.
 - According to the DEDSTFMRS PJM document, 200kV+ facilities with 7+ elements are required to be in a complete breaker and a half setup at a minimum. This facility has 9 elements and is currently in an incomplete breaker and a half setup.

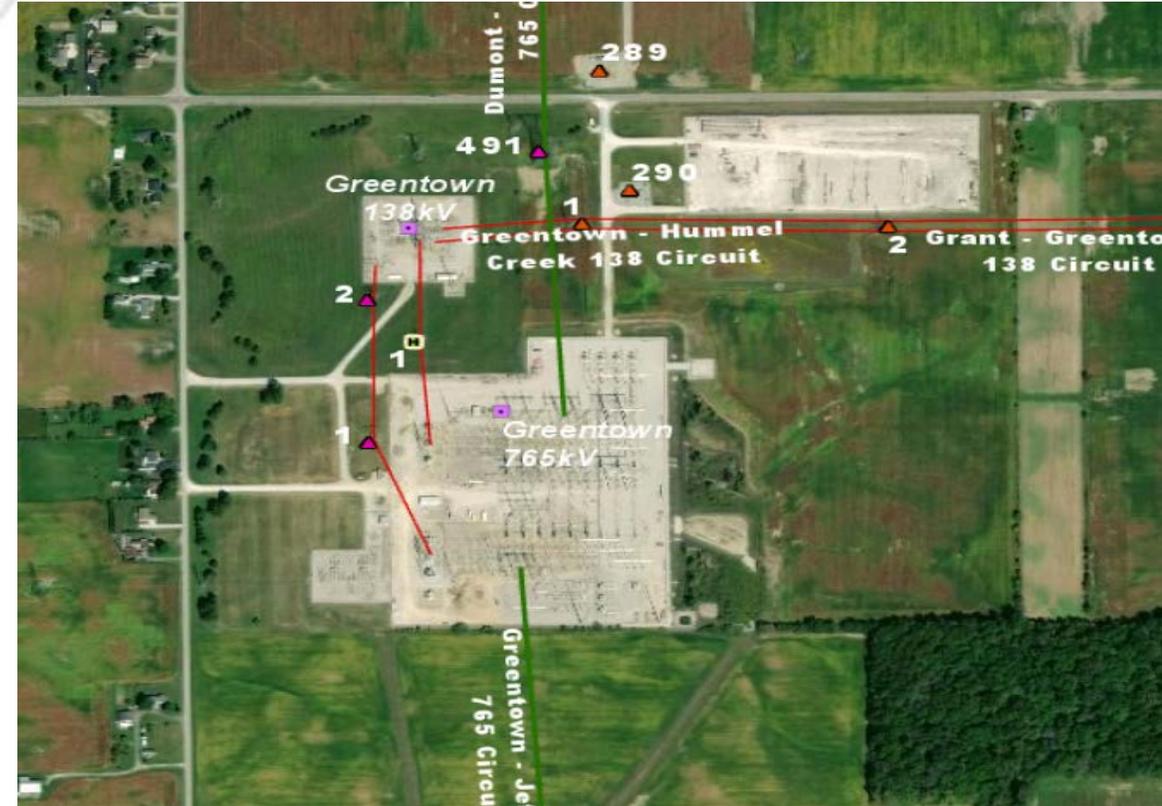
- Greentown
 - According to the DEDSTFMRS PJM document, BES facilities with 7+ elements are recommended to be in a complete breaker and a half setup at a minimum. This facility has 7 elements and is currently in an incomplete breaker and a half setup.

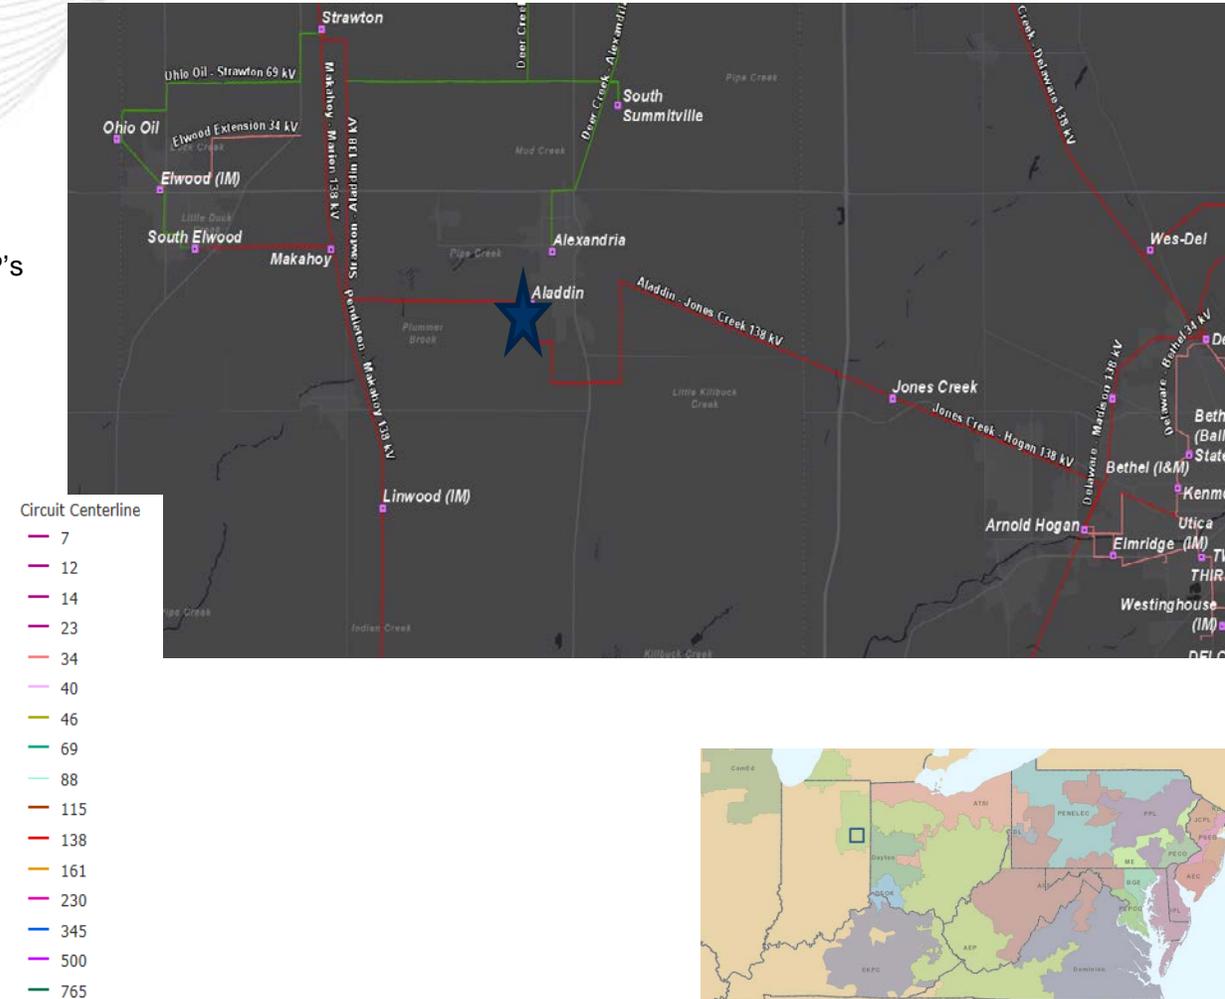
- This line currently has 4 MOABS in series (2 at Aladdin and 2 at Jones Creek) which is above AEP's max of 3.

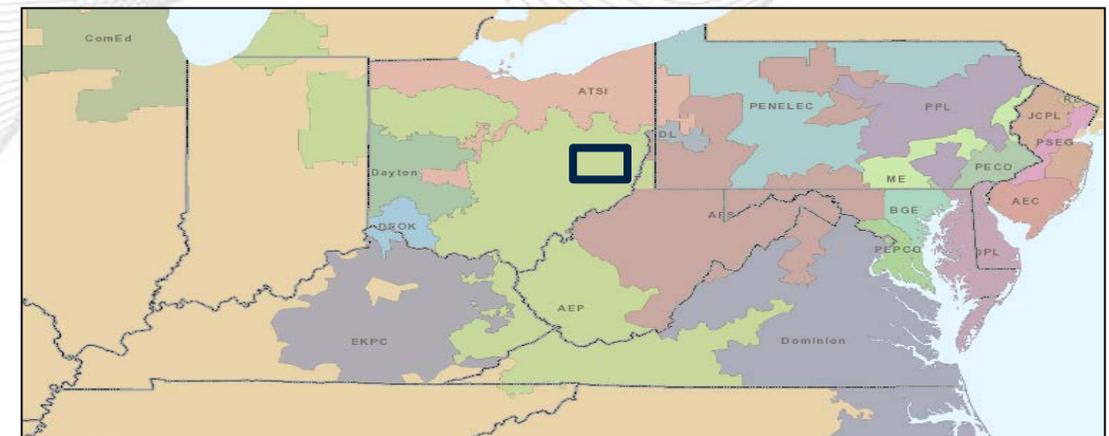
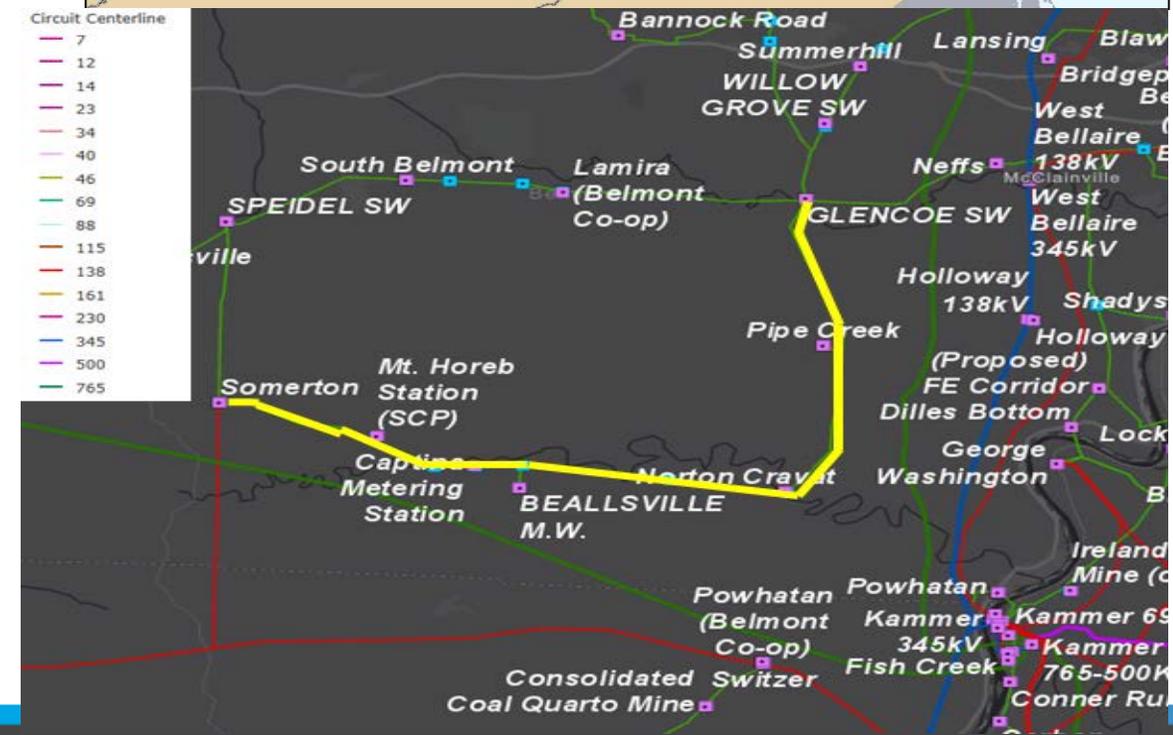
The Glencoe-Somerton 69kV circuit is 22.5 miles in length and has numerous condition issues. Within the last 5 years, it has experienced 18 momentary outages (3.6 per year) and 7 permanent (sustained) outages (1.4 per year). The average outage duration has been 13.7 hours. AEP and South Central Power Co-op customers served from this circuit suffered nearly 3.5 million minutes of customer interruption (CMI) during the 2015-2018 timeframe. The circuit currently has 148 open conditions (43 structural, 23 on conductor, 5 for shielding/grounding, 24 for hardware, and 53 for forestry/ROW). The majority of the wood poles were installed in 1953 and 1970 (84% of circuit length). The conductor was also primarily installed in 1953 (219 kcmil ACSR) and 1970 (336 kcmil ACSR). The majority of the outage causes have been attributed to T-Line condition issues.

The two 69kV delivery points for South Central Power Co-op's Beallsville and Pipe Creek stations are connected via hard taps (no sectionalizing switches present). This requires an outage to the customer whenever maintenance or emergency repairs must be done on either side of the customer tap.

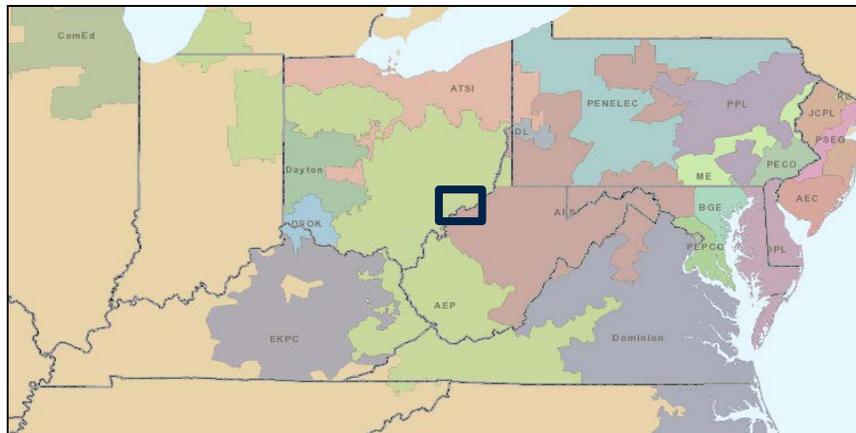
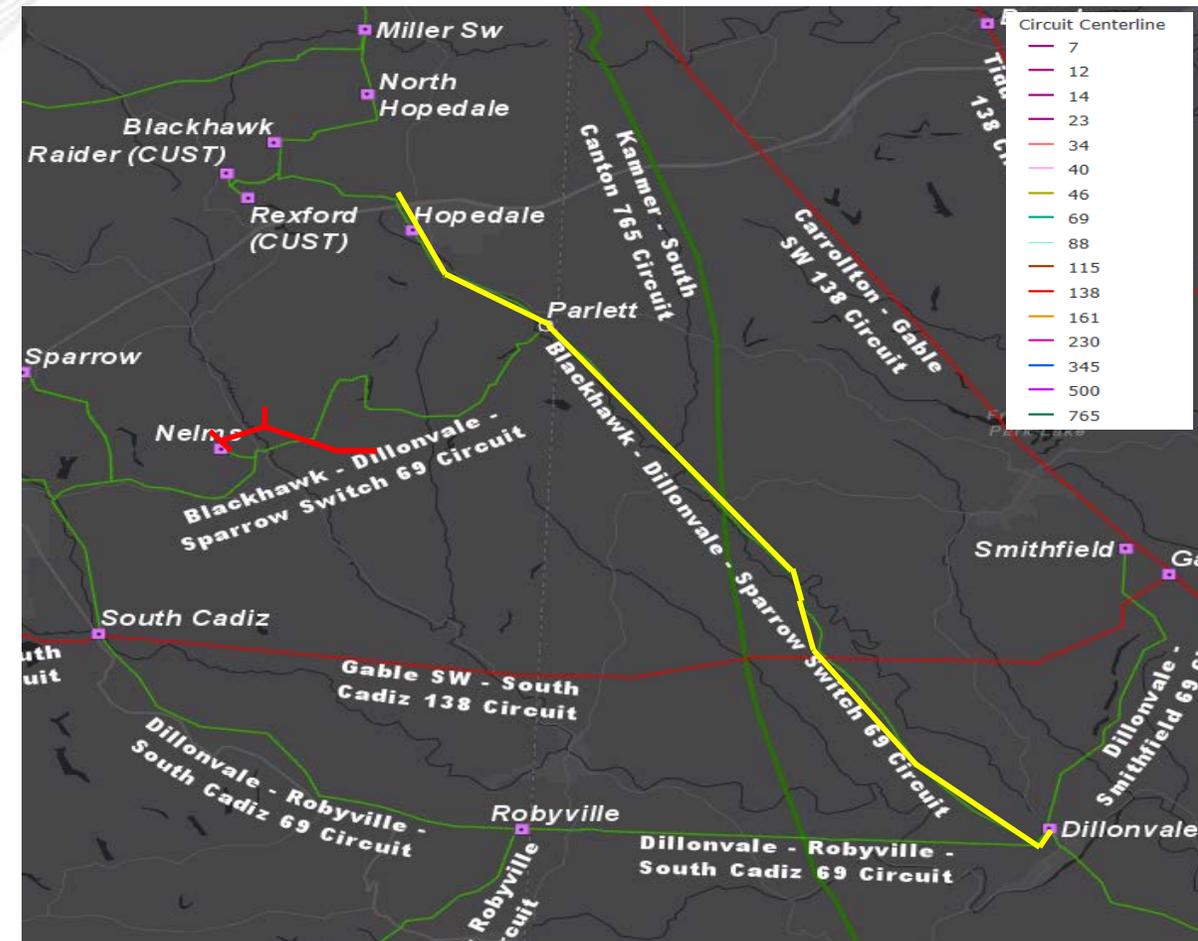
The Blackhawk-Dillonvale-Sparrow 69 kV line was originally constructed in 1918 and approximately 30% of the wood structures are still from 1918. More than half of the structures are of pre-1980 vintage and are affected by heavy rot and woodpecker/insect damage. 70% of the conductor is from 1926 (or prior) and is showing signs of tensile-related failures. There are 180 open A conditions on this line. Sections of the Blackhawk-Parlett line (Blackhawk Extension, Raider Extensions and Rexford Extension) have been recently rebuilt to 138 kV standards. (Shown in Red)

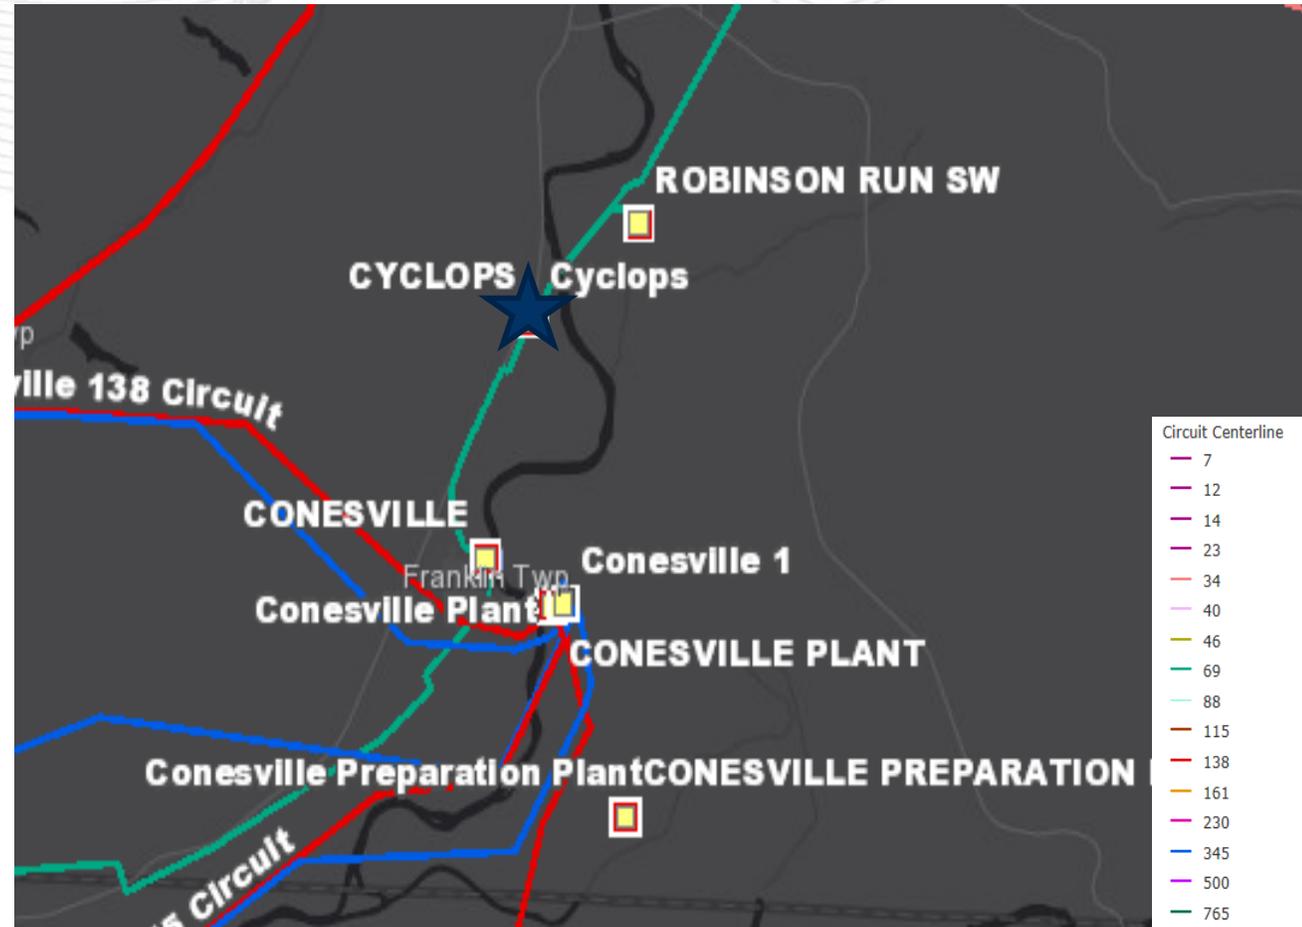
- Cyclops 69kV circuit switcher A is currently being used as a line CB. This model has limited spare parts availability and reliability concerns. This circuit switcher has also experienced 41 fault operations.
- Cyclops 69kV CB B is an oil type breaker (vintage 1955) that has exceeded the manufacturers recommended number of fault operations (36 total faults). Oil breakers are difficult to maintain due to oil handling requirements. Oil spill can occur during maintenance and fixes.
- Cyclops station currently has 19 electro-mechanical relays employed.
- Cyclops station is currently built upon a four-pole wooden bay that is progressively deteriorating.

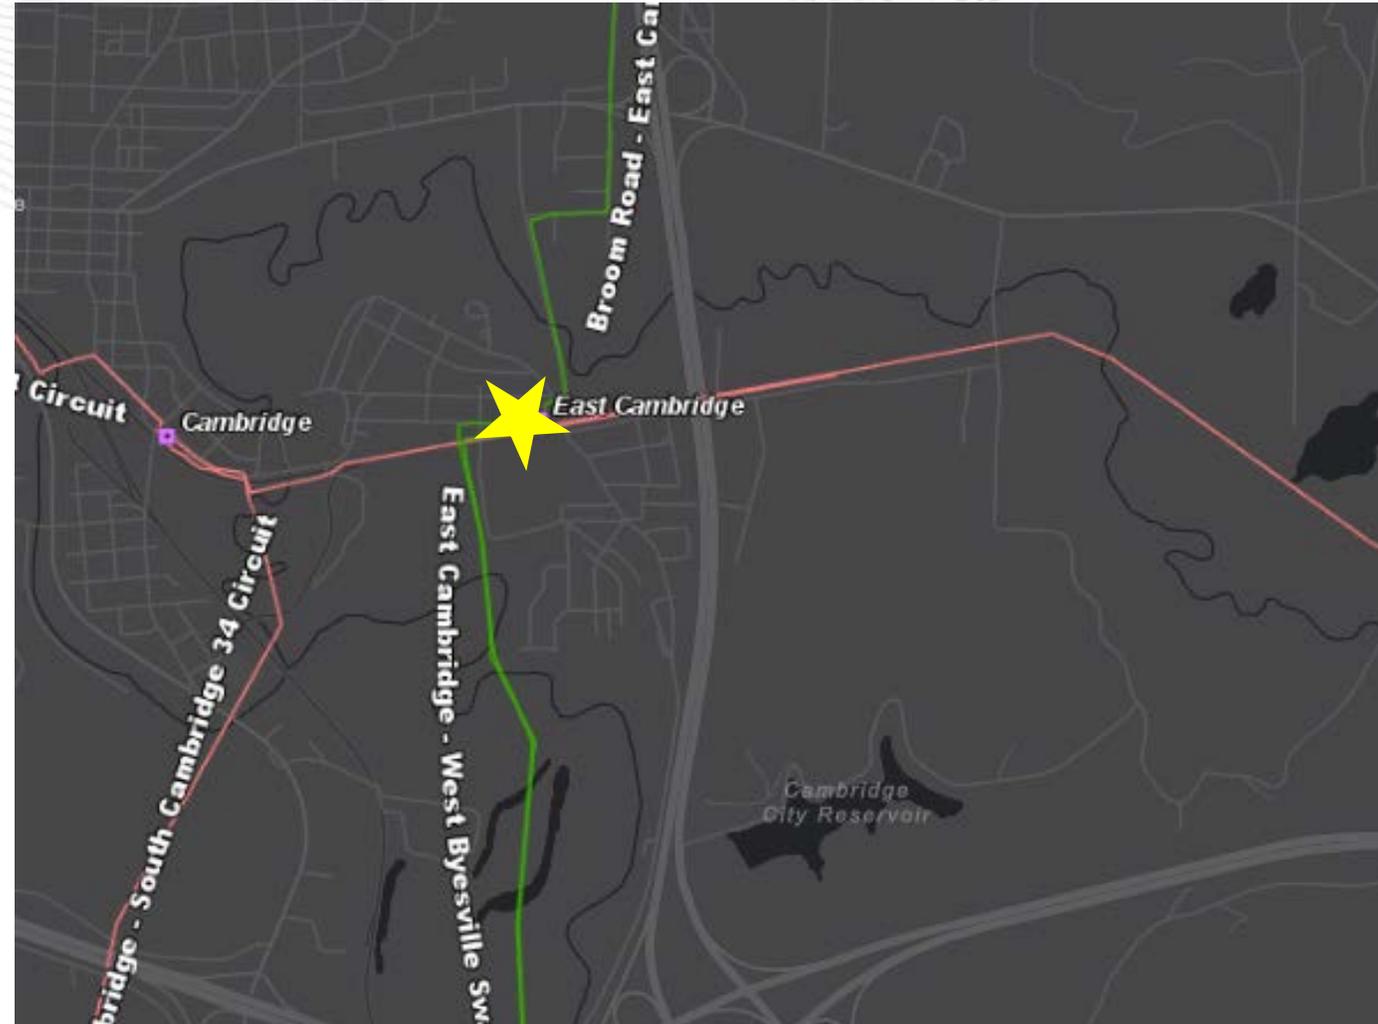
- East Cambridge 34.5kV CB “D”, 69kV CB “A” and 69kV CB “C” are vintage (1970-1975) circuit breakers. Oil breakers are difficult to maintain due to oil handling requirements and risk of oil spills during maintenance and failures. In addition, these CB’s have exceeded the manufacturers recommended fault operations: CB A (8), CB C (28), and CB D (91).
- East Cambridge circuit switcher AA (vintage 1970) is recommended for replacement due to reliability concerns and lack of spare part availability.
- East Cambridge currently has 36 electro-mechanical relays employed.

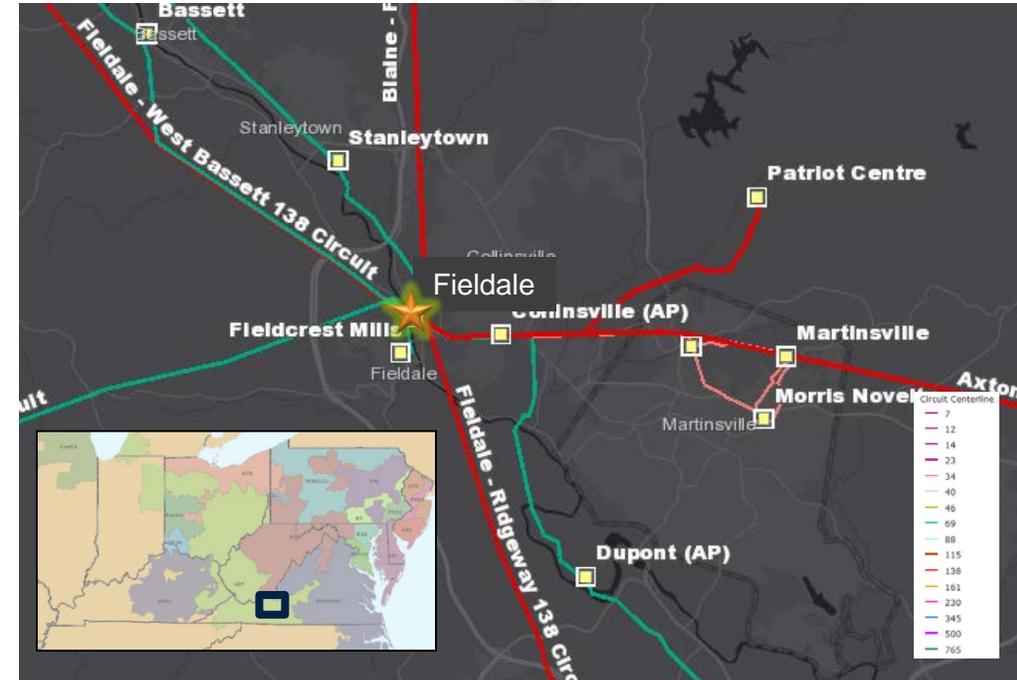
Fieldale Station: Circuit breakers "J" (recently failed), "T" (39 operations), and "F" (15 operations) are FK type oil breakers. The drivers for replacement are bushing damage, no repair part availability and potential of PCB (polychlorinated biphenyl) presence. PCB was used as coolant and lubricant in electrical equipment because of their insulation capabilities. Their manufacturing was stopped in 1977 because of evidence of environment issues and harmful health effects. However, equipment installed prior to 1977 is at risk of having PCB contents.

Breakers "BC" (30 fault operations) and "AC" (31 fault operations) are air blast breakers. AEP is replacing air blast breakers across the system because of safety concerns. These types of breakers tend to fail violently, frequently dispersing porcelain shards from their bushings during failures which is a safety issue for station personnel and public.

Breakers "G" (36 operations), "C" (47 operations), and "D" (27 operations) are also oil breakers but of the type ITE (CB G) and CF-48 (CB C & D). Oil breaker maintenance has become more difficult due to the oil handling required. CF-48 also are notorious for mechanical damage related to the breaker's open and close contacts.

Circuit switchers "DD" and "EE" are Mark V type. Mark V's are an obsolete type that do not coordinate with modern relaying packages. Other drivers for replacement are age and no repair part availability. Transformer 3 (recently failed) is showing a breakdown in winding insulation (dielectric strength). It also shows C2H2 levels above IEEE thresholds. Age and short circuit strength breakdown (due to the amount of through faults suffered) is the main driver for replacement.

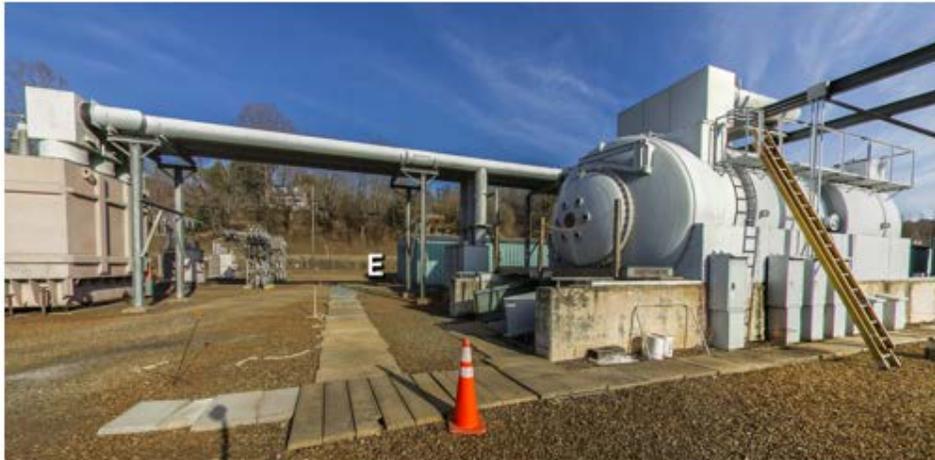
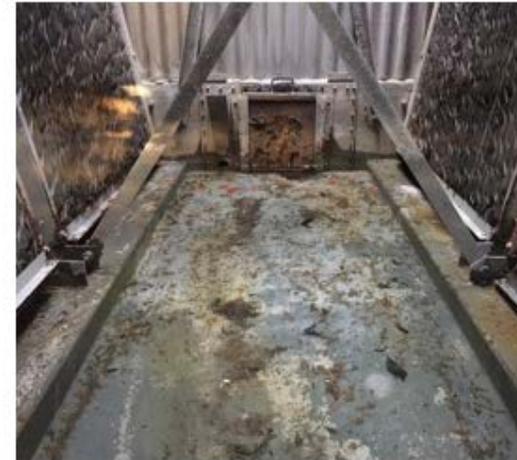
Cooling tower
interior pan

- The existing device has multiple problems with the cooling such as water leakages. Corrosion of the steel parts of the cooling system is becoming more of a concern from a machine reliability standpoint. There is no longer vendor support for the cooling system which has made spare parts difficult to procure.

- Environmental concerns include the use of mercury in some switches (26 units with approx. 2 ounces of mercury per unit), the use of asbestos for insulation, and the possibility of bacterial contamination in the cooling system. Due to the open loop cooling system being at a higher risk to develop bacteria, respirators are required when cleaning the cooling pit during maintenance.

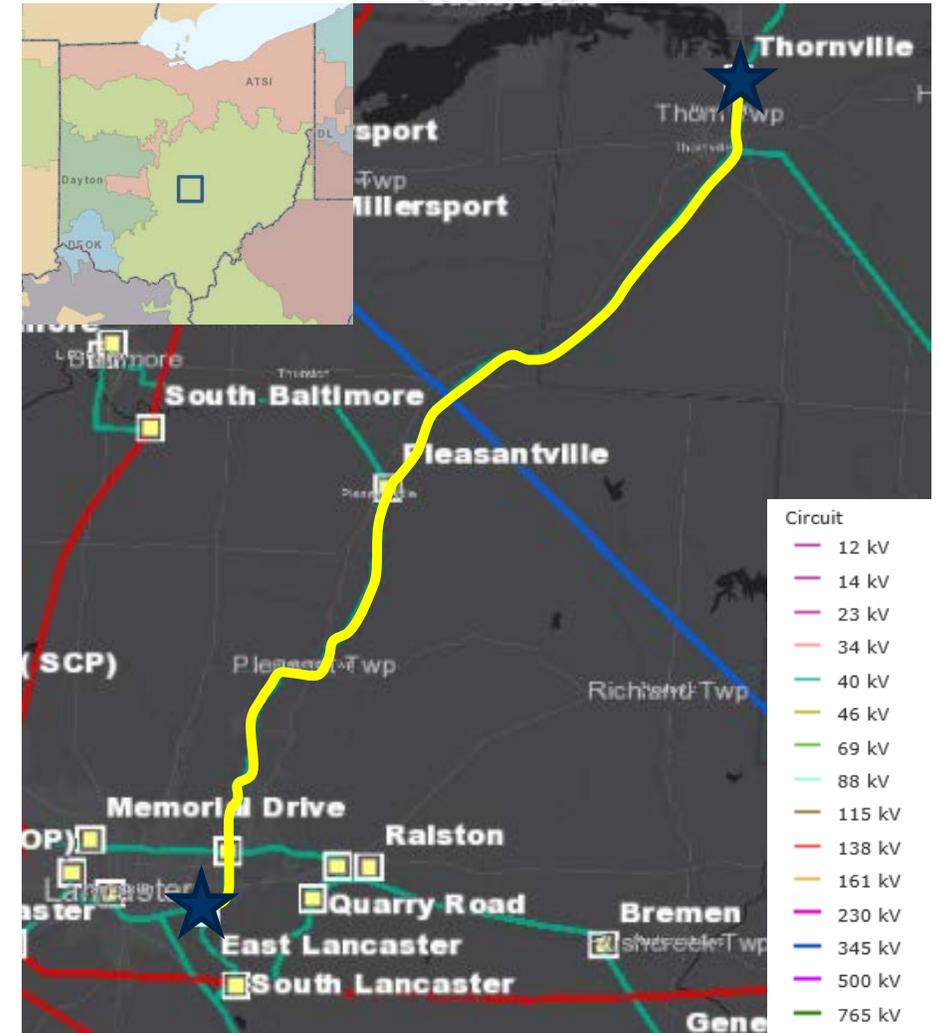
- The existing 18.4 mile 69 kV section between Thornville –Lancaster 69 kV line was constructed in 1915 using wood pole structures with several copper conductors (mostly 1/0 Cu).
- There are currently 228 open A conditions on this line. The Baltimore-East Lancaster 69 kV circuit has experienced over 350,000 customer minutes of interruption over the past three years. The majority of outages were due to conductor failures, shielding failures, structure washouts, and insulators failures.

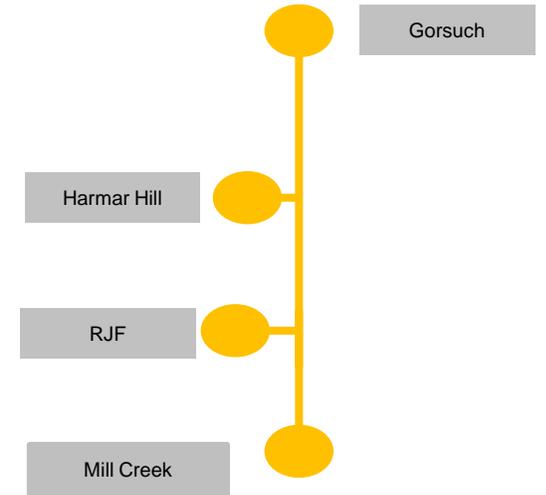
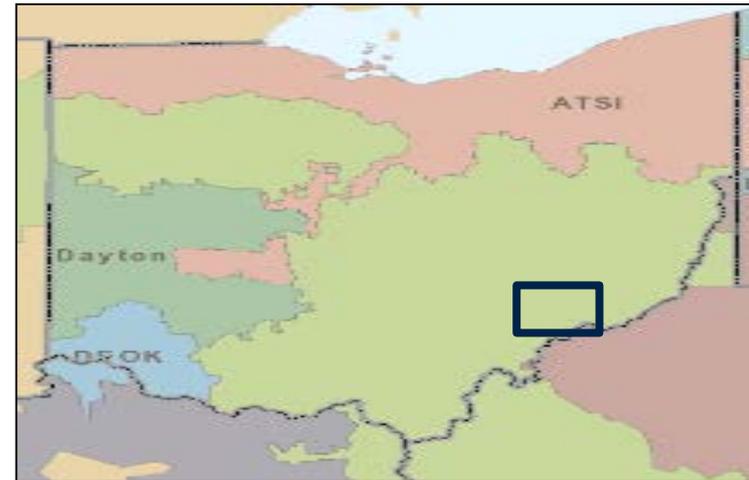
RJF is a customer owned substation that is served off a 138kV hard tap. Harmar Hill is served from a tap with a one way switch. Any line work along between Mill Creek and Gorsuch causes considerable outages to both customer loads. There is limited transfer capability at Harmar Hill and no transfer capability for RJF. AEP's internal guidelines justify sectionalizing on this line (FOI: 10.17).

Mill Creek will be replaced by a new substation Devola as part of an unrelated project (S1125).

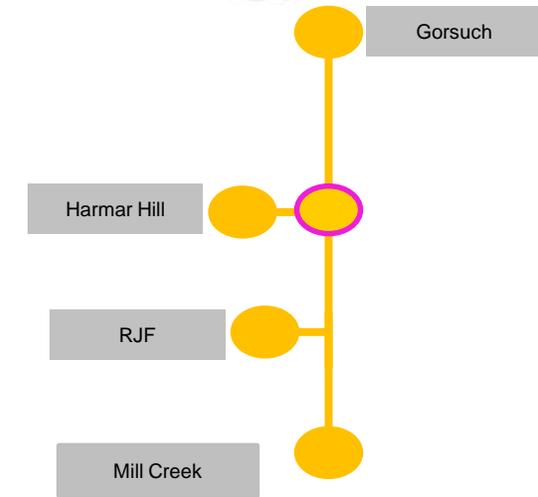
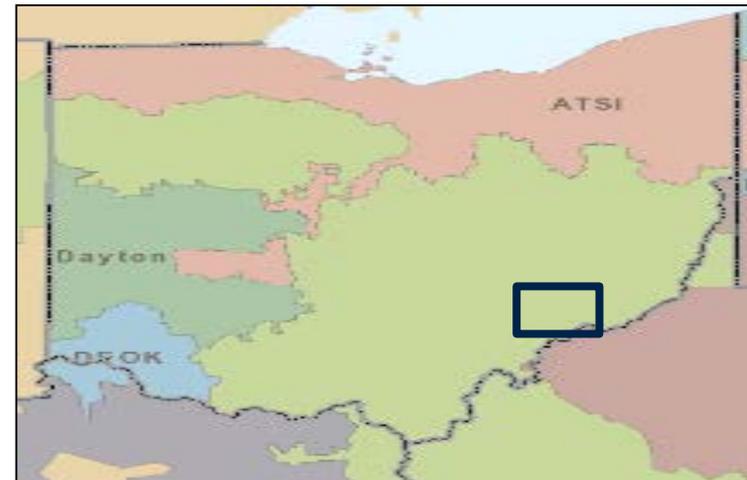
Install a 3-way, SCADA-controlled phase-over-phase switch at Harmar Hill to replace the one-way line switch on the Gorsuch – Mill Creek 138 kV circuit.
