Sub Regional RTEP Committee: Western AEP Supplemental Projects

March 19, 2020

AEP Transmission Zone M-3 Process Muskingum, Guernsey, Tuscarawas & Stark Counties, Ohio

Need Number: AEP-2020-OH001 (revised)

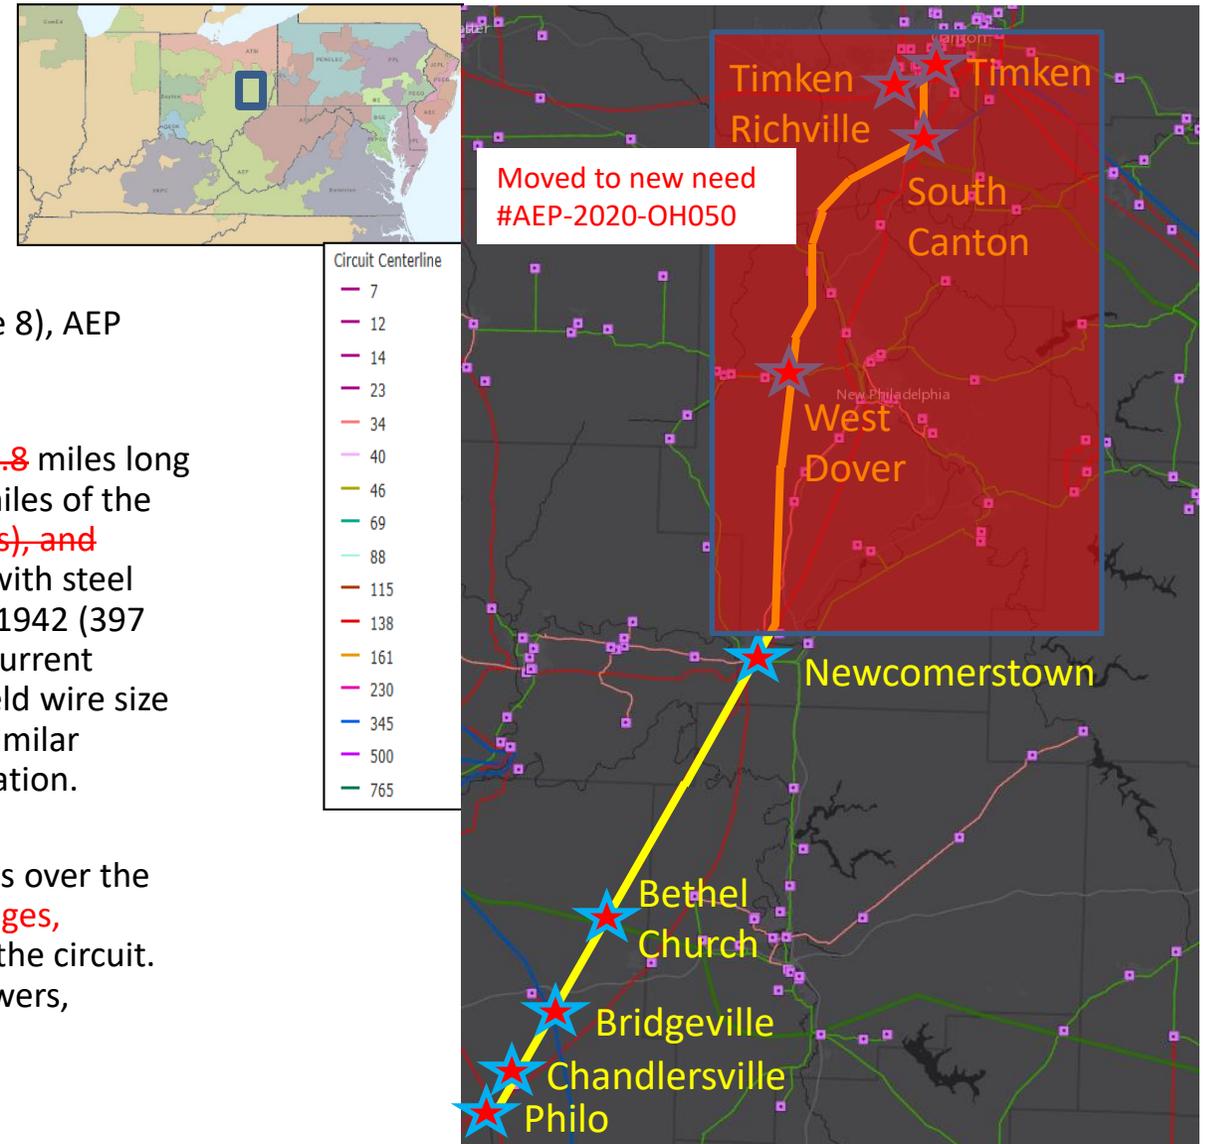
The Philo-Newcomerstown ~~Torrey~~ 138kV transmission line ~~section asset~~ is ~~32 70.8~~ miles long and consists of portions of the following circuits: Philo-South Canton (~~32 68.2~~ miles of the total circuit length of 75.2 miles), ~~South Canton-Timken Richville (2.0 of 3.5 miles), and Timken Richville-Timken (0.6 of 3.4 miles)~~. The line was originally built in 1942 with steel lattice towers. The conductor is 6-wired single-circuit, with one side installed in 1942 (397 ACSR) and the other side installed in 1954 (477 ACSR). The line does not meet current grounding and shielding requirements, due to the condition of the obsolete shield wire size (159 ACSR), and the line shielding angle being inadequate. This T-line exhibits similar conditions as the examples listed in AEP's 1930's steel lattice tower line presentation.

The Philo-South Canton 138kV circuit has experienced ~~18 15~~ momentary outages over the past 5 years (~~zero sustained outages, resulting in zero CMI~~) and 4 sustained outages, ~~resulting in 437,567 minutes of CMI~~. There are currently 18 open conditions on the circuit. Examples of the conditions include: burnt insulators, worn hardware, rusting towers, damaged shield wire, and severe rusting of the tower steel.

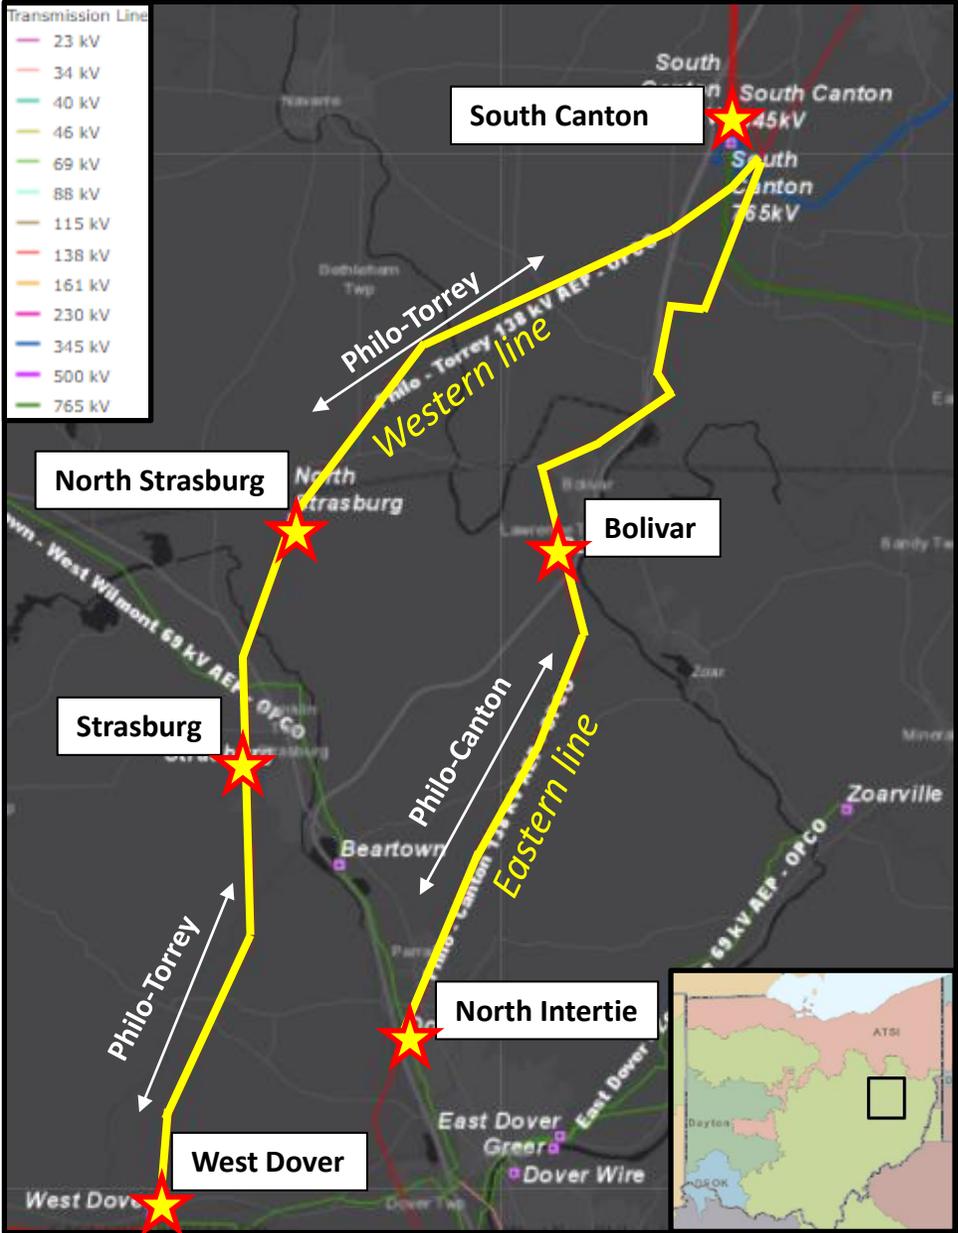
- The South Canton – North Intertie eastern 138kV transmission line is 14.6 miles long, originally constructed in 1923. The vast majority of the structures are still original, as well as the six-wired 336 ACSR conductor, insulators, and hardware. This line is made up of several circuits connected between South Canton and Sunnyside stations.
- Insulator assemblies are showing corrosion and deterioration, which could lead to additional failures and safety concerns.
- This line has experienced 12 momentary outages and 2 sustained outages over the past 10 years (2008/2018).

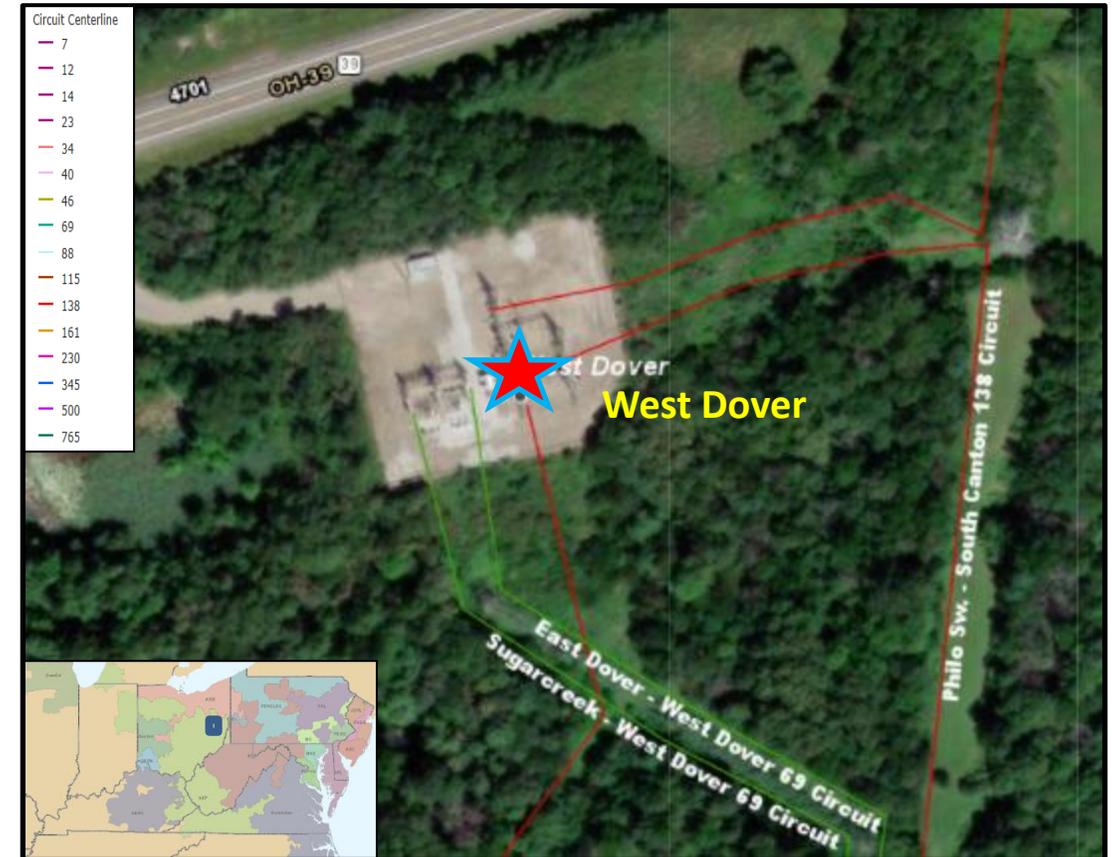
West Dover 138-69kV station creates a 3-terminal point on the line, due to the lack of 138kV line breakers or a 138kV transformer protection device (just a MOAB/ground-switch system today). This complicates the circuit protection scheme and is a risk for misoperations and over-tripping. In addition, due to the lack of breakers at the station, there are 3 dissimilar zones of protection combined: 138kV circuit, 138-69kV XFMR, 69kV bus.

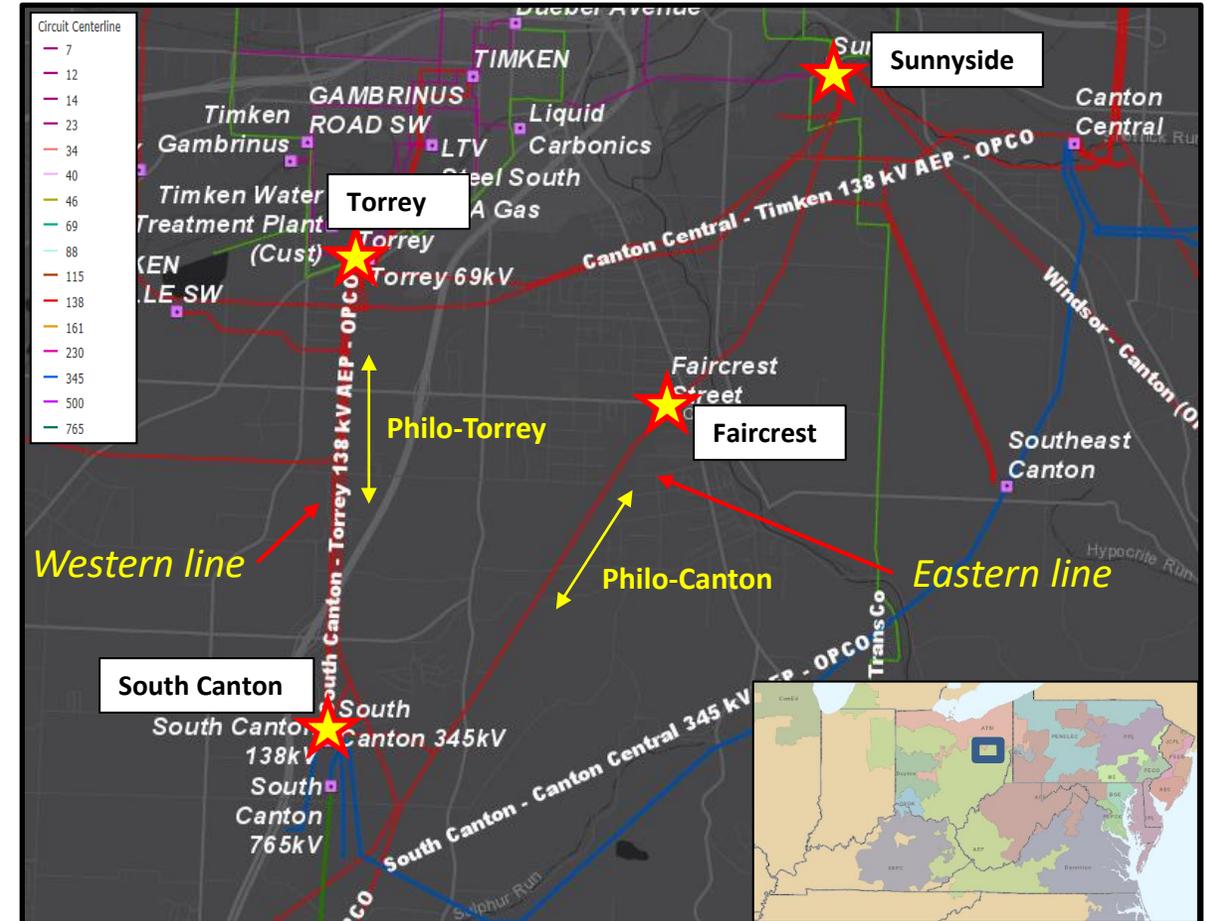
- The South Canton - Sunnyside eastern 138kV transmission line is 5.5 miles long, originally constructed in 1923. The vast majority of the structures are still original, as well as the six-wired 336 ACSR conductor, insulators, and hardware. This line is made up of several circuits connected between South Canton and Sunnyside stations.
- Insulator assemblies are showing corrosion and deterioration, which could lead to additional failures and safety concerns.
- This line has experienced 3 momentary outages and 1 sustained outages over the past 10 years (2008/2018).

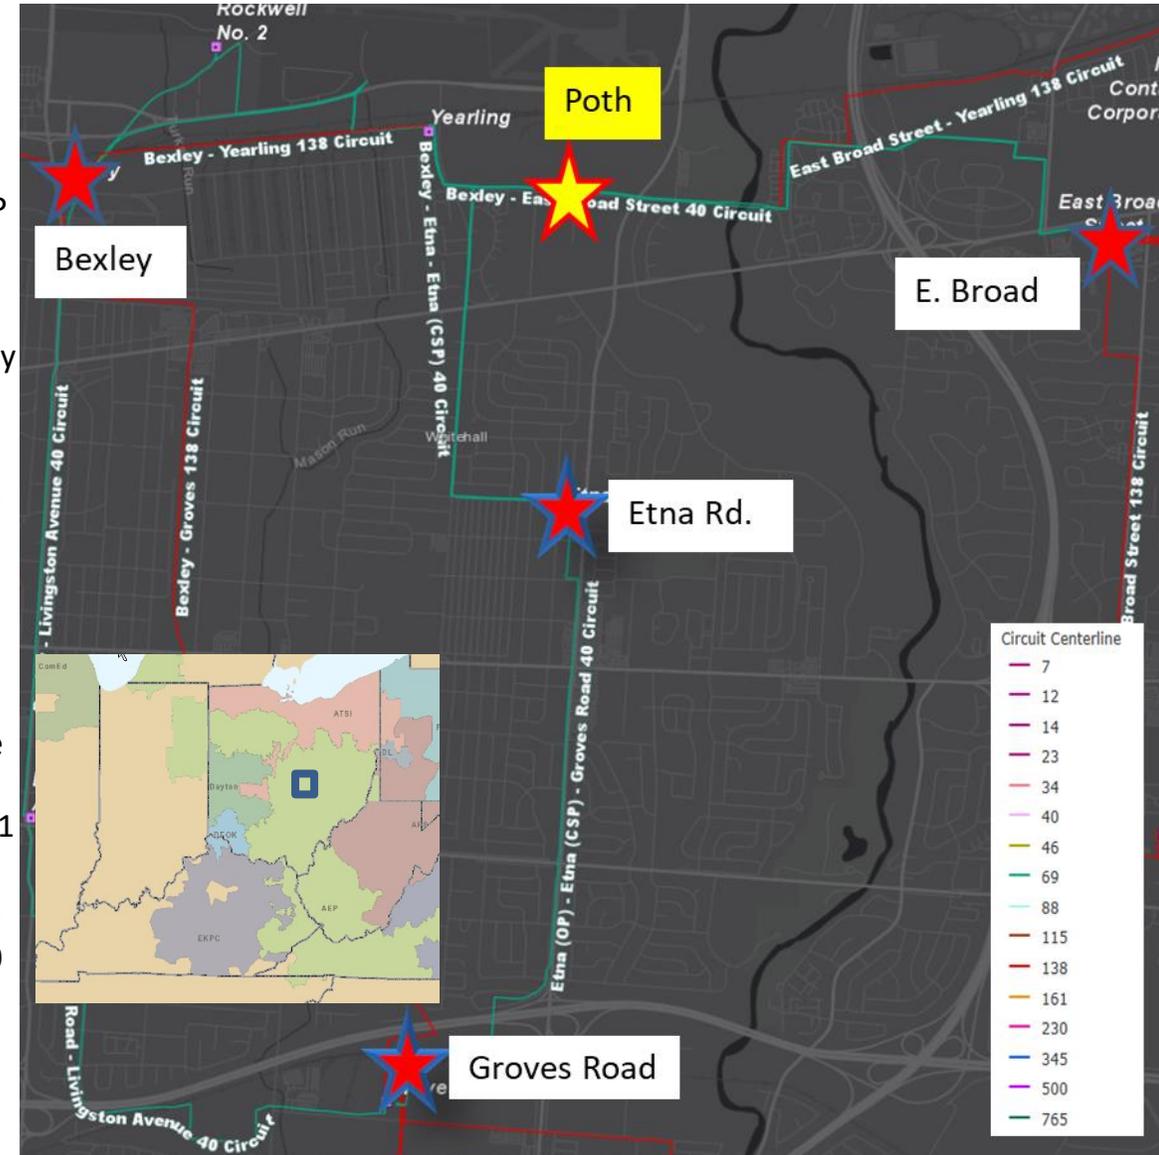
Etna-Groves Road 40 kV line is a majority 1960's vintage (70%) wood pole line with the remainder being built since 1990. The conductor is the original 636 ACSR from 1965. There are a total of 56 open conditions on this line with 51% (42/82) of the poles having at least one condition. These conditions include rot top poles and cross arms, woodpecker damage, broken/missing ground leads, and damaged guy wires. Over the last 5 years there have been 1 momentary and 3 permanent outages on this line.

Etna Tap 40 kV extension (part of the Etna – Bexley circuit) is a vintage 1957 (57%) with the remainder between 1970 (8%), 1980 (5%), 1990 (5%), and 2010 (22%). There are currently 30 open conditions with 28% (22/80) of poles having at least one condition. These conditions include rot top poles and cross arms, woodpecker damage, broken/missing ground leads, and damaged guy wires. Over the last 5 years there have been 4 momentary and 2 permanent outages.

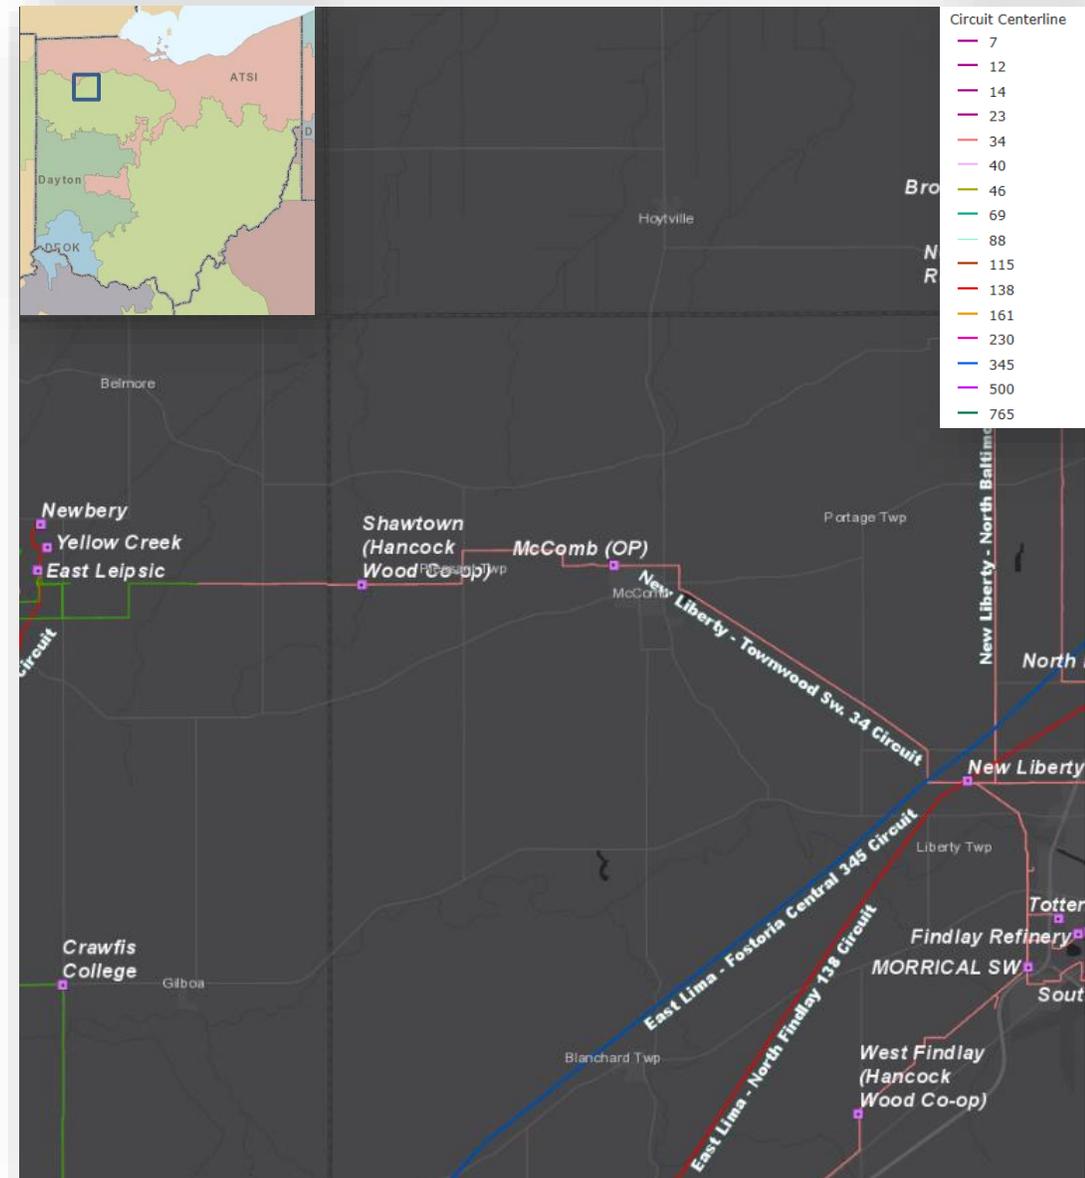
The East Leipsic – Townwood Switch 34.5 kV line (vintage 1934) is 4.04 miles long and still has the original conductor on 65% of the line with the remainder from 1991 (26%) and 2011 (9%). The conductor is a mixture of 336 ACSR (65%), 4/0 ACSR (26%), and 556 ACSR (9%). The majority of the wood pole structures are a mix of 1960's (33%), 1970's (20%), 1990's (36%), and 2000's (11% - steel) vintage. There are 9 open conditions on the 92 structures that include broken/damaged insulators, damaged hardware, and missing ground leads.

The New Liberty – Townwood Switch 34.5 kV line (vintage 1936) is 13.99 miles long and still has the original conductor on 50% of the line with the remainder from 1939 (49%) and 1956 (1%). The conductor is a mixture of 336 ACSR (50%), 2/0 ACSR (49%) and 4/0 (1%). The majority of the wood pole structures are a mix of 1930's (13%), 1950's (5%), 1960's (14%), 1970's (4%), 1980's (7%), 1990's (27%), 2000's (30%). There are 49 open conditions on this 307 structure circuit that include insect damage, broken ground wire, woodpecker damage, rot heart/top, and loose insulators.

There have been a total of 1 momentary and 2 permanent outages over the last 5 years (57,384 CMI) on these two line sections.

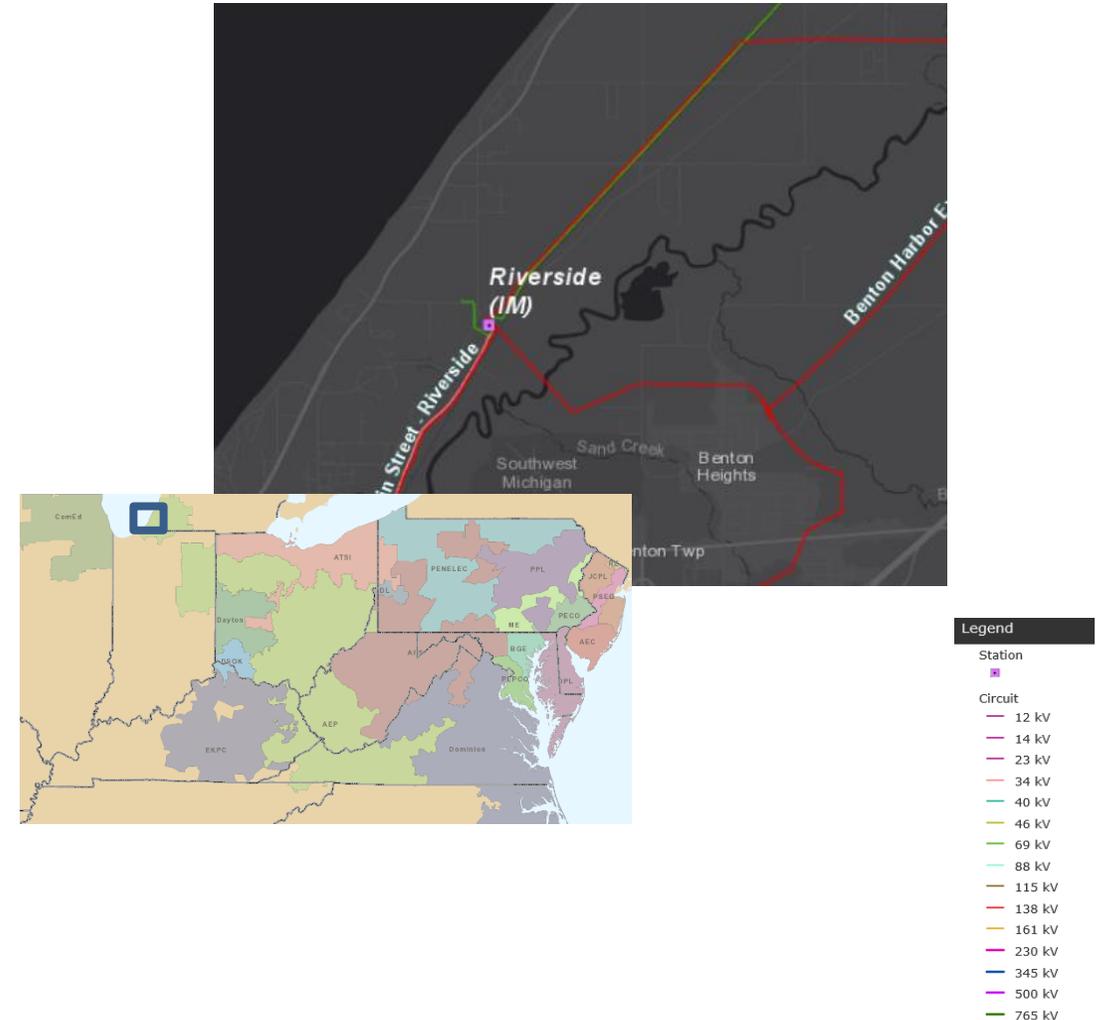
- (2) 138kV Breakers “O” & “A”
 - 1988 vintage SF-6 filled breakers
 - The breaker type has hydraulic leak issues on internal mechanisms which are caused by porous cylinder blocks and chips in the seal groove on the spring connecting rods.
 - Breaker A has operated for a fault 17 times exceeding its manufacturer recommendation of fault operations (10)

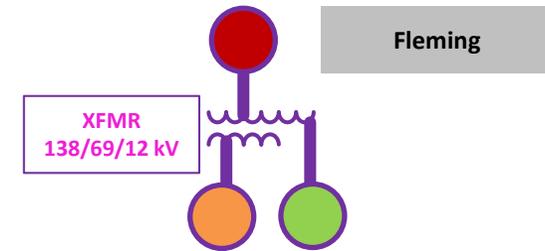
- Rebuild Fleming station in the clear
- Replace 138/69kV Fleming Transformer #1 with 138/69kV 130 MVA transformer with high side 138 kV CB
- Install a 5 breaker 69 kV ring bus on the low side of the transformer, replace 69 kV circuit switcher AA, replace 69/12kV transformer #3 with 69/12kV 30 MVA transformer, Replace 12 kV CB A and D. Retire existing Fleming substation.

Legend	
345 kV	
138 kV	
69 kV	
12 kV	
New

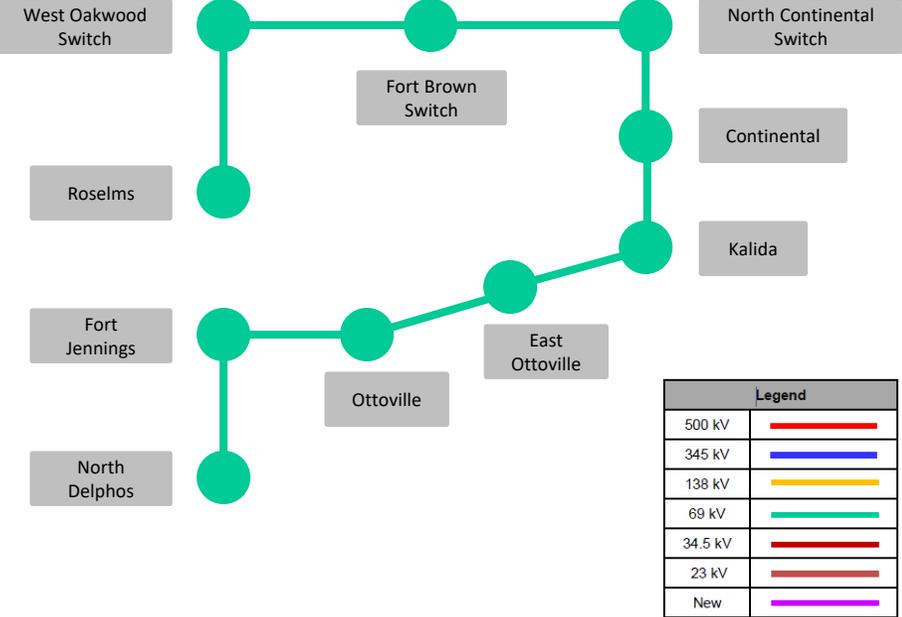
Existing Configuration:

- Rebuild 16 miles of 69 kV single circuit line from North Continental Switch (existing switch to be retired) to Roselms Switch (located next to the existing Roselms- PP Co-op Station). **Estimated Cost: \$38.4M**
- Build 9.4 miles of single circuit 69 kV line from Roselms to near East Ottoville 69 kV Switch. **Estimated Cost: \$13.7M**
- Rebuild 7.5 miles of double circuit 69kV line between East Ottoville Switch and Kalida Station (combining with the new Roselms to Kalida 69 kV circuit). **Estimated Cost: \$23.6M**
- Rebuild 5.1 miles of single circuit 69 kV line from East Ottoville to North Delphos. **Estimated Cost: \$9.4M**
- At North Continental, remove normally open bypass switch. **Estimated Cost: \$0.1M**
- At Fort Brown Switch, install a three way 69kV, 1200 A phase-over-phase switch, with sectionalizing capability. **Estimated Cost: \$0.7M**

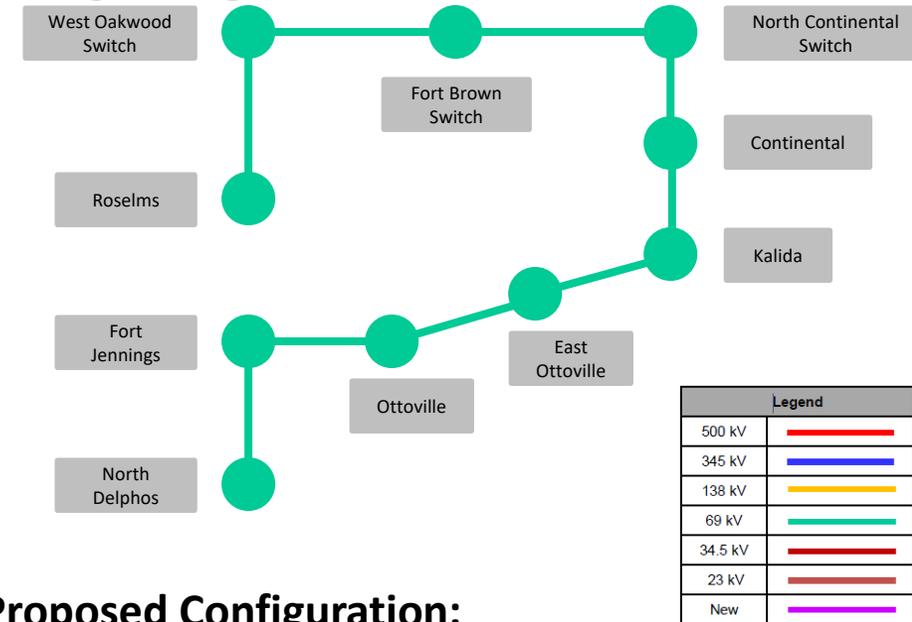
Existing Configuration:

- At Ottoville station, install 2- three way 69 kV, 1200 A, phase over phase Switches, with sectionalizing capability. **Estimated Cost: \$1.9M**
- At Fort Jennings, replace hard tap with a three way 69kV, 1200 A phase-over-phase switch, with sectionalizing capability. **Estimated Cost: \$0.6M**

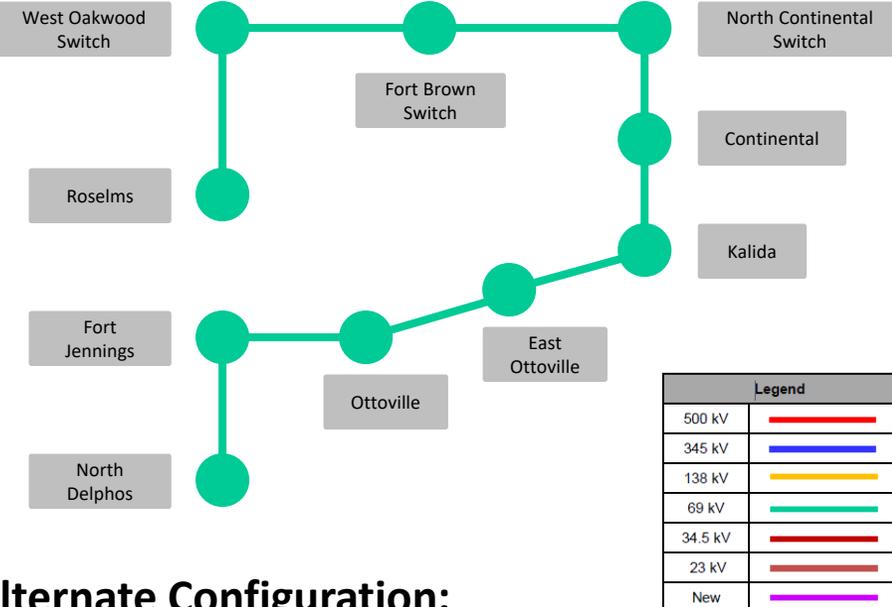
Existing Configuration:

- Rebuild the 69 kV line from North Continental Switch to Roselms .
- Build a new 69 kV line from Roselms to East Ottoville.
- Rebuild the 69 kV line from East Ottoville to Kalida.
- Install a 4-breaker ring 69 kV station at E. Ottoville
- Rebuild the 69 kV line from East Ottoville to North Delphos.
- Replace switches as indicated in the chosen solution, with the exception of East Ottoville 69 kV.
- **Estimated Cost:** \$94 M

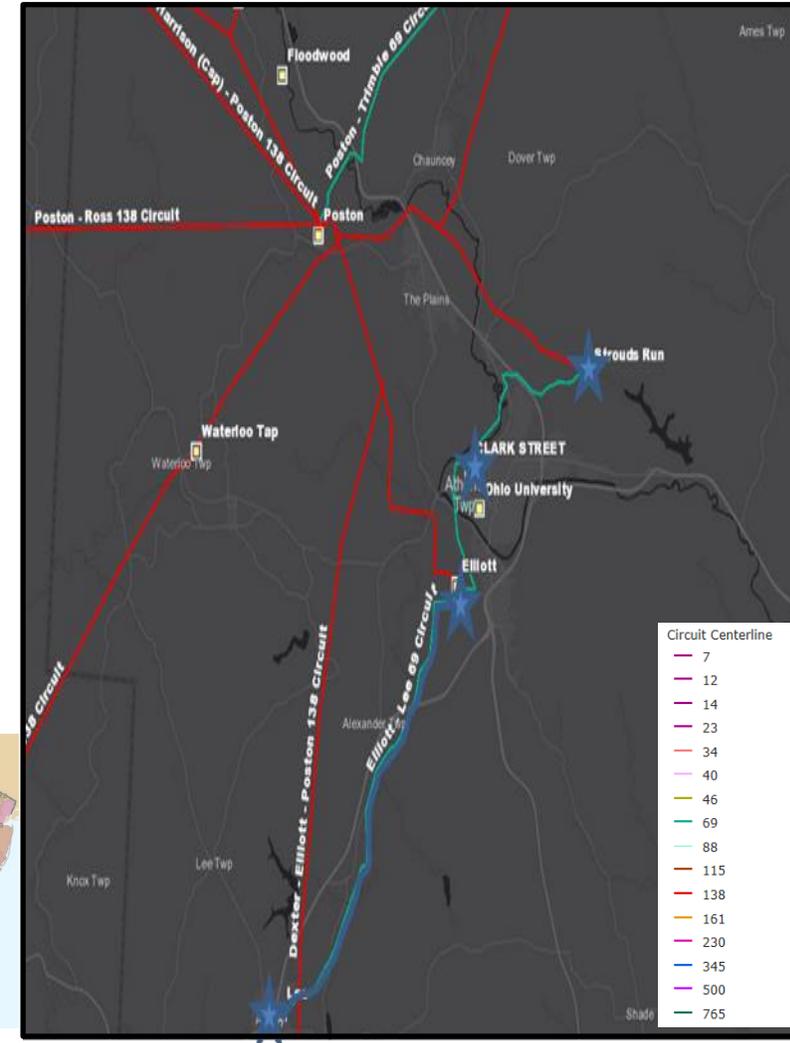
AEP Transmission Zone M-3 Process Athens Area Improvements

- The Elliot – Lee 69kV 8 mile, 69 kV line (vintage 1974) was constructed using wood pole structures with 336.4 KCM ACSR 18/1 conductor (73 MVA rating).
- There are 106 open A conditions on this line, including rotten structures, burnt/broken insulators, and loose/broken/sagging conductor sections, improperly installed shield wires and woodpecker damaged structures.
- These stations still have the following amount of electromechanical relays employed: Elliot (29), Strouds Run (78), Clark Street (25). EM relays have limited vendor support, lack SCADA functionality, and don't offer fault data collection.

- The Crooksville – Poston – Strouds Run 138kV circuit is a three-terminal line, which limits sectionalizing and can cause mis-operations and over tripping.
- The Dexter – Elliott – Poston 138kV circuit is a three-terminal line, which limits sectionalizing and can cause mis-operations and over tripping

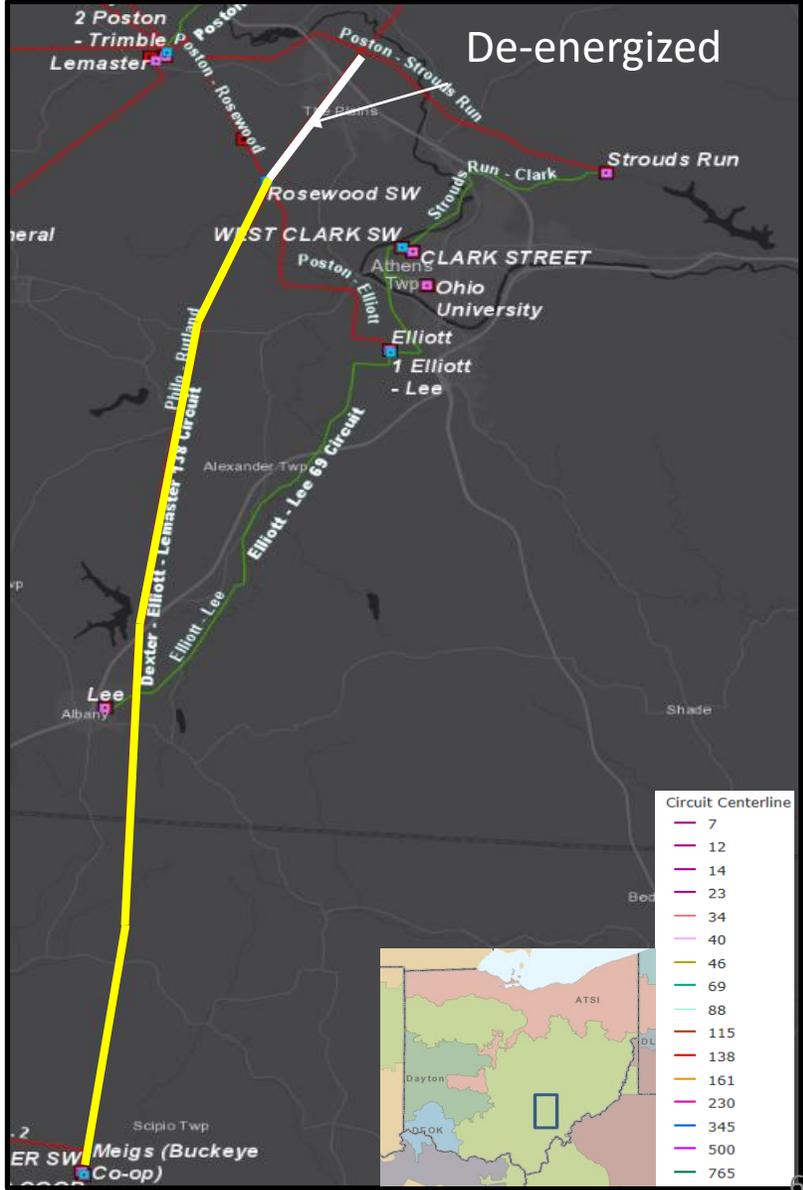
AEP Transmission Zone M-3 Process Athens Area Improvements

Dexter – Rosewood 138kV (1927 Steel Lattice Line)

- Length: 8.8 Miles
- Original Construction Type: Aluminum/Steel Lattice
- Original Conductor Type: 397.5 CM ACSR 30/7 (1926 vintage)
- Momentary/Permanent Outages: 3 total outages over last 5 years
 - Total structure count: 38
- Please reference needs materials on pre-1930s era lattice lines
- There is an additional 2.5 miles of the 1920’s Philo - Rutland lattice line which is de-energized and runs through the middle of The Plains community north of Athens

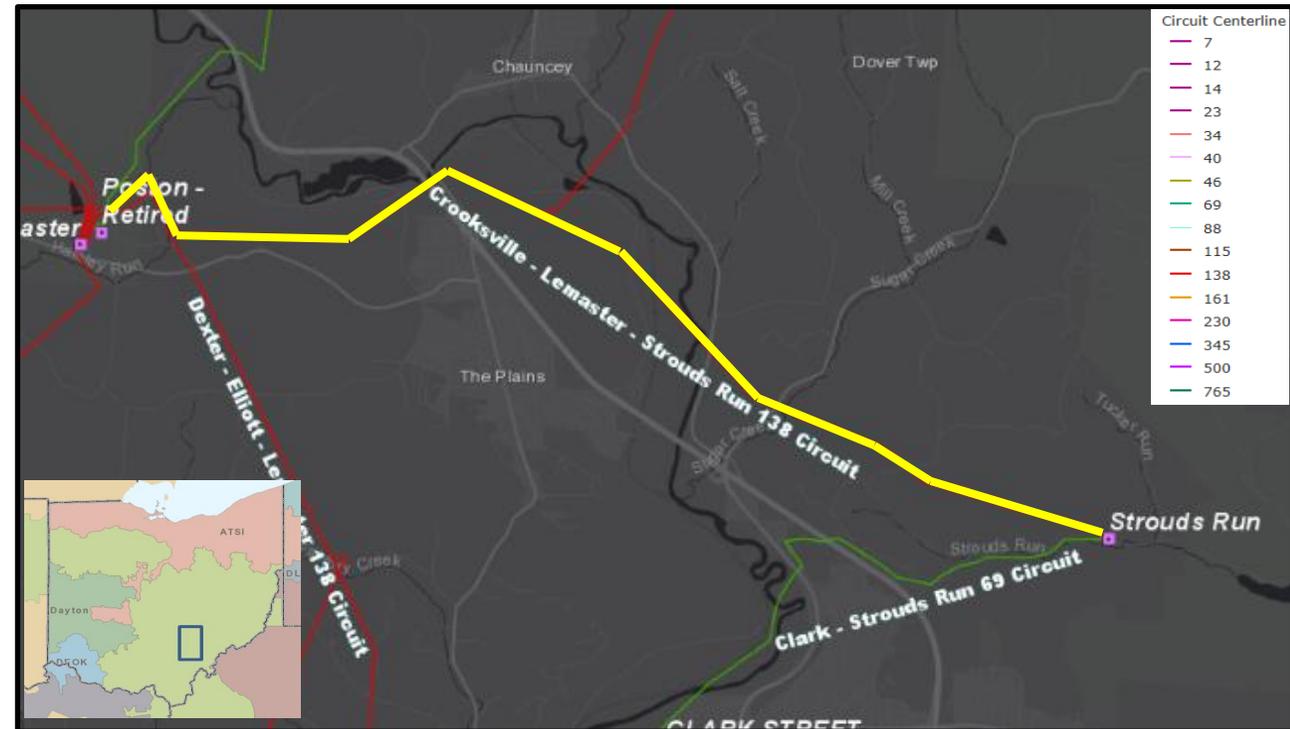
AEP Transmission Zone M-3 Process Athens Area Improvements

Poston – Shrouds Run 138kV (1965)

- Length 7.52 Miles
- Original Construction Type: Wood H-Frame
- Original Conductor Type: 636 ACSR Conductor (vintage 1966)
- Momentary/Permanent Outages: 3 total outages last 5 years
 - Number of open conditions: 62
 - Total structure count: 46
 - Open conditions include: rot top, woodpecker holes, bowed structures, and burnt poles
 - Unique structure count with open conditions: 31

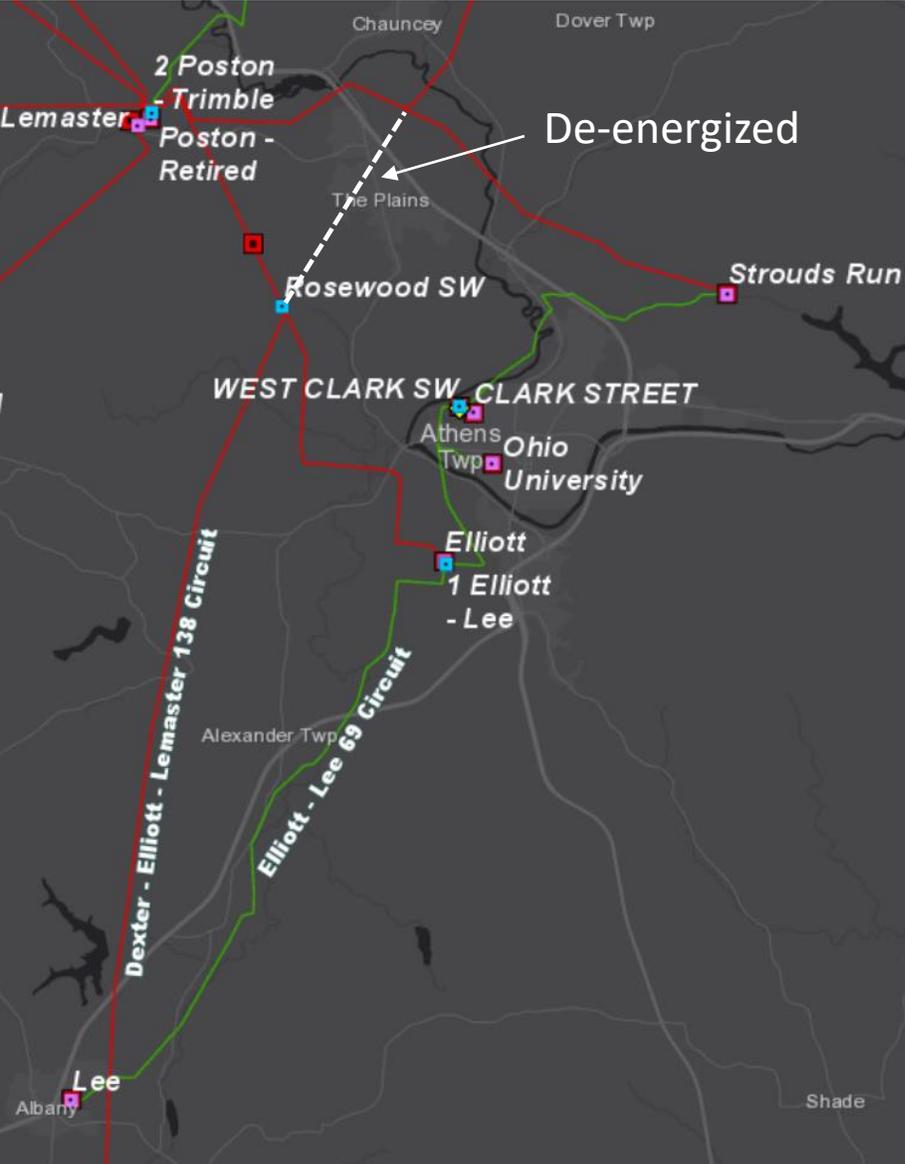
Existing:

- Convert Lee to 138 kV service and install two line MOABs connected to the 138 kV line between Dexter and Elliot. **Estimated Cost: \$3.0M**
- At Clark Street, replace 69 kV circuit breakers “61” & “64” (3000A 40kA). **Estimated Cost: \$2.9M**

- At Elliot, install a new 138/69 kV transformer (130 MVA) in addition to high and low side protection (3000 A 40 kA) which will replace transformer #1 at Strouds Run that will be retired. Replace existing 138 kV circuit breaker “102” and 69 kV circuit breakers “61” and “66” (3000A, 40 kA). Install 138 kV circuit breaker (3000A, 40 kA) on the new 138 kV line towards Dexter (via Lee) along with a 138 kV bus-tie breaker (3000, 40 kA). Retire 69 kV circuit breaker “67” due to the conversion of Lee station to 138 kV. **Estimated Cost: \$6.7M**

- Rebuild ~3.68 miles of single circuit line from the Poston - Strouds Run line as double circuit 138kV transmission line to eliminate the hard tap on the line. **Estimated Cost: \$16.0M**

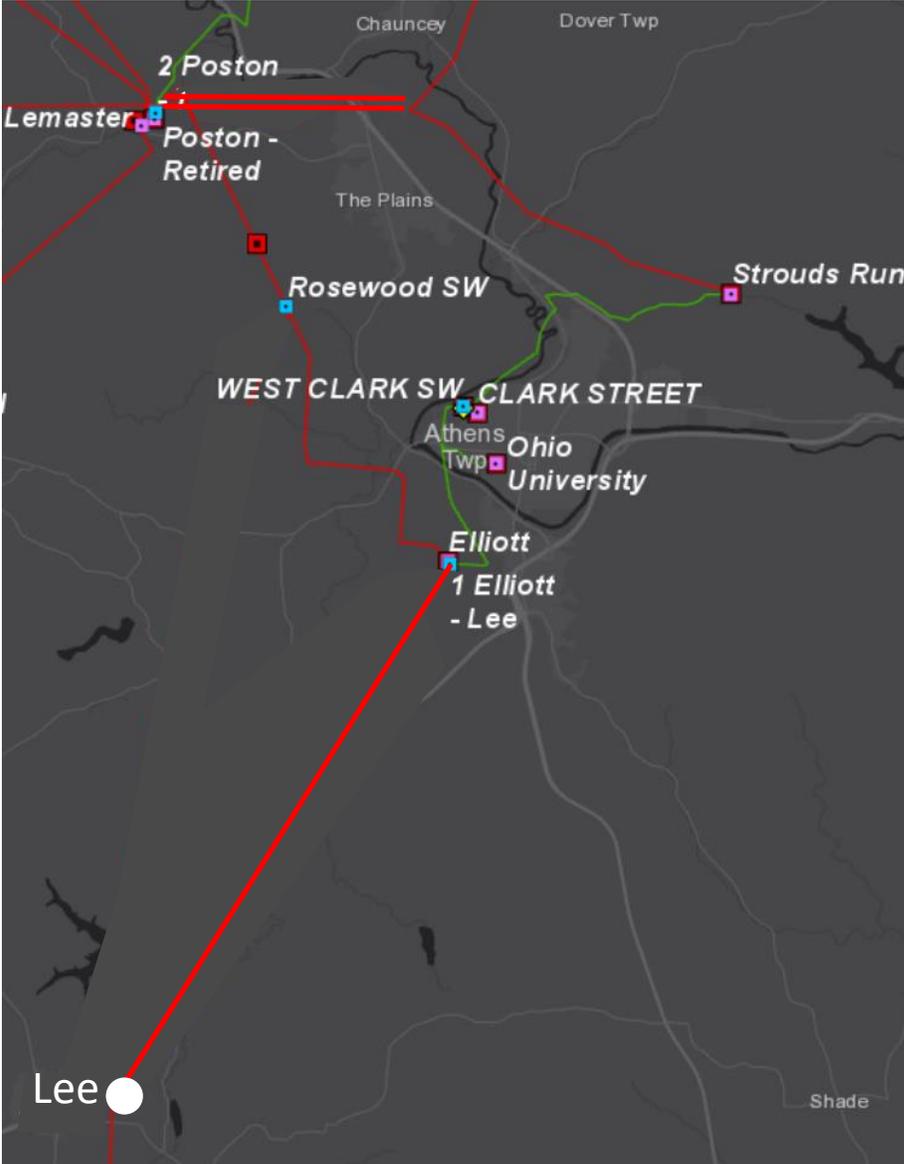
Proposed:

- At Strouds Run, install a 138kV line breaker (3000A 40kA) towards Lemaster. Replace transf #2 high side circuit switcher with a circuit breaker (3000A, 40 kA). Replace the 69kV circuit breaker “66” (3000A, 40kA). Retire 138/69/13 kV 33.6 MVA transf #1, 69 kV circuit breaker “63”, and circuit switcher # 1. **Estimated Cost: \$1.6M**
- At Lemaster station, install a 138kV breaker (3000A 40kA) to accommodate the new circuit. **Estimated Cost: \$1.0M**
- Remove Rosewood switch. **Estimated Cost: \$0.1M**

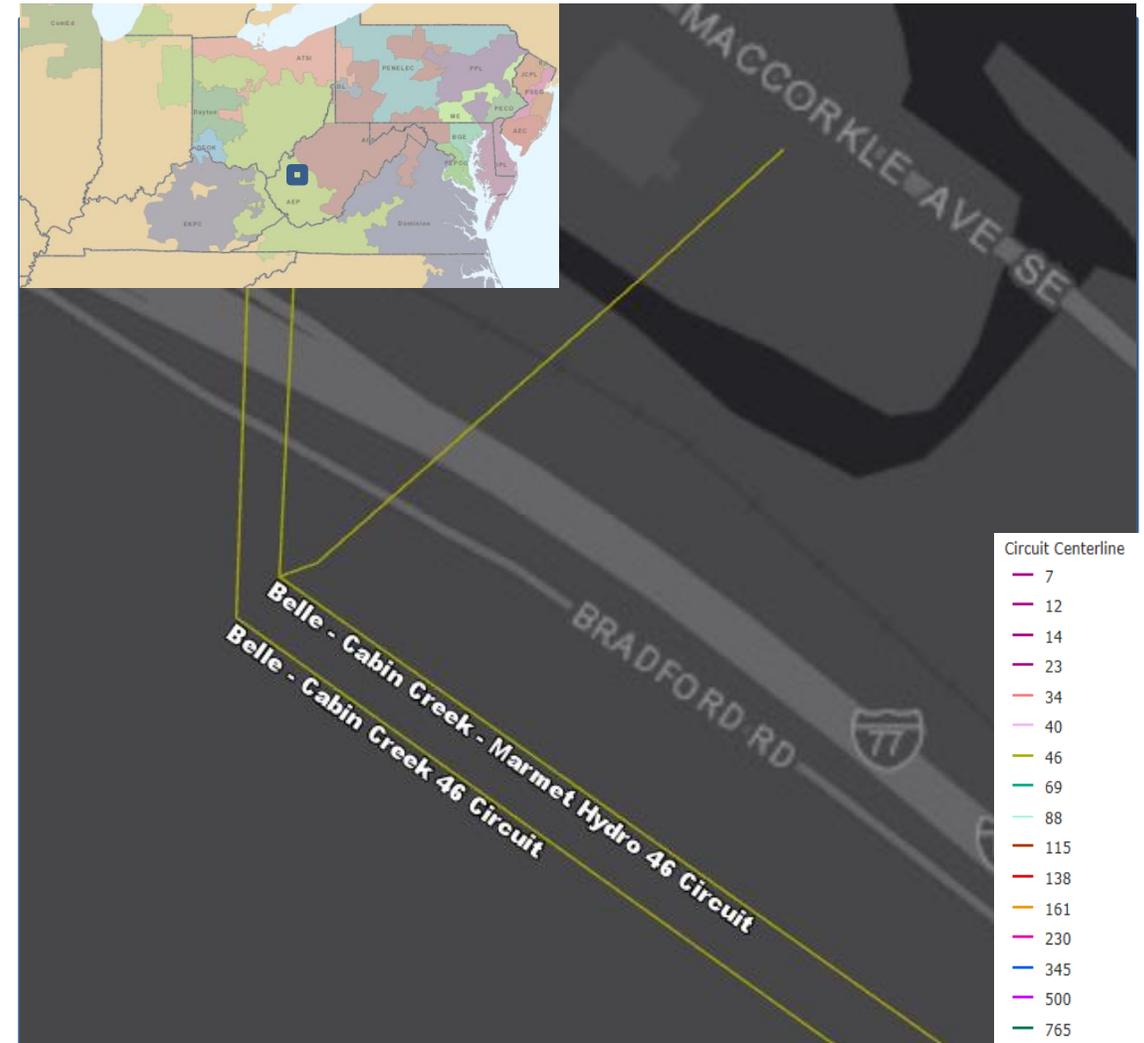
AEP Transmission Zone M-3 Process Hernshaw Area Project

- A customer station is currently served off a hard tap on the Belle – Cabin Creek – Marmet Hydro 46 kV circuit.
 - Hard taps are difficult to maintain due to required outages or temporary jumper configurations in lieu of a switch.
 - Hard taps can also result in extended outages to customers due to the inability to sectionalize faulted facilities.

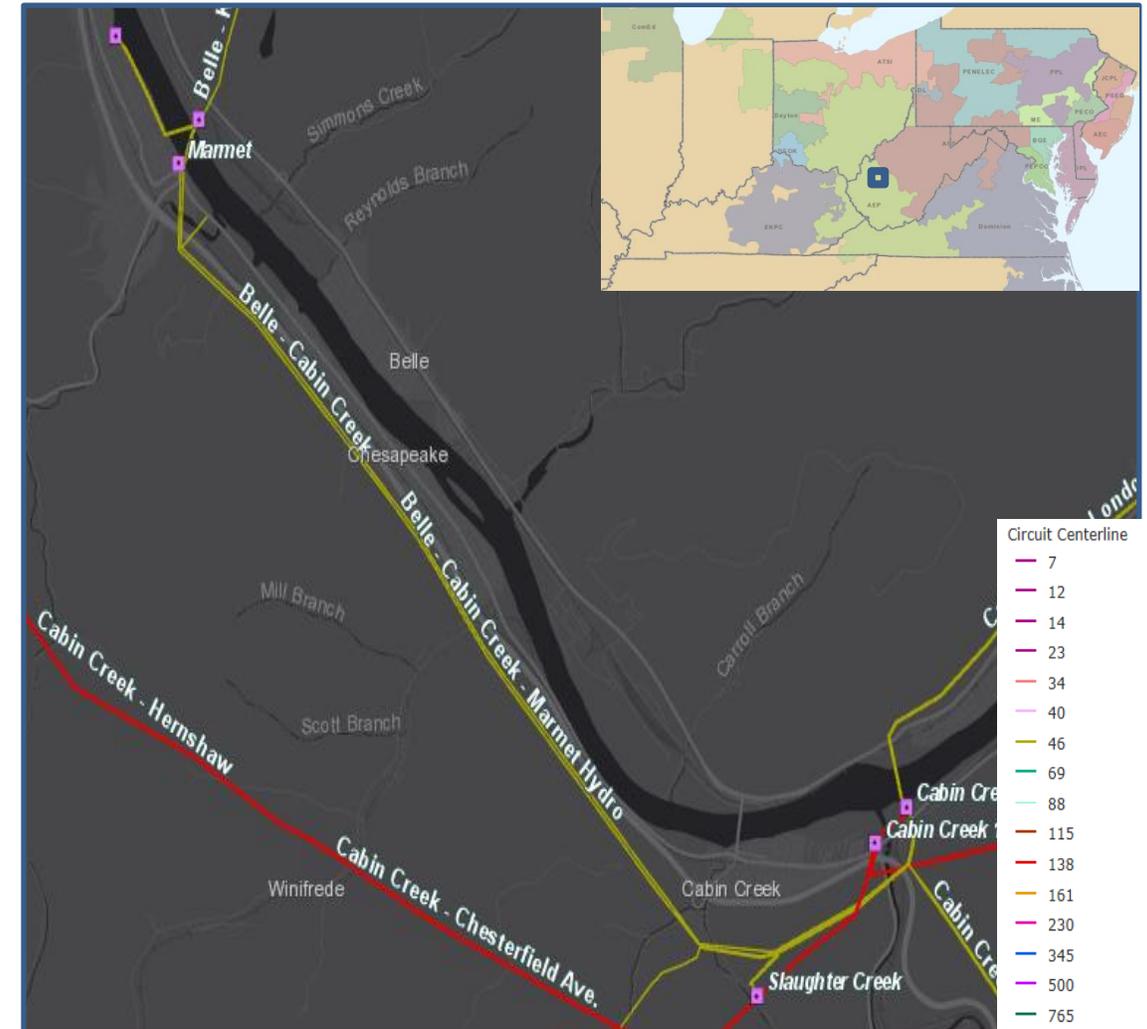
AEP Transmission Zone M-3 Process Hernshaw Area Project

- Majority of the circuit is constructed with 1930s lattice structures.
- Between 2015-2018 the circuit experienced 4 momentary and 3 permanent outage resulting in approximately 24k customer minutes of interruption
- There are currently 13 open conditions associated with the structures and hardware and include heavy rust, broken insulators and damaged shield wire hardware.
- The line does not comply with current NESC Standards.
- Most structures are situated on an extreme side hill, which also sits above the WV Turnpike which presents a significant danger/risk should the structures fail.
- This line parallels the Belle – Cabin Creek – Marmet line, need AEP-2019-AP028.

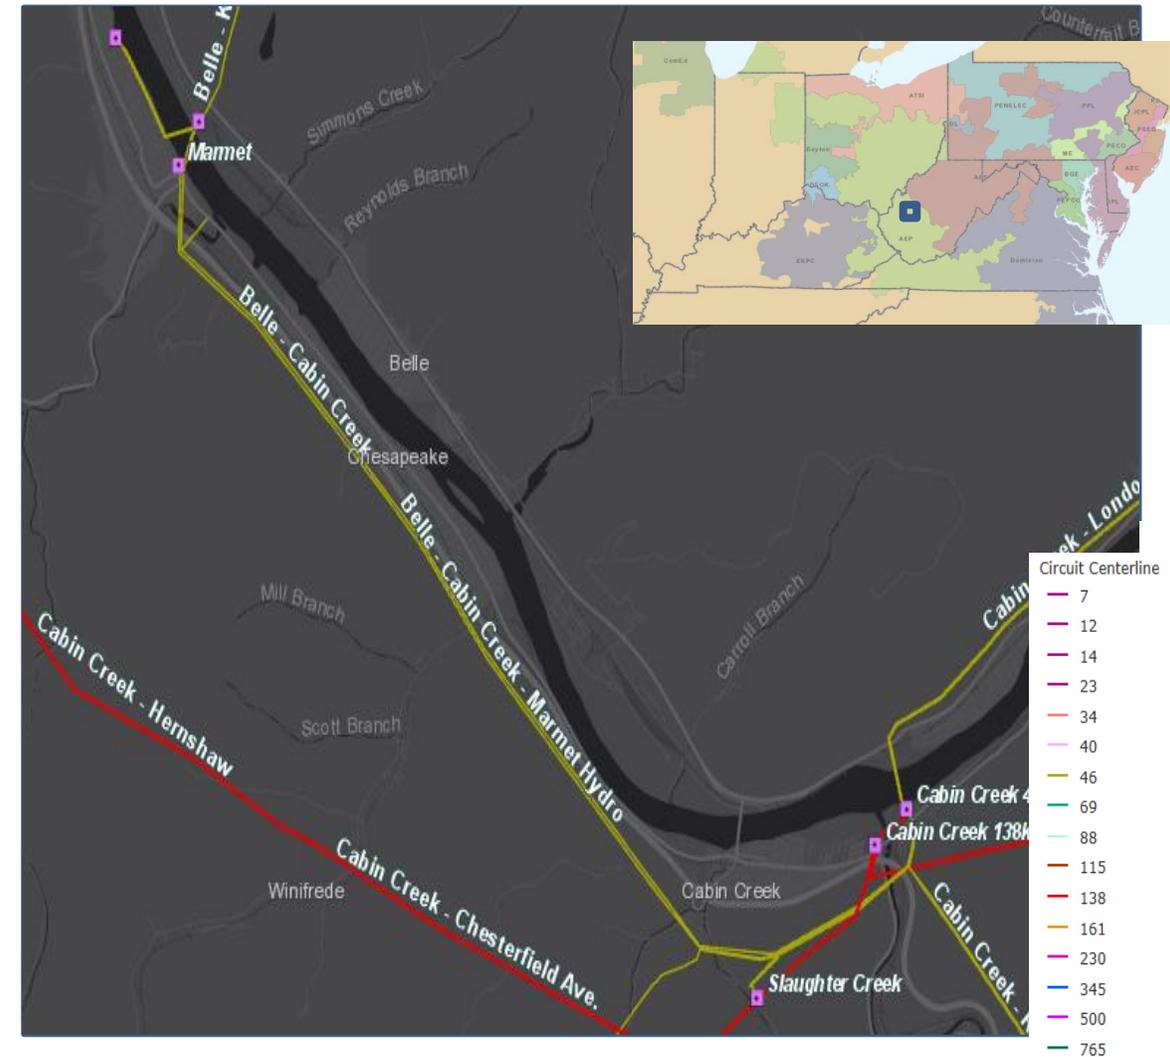
AEP Transmission Zone M-3 Process Hernshaw Area Project

- Majority of the circuit is constructed with 1930s lattice structures.
- Between 2015-2018 the circuit experienced 6 momentary and 2 permanent outage resulting in approximately 242k customer minutes of interruption
- There are currently 13 open conditions associated with the structures and hardware and include heavy rust, broken insulators and corroded shield wire.
- The line does not comply with current NESC Standards
- Most structures are situated on an extreme side hill, which also sits above the WV Turnpike which presents a significant danger/risk should the structures fail.
- This line parallels the Belle – Cabin Creek – Marmet line, need AEP-2019-AP027.
