Sub Regional RTEP Committee: Western AEP Supplemental Projects

March 19, 2020

AEP Transmission Zone M-3 Process Muskingum, Guernsey, Tuscarawas & Stark Counties, Ohio

Need Number: AEP-2020-OH001 (revised)

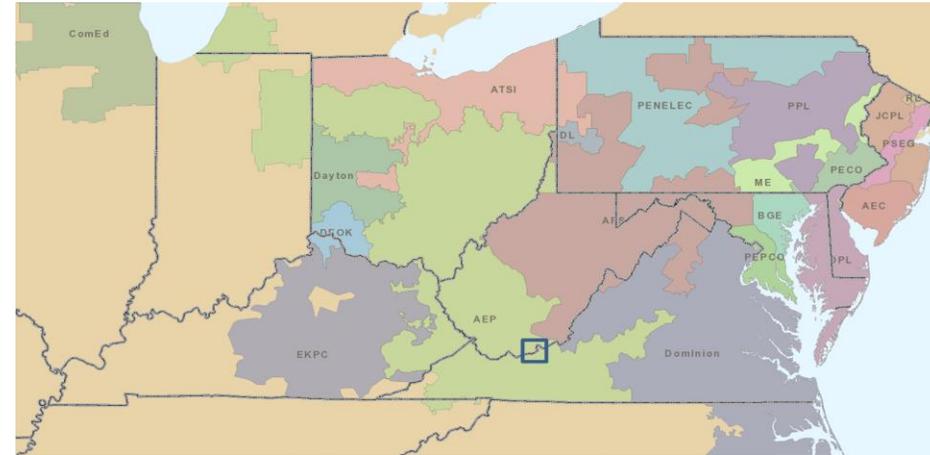
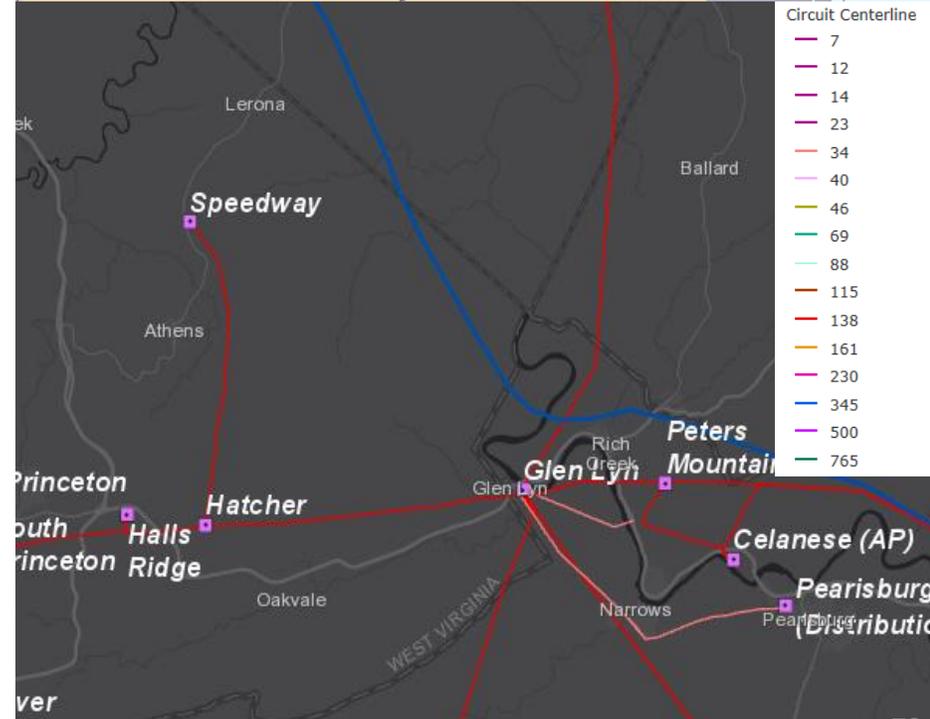
AEP Transmission Zone M-3 Process Mercer County, West Virginia

- There are 34 open conditions associated with the 1960s wood structures that comprise the 7.3 mile Speedway Tap that serves Speedway station. These conditions include damage due to woodpecker holes, damaged poles, and corroded cross-arms.

Speedway Station

- Speedway station is currently radially served off the ~7.3 mile Speedway 138 kV Tap.
- Speedway station has 20 MW of nontransferable load (25 MW peak).
