Western Sub Regional RTEP: AEP Supplemental Projects

October 20, 2023

AEP Transmission Zone: Supplemental S1598 Scope change

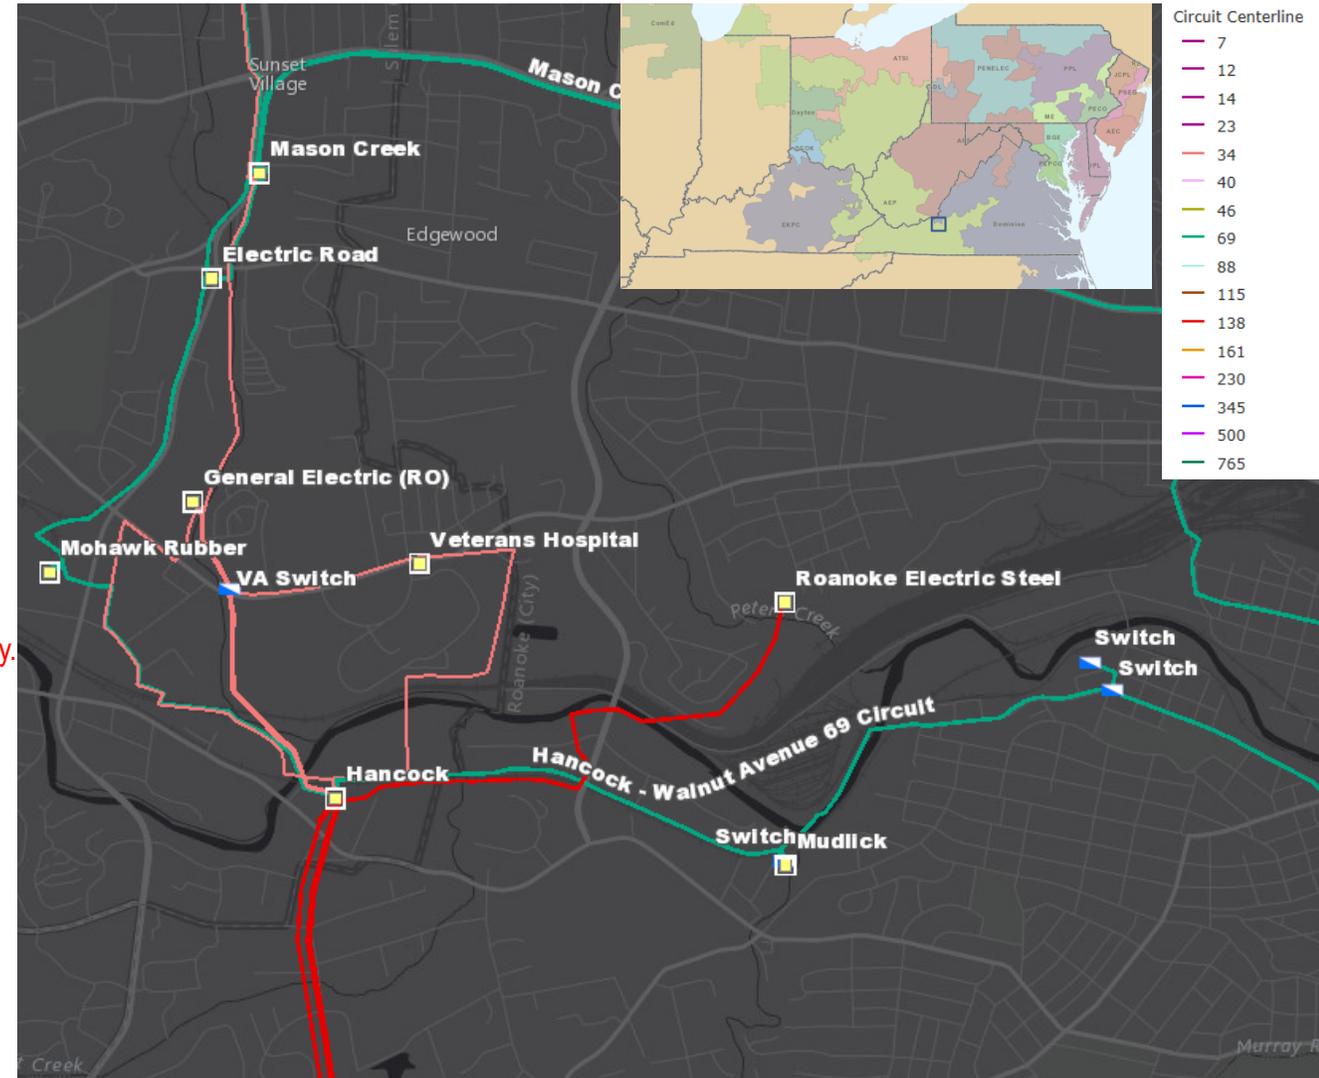
Potential Solution

At Hancock station, build a new 138 kV breaker and half configuration with 3 strings. Install 9 new 3000 A/40 kA circuit breakers. Replace the existing 69 kV/27 kA/1800 A CB "N" and "CA", 1200 A/21 kA CB "M" and 2000 A/31.5 kA CB "Q" with 3000 A/40 kA circuit breakers. Replace the existing 34.5 kV/560 A/12 kA CB "R" and "S", 1200 A/16.8 kA CB "I" with 1200 A/25 kA circuit breakers. Install new DICM. Replace 138/34.5 MVA Transformer #2 with new 138/69/34.5 kV 130MVA. Add new 138/34.5 kV 30 MVA Transformer #3 with high side Circuit Switcher (3000 A, 40 kA). Replace the existing 138 kV 1200 A/61 kA Circuit Switcher "BB" with new 650A, 31.5 kA CS. Replace 138kV Bus #1, 34.5kV Bus #1 and 34.5kV Bus #2 CCVT's. Replace 34.5 kV Circuit Breakers "P" and "J" with new 34.5 kV, 3000 A, 40 kA CB's. Replace 34.5 kV Capacitor Bank Circuit Switcher "AA" with new 40 kA CS. Install Bus Regulators on 34.5kV Bus #3. Replace remote end line relaying. **Estimated Cost: \$30.0M**

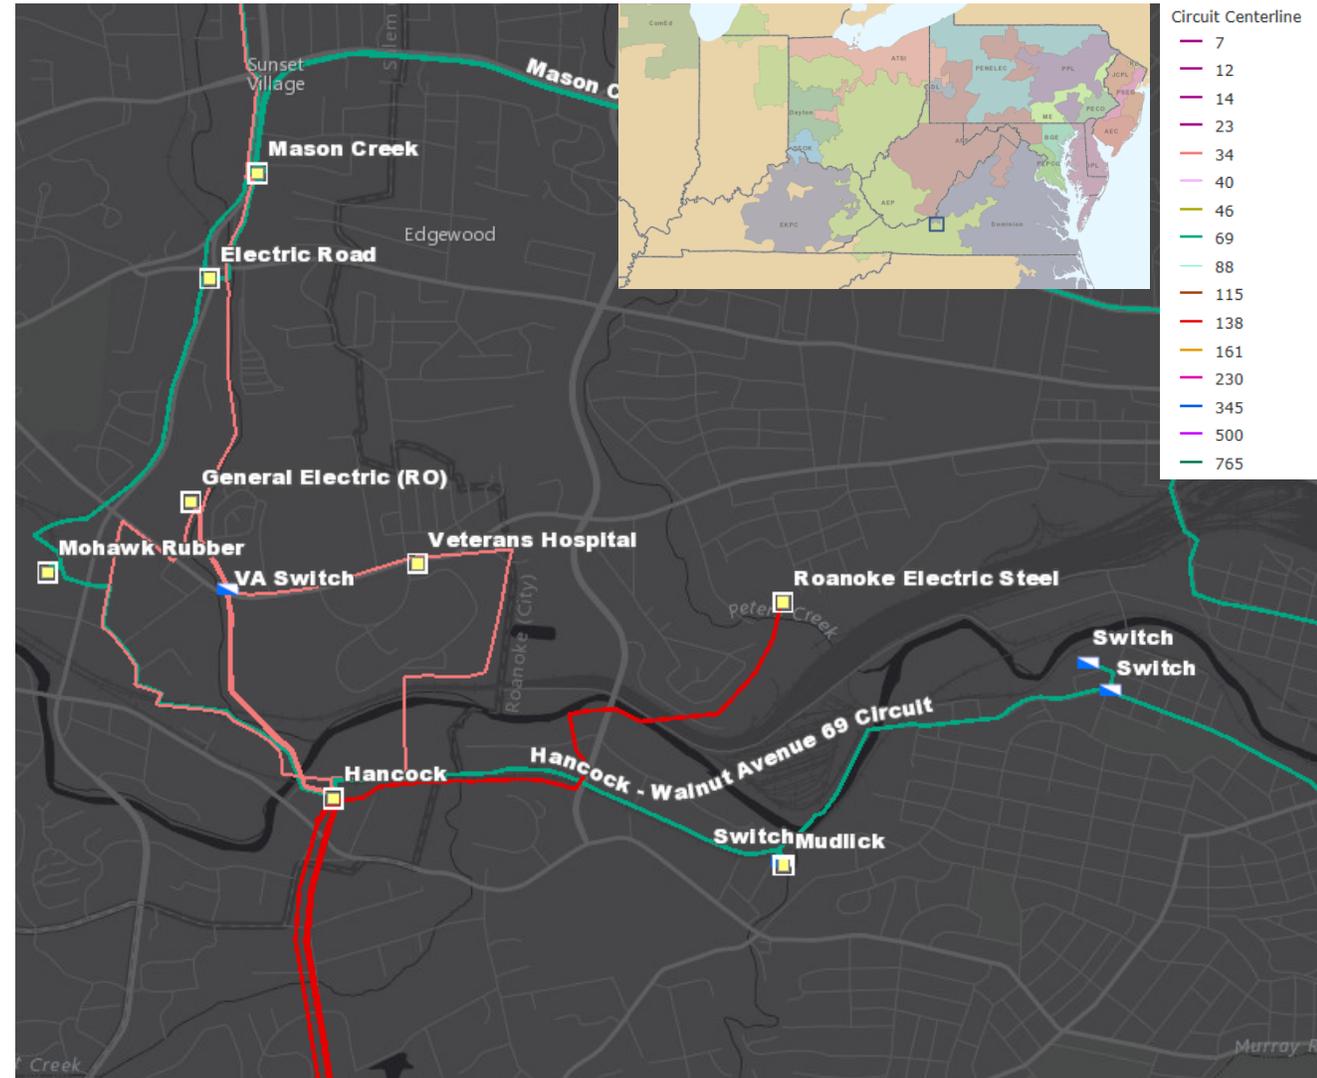
Potential Solution

At Hancock Station:

- Replace 138 kV CBs A, B, C and associated disconnect switches, foundations, and CCVTs
- Install 2 additional 138 kV bus tie breakers and utilize the position between the breakers to feed Roanoke Electric Steel

- Replace 138/69/34.5 kV T1, install a high-side circuit switcher and change connection to bus #1, Install ground bank on 69 kV side
- Replace 138/34 kV T2, install a high-side circuit switcher, new foundations, add oil containment, Install ground bank on 69 kV side

- Replace 138 kV, 50.4 MVar Capacitor Bank and Circuit Switcher BB, associated switches and foundation
- Replace all Transmission 34.5 kV bus work, circuit breakers, associated disconnect switches and foundations. Replacement 34.5 kV breakers will be 3000 A, 40 kA. Replace 34.5 kV capacitor bank AA with 9.6 MVar bank, associated circuit switcher and foundation.

- Expand control house and replace all electromechanical relays (116), 7 static relays and 9 microprocessor relays
- Install 138/34.5 kV 30 MVA non-LTC Transformer with high side circuit switcher replacing the non-standard 34.5/34.5 kV configuration and removing the N.O. by-pass around 34.5 kV CB K

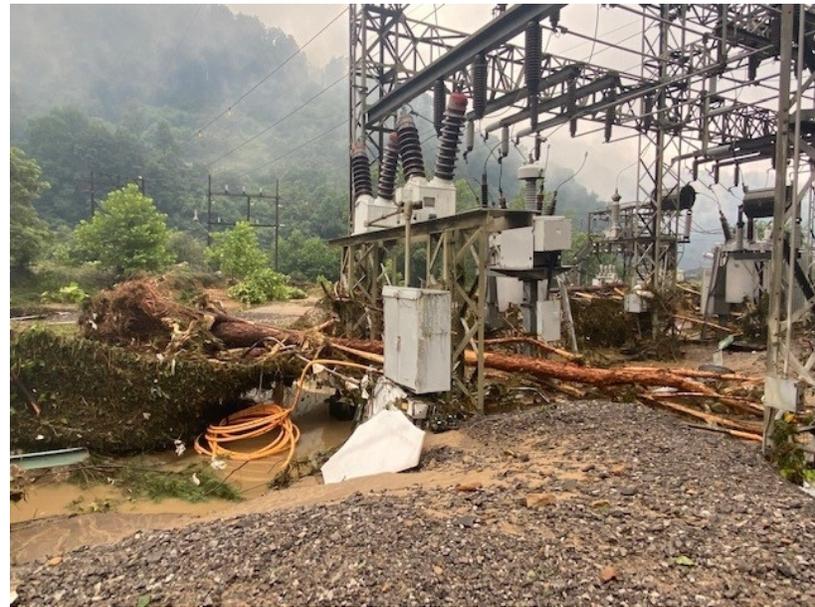
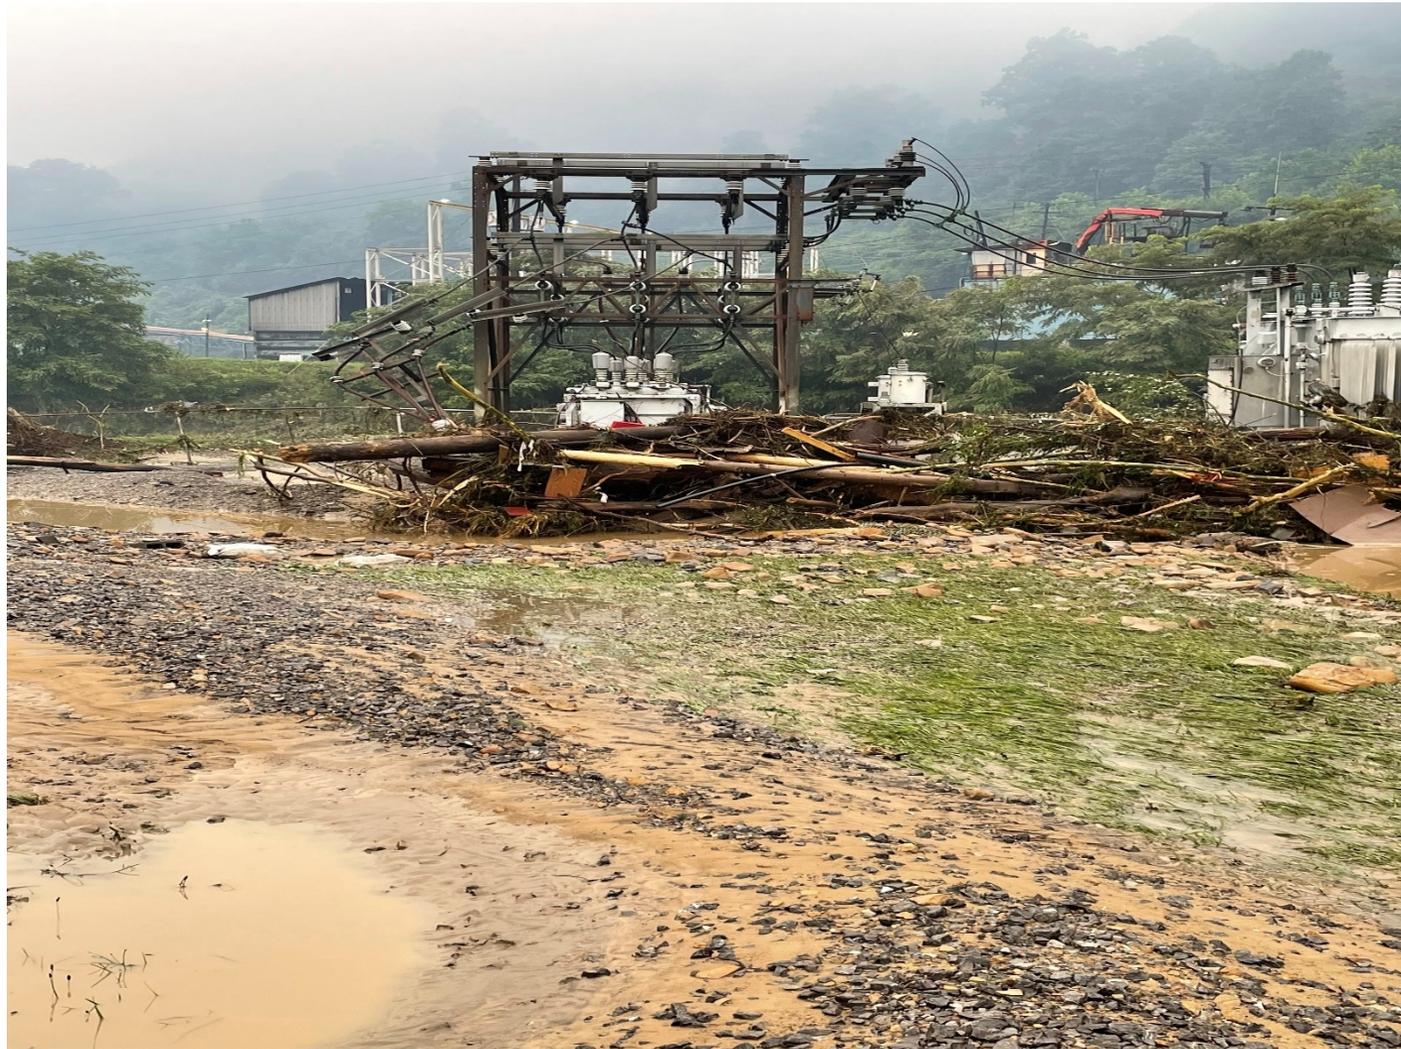
Dismal River Substation:
A flooding event heavily damaged and failed Dismal River substation in July 2022.
APCo Distribution has requested a new station to replace Dismal River substation

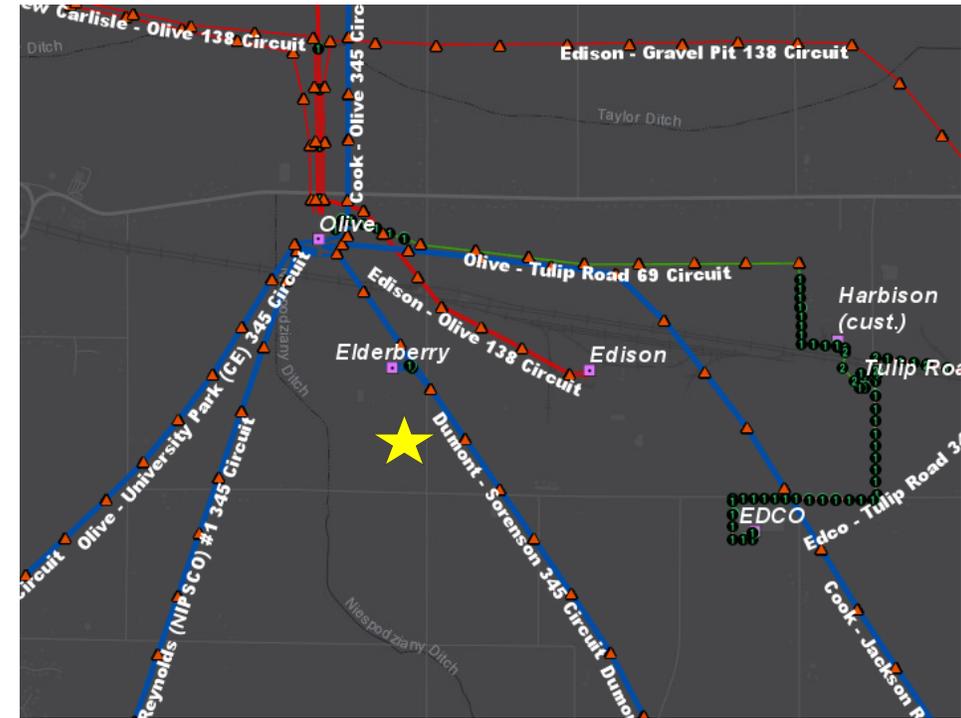
- A customer has requested new service for a 120MW manufacturing facility in New Carlisle, IN area.

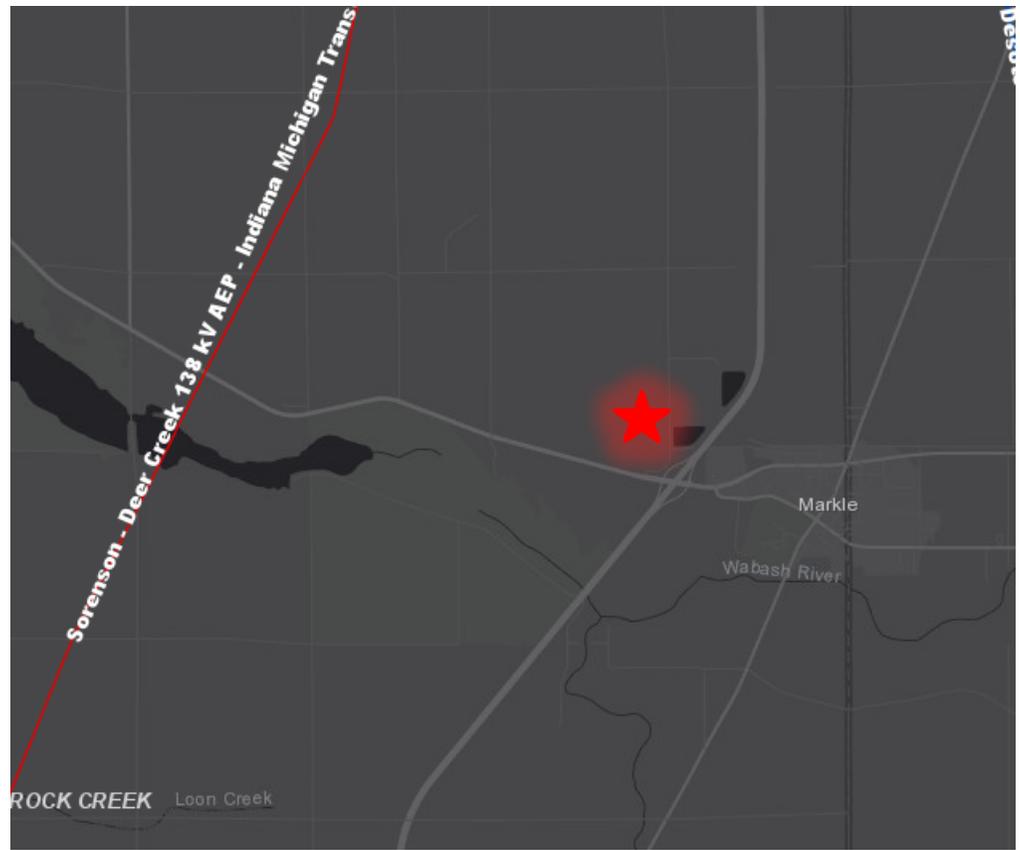
Problem Statement:
 WVPA has requested a new delivery point for a peak load of 12MW in Markle, Indiana.

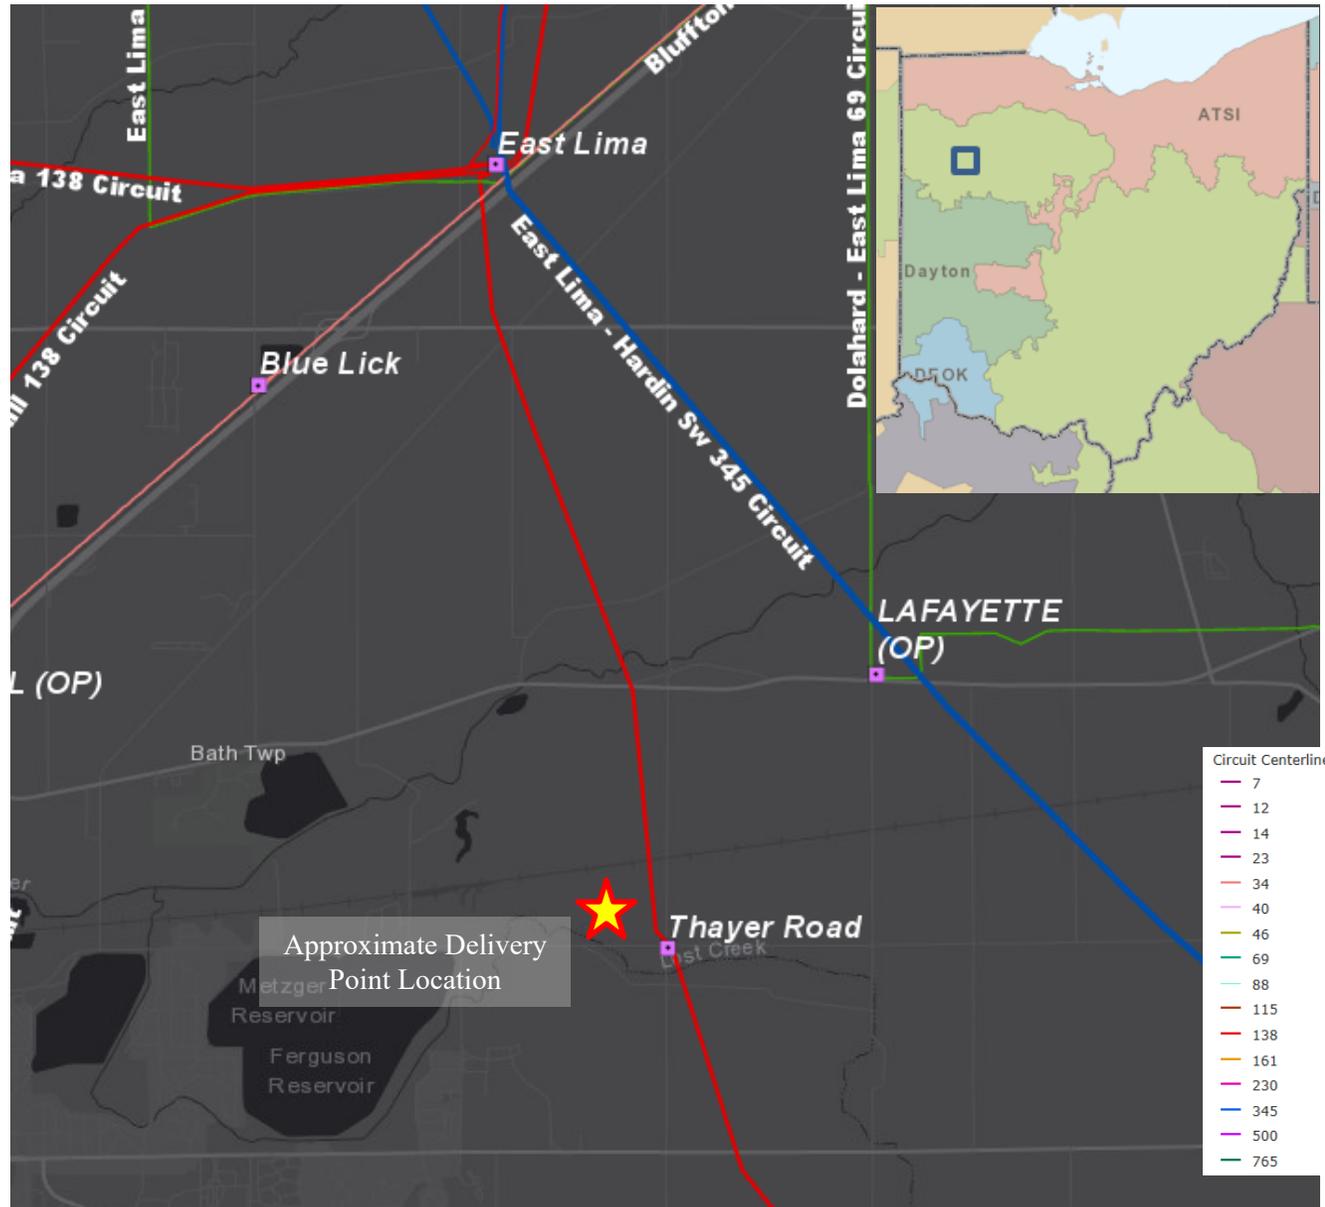
- Buckeye Power is requesting on behalf of Midwest Electric Co-op a new 138kV delivery point tapped off of the East Lima - Sterling Circuit by January 2025. Anticipated load is about 7.5 MVA.

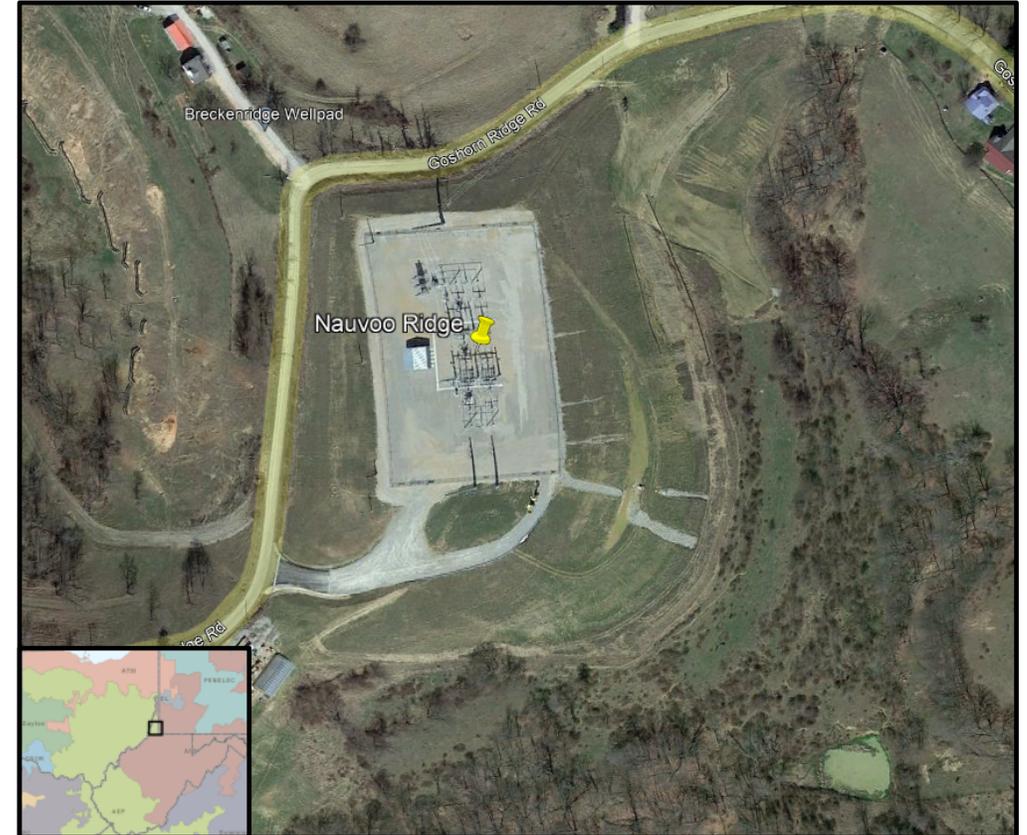
Problem Statement: AEP Ohio has requested to add capacity at
Nauvoo Ridge station, to meet growing load and bolster the area's
existing distribution circuits. The anticipated peak load is
approximately 6.7 MVA. The requested in-service date is
November 2025.

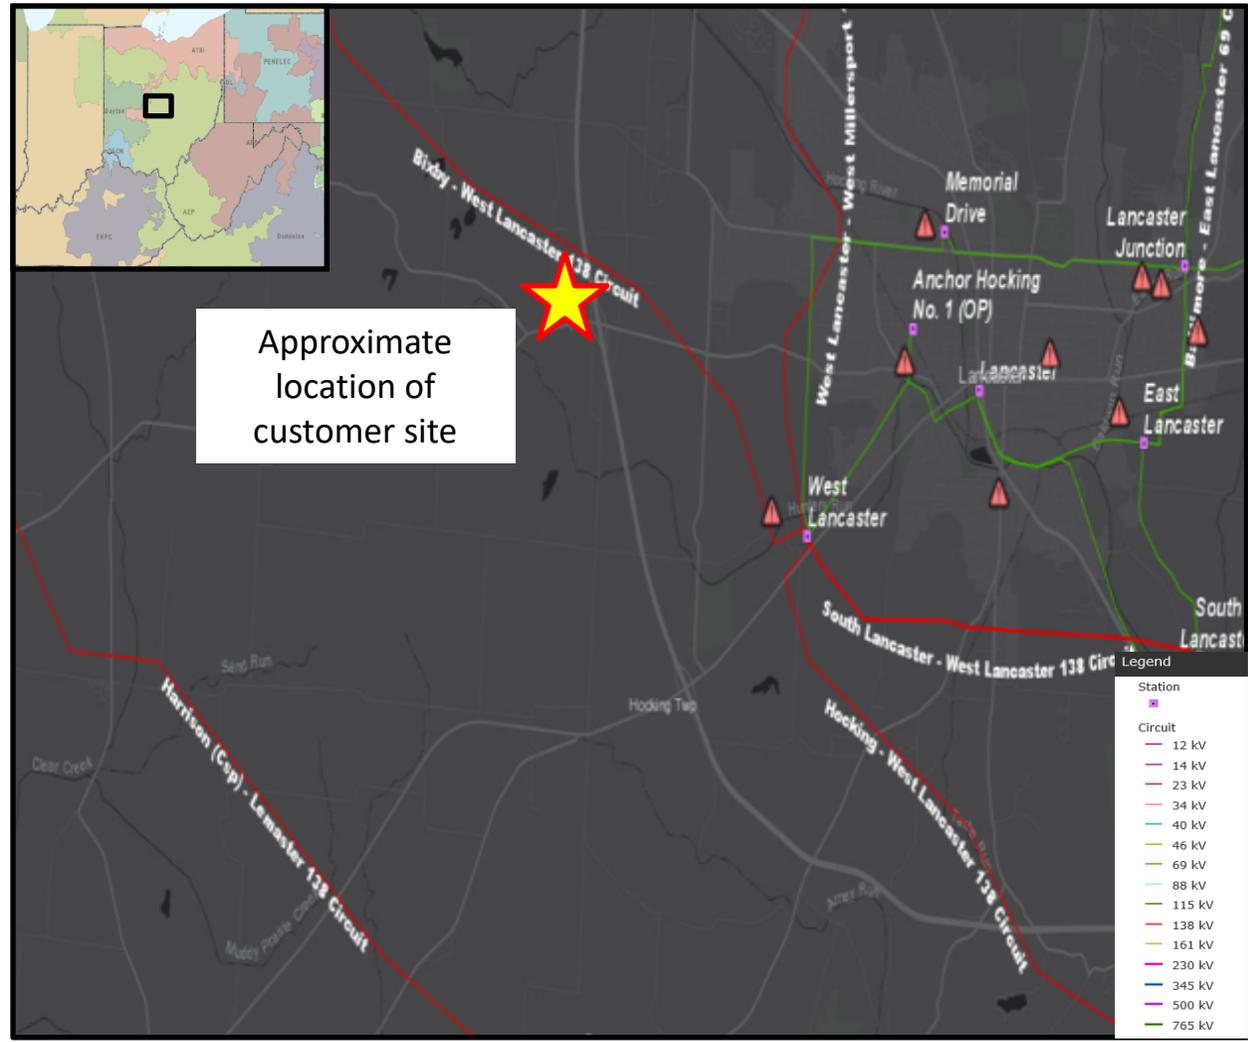
- A customer has requested additional transmission service in Lancaster Ohio, near Sifford station.
- The incremental projected demand for the site is 96 MW, bringing the total load for the customer's site to 196 MW.
- Customer requested in-service date of 09/30/2024.

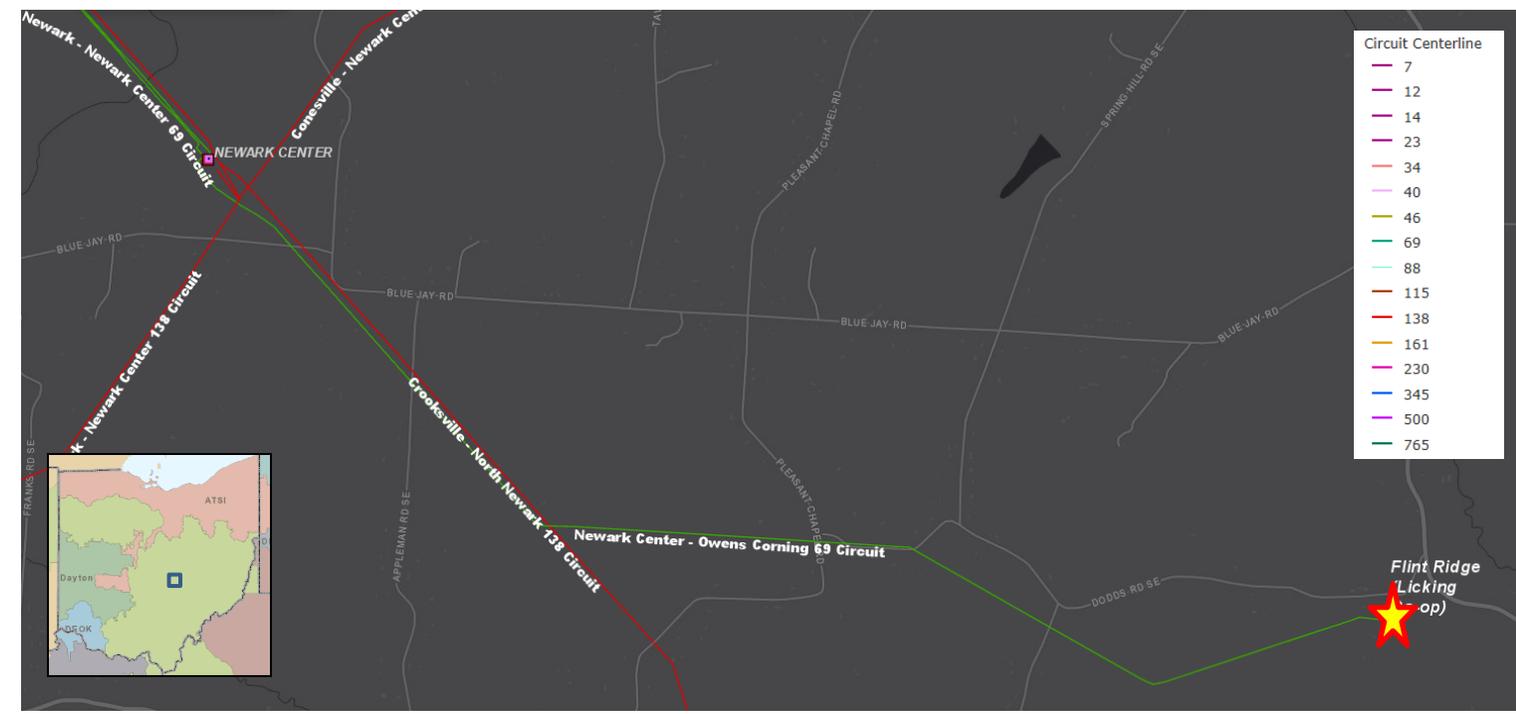
- Licking Rural Electrification Co-op's Flint Ridge delivery point is served via a hard tap from the Newark Center - Owens Corning 69kV circuit, with no line sectionalizing switches present. The hard tap limits operational capabilities for this circuit. LRE loses service to Flint Ridge for any fault on the western portion of the circuit, and AEP Ohio loses service to Owens Corning for faults on the radial to Flint Ridge.
- Load is approximately 6.256 MW
- CMI: There were 6 permanent outages in the last 5 years totaling 8,219,652 customer minutes of interruption for 1,997 customers.

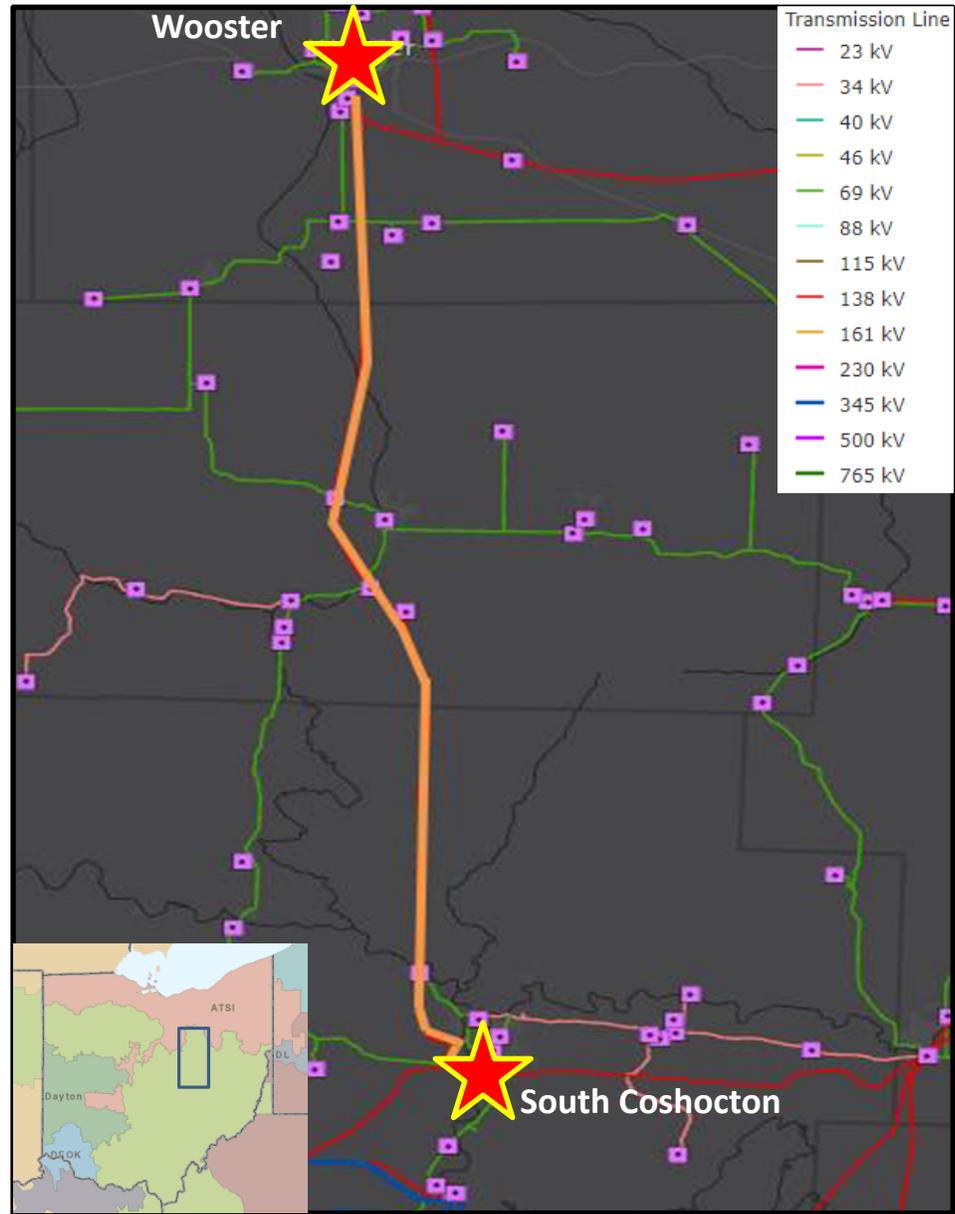
AEP Transmission Zone M-3 Process South Coshocton – Wooster Rebuild

Wooster – South Coshocton: The 37.7-mile line will be rebuilt using 795 ACSR DRAKE to alleviate identified asset renewal conditions. This includes the 15.2-mile West Millersburg – Wooster 138kV circuit as well a portion of the 30.9-mile single circuit Ohio Central – West Millersburg 138kV circuit up to structure 13 outside Ohio Central station. **Estimated Cost \$96.5M**

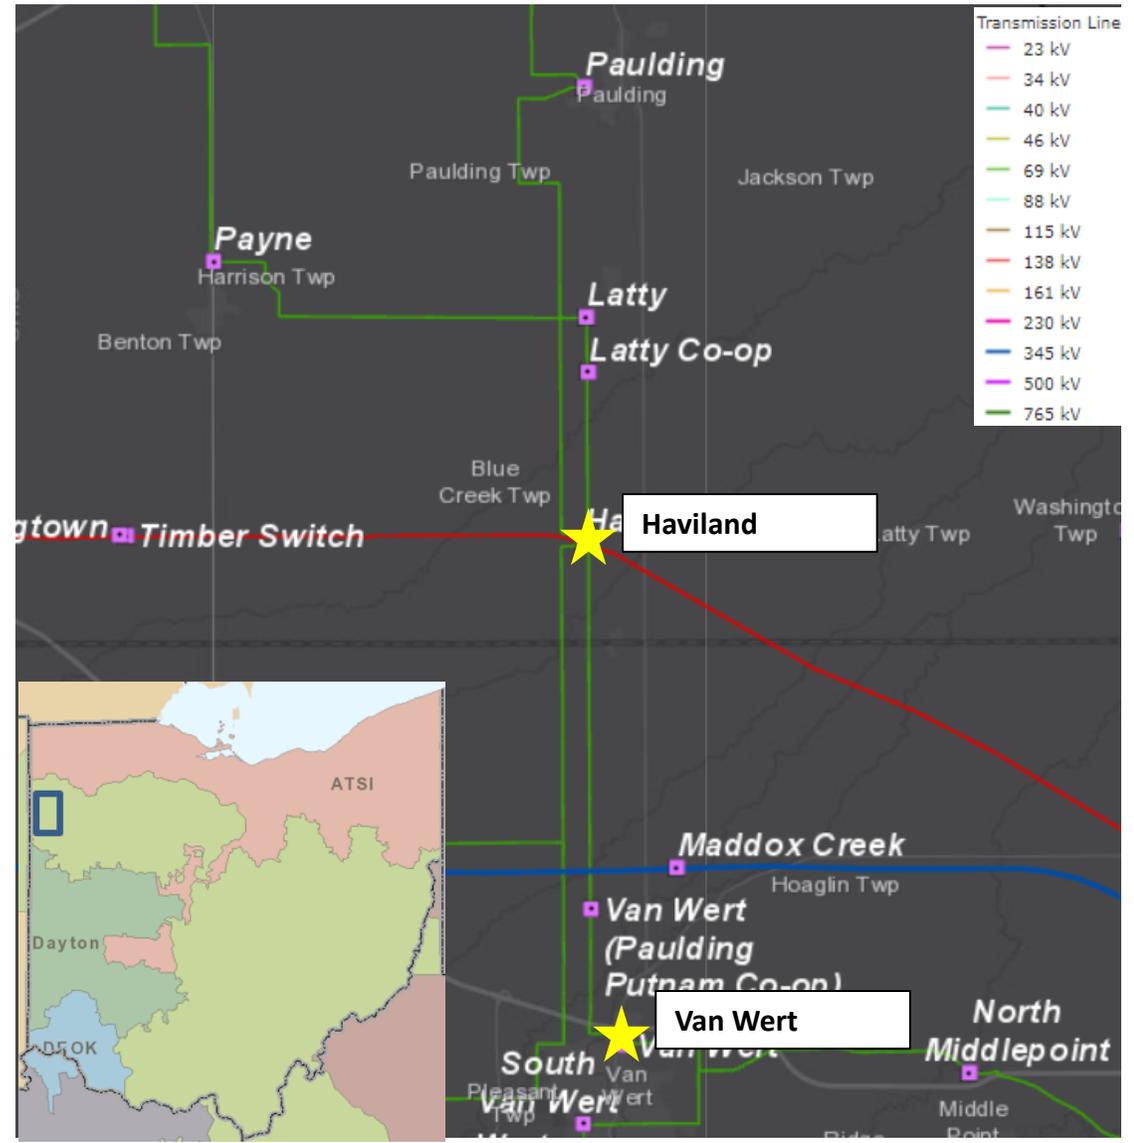
Van Wert - Haviland 69kV Line(1926) :

- Length of Line: 10.06 Miles
- Total Structure Count: 249
 - Wooden, Steel Monopole Structures
 - Vertical post insulators
- Conductor Types: 556.5 ACSR 18/1 (Osprey), 4/0 COOPER, 556.5 ALUMINUM 19 (Dahlia), 795 ACSR 26/7 (Drake)
- Outage History: 1 Momentary and 2 Permanent outages – average duration of 38.72 hours, 66.6K CMI between 2015 and 2020
- Open Conditions: 19, including splice/dead end conductor issues, damaged/missing ground lead wires, broken shield wire, disconnected grounding mat and chipped insulators
- The Van Wert - Haviland line fails to meet 2017 NESC Grade B loading criteria, current AEP structural strength requirements, and the current ASCE structural strength requirements. The line is insulated with vertical post insulators that do not meet current AEP standards for CIFO and minimum leakage distance requirements.

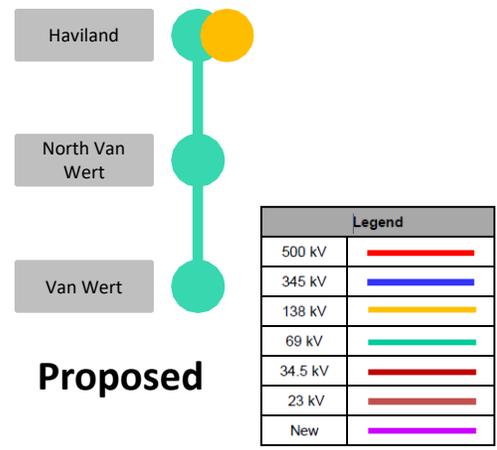
Existing

AEP Transmission Zone M-3 Process Haviland-Van Wert Rebuild

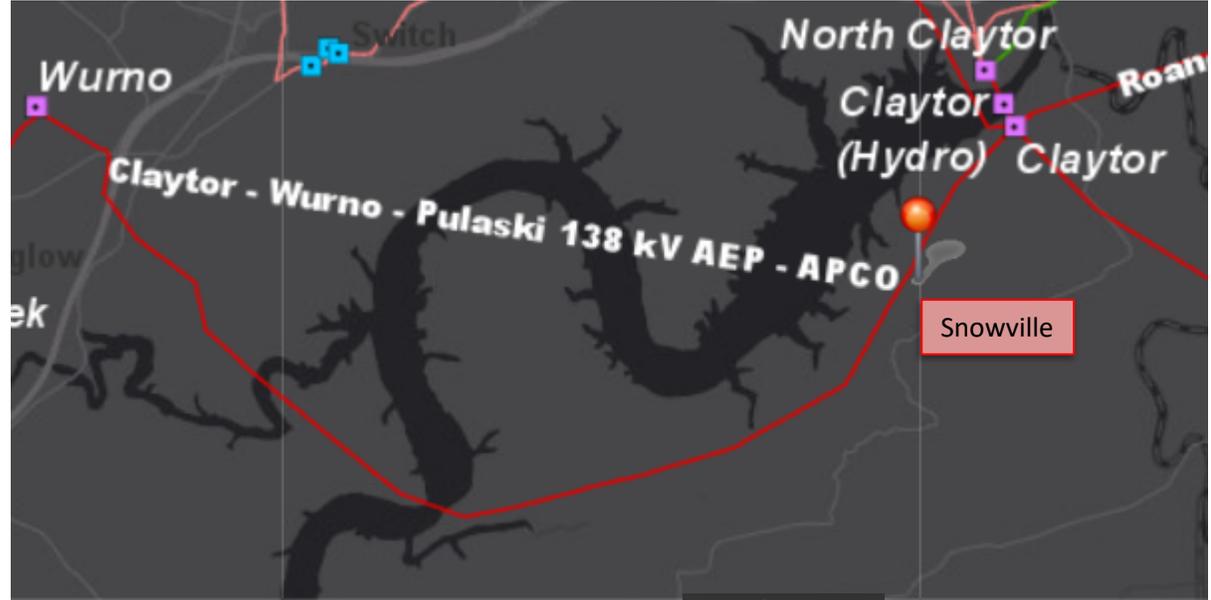
- AEP Distribution has requested a new delivery point (Snowville).
- The Distribution customers south of Claytor Lake are fed by one 34.5kV distribution circuit out of Wurno station and the circuit has one lake crossing. This circuit is currently 187-line miles long and has no other 34.5kV distribution circuit ties. Over the past five years, there were 223 distribution outages resulting in 5.9 million CMI.
- The greenfield Snowville station will pick up 6.5 MVA from Wurno station.
