SRRTEP Committee: Mid-Atlantic Committee PPL Supplemental Projects

October 21, 2019

PPL Transmission Zone M-3 Process

Macungie 69kV Tap

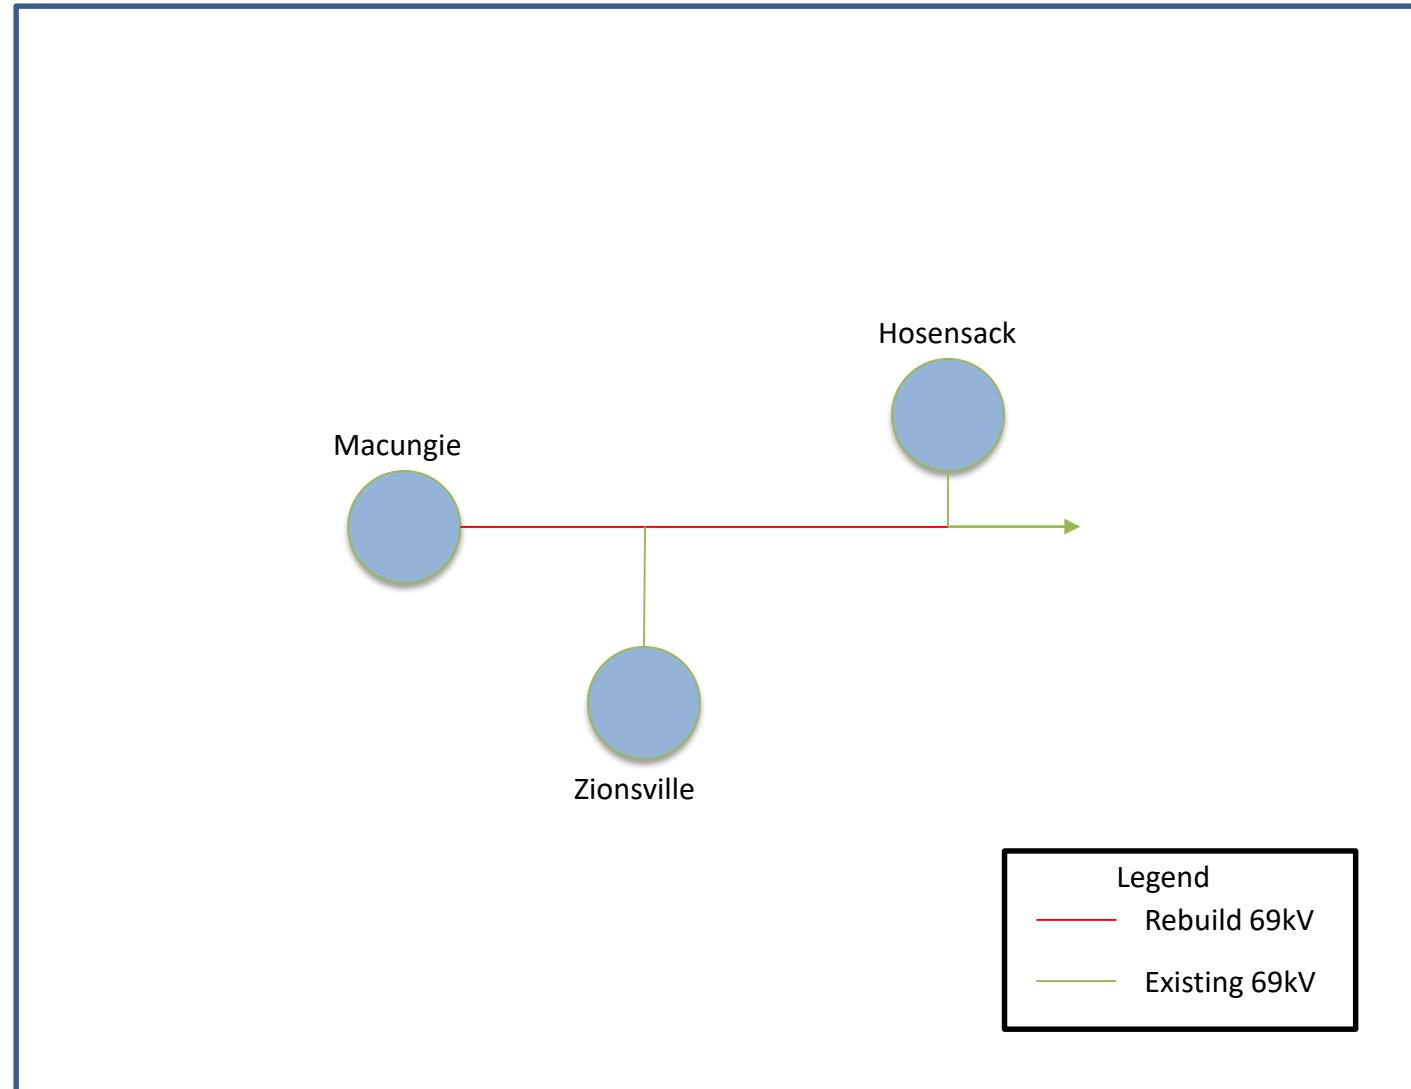
Rebuild the existing Macungie 69kV Tap line – \$7.5M

- Rebuild to PPL’s current design standard utilizing monopole steel structures and 556 ACSR conductor

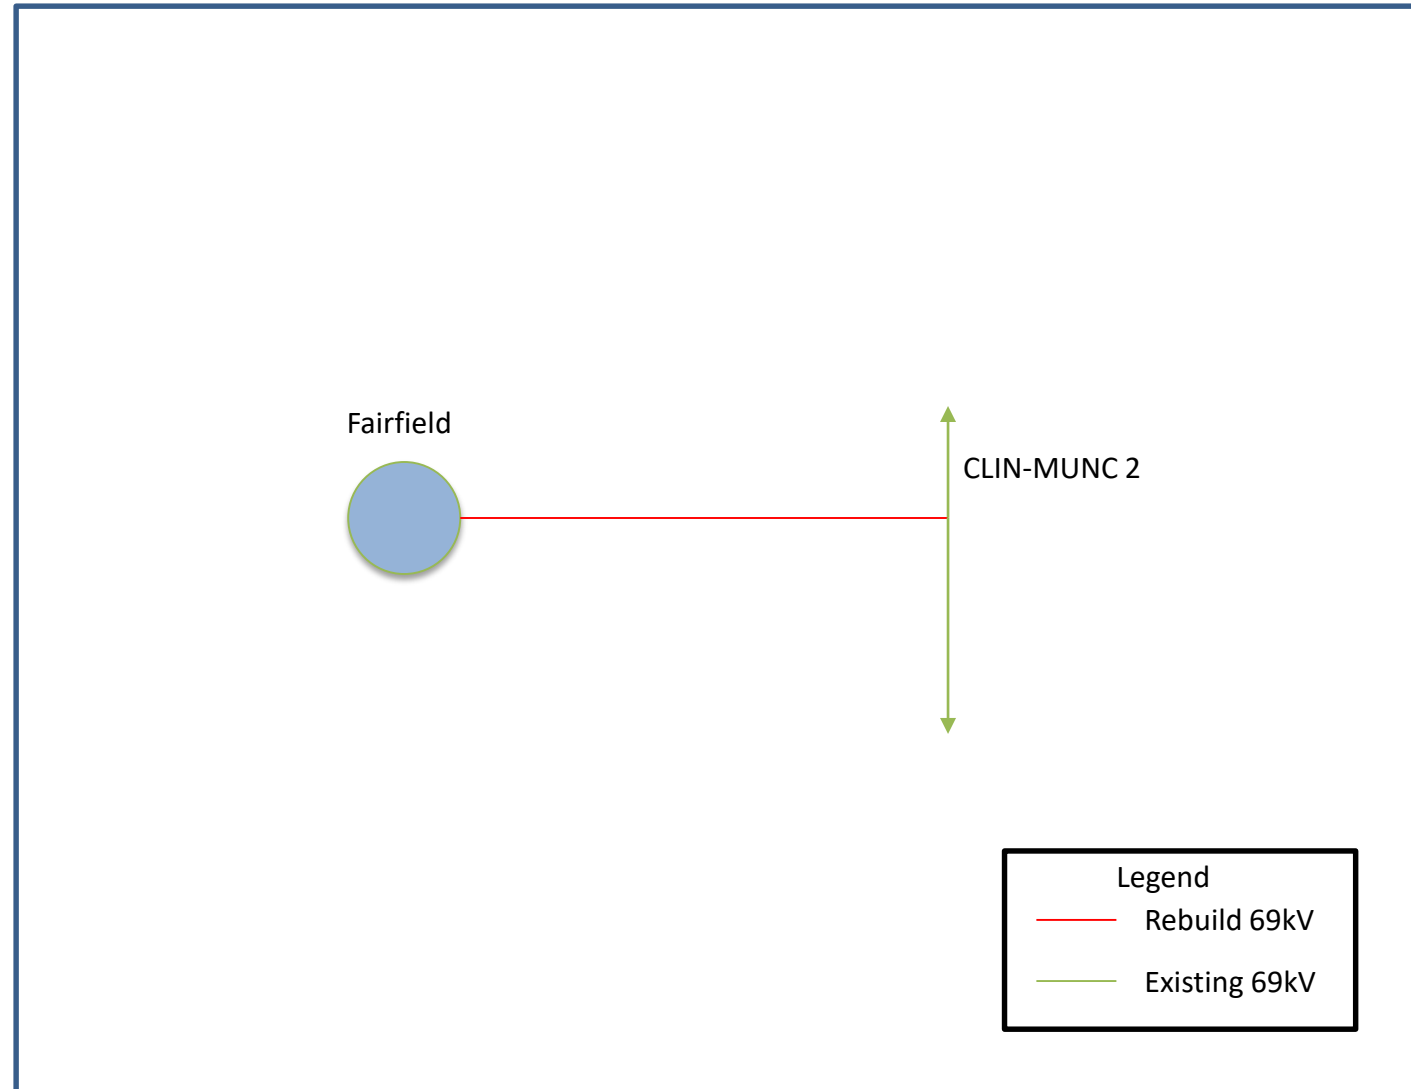
Rebuild the existing Fairfield 69kV Tap line – \$0.36M

- Rebuild to PPL’s current design standard utilizing monopole steel structures and 556 ACSR conductor
