Sub Regional RTEP Committee Western Region AEP

November 29, 2018

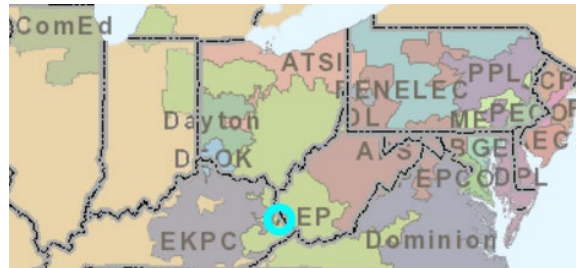
Need Number: AEP-2018-AP011

Capacitor switchers 'BB' and 'CC' at Inez station are Mark V model which no longer support modern relaying packages. Mark V's have been historically prone to mechanism failures and are being replaced system wide where possible. S&C circuit switcher 'AA' at Inez station is an S&C 2030 type with no gas monitor.

The Inez 138 kV yard was designed as a breaker and a half station, but the 'B' string was never completed leaving dissimilar zones of protection between the #1 bus and 20+ mile Inez to Johns Creek 138 kV circuit. Dissimilar zones of protection also exist between the 138 kV bus #2, 138/69 kV transformer #1, and the 138 kV circuit to the Martiki coal service point.

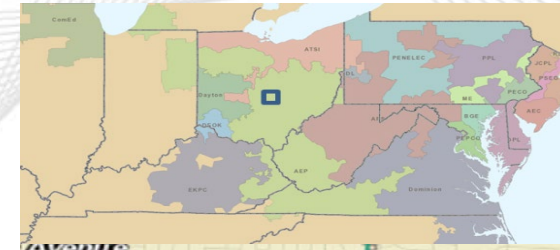
Need Number: AEP-2018-OH018

- A study of the current physical loading capability of the structures along the Astor-Shannon-Groves & Shannon – Bixby 138 kV circuits revealed that many of the poles are currently overloaded under NESC Heavy Loading Conditions. Additionally, the line structures are unable to handle the addition of telecom fiber, which is needed to improve communications in this area.

- No outage history (0 CMI/CI)
 - The Astor-Groves-Shannon 138 kV circuit is a three-terminal line, which limits sectionalizing and can cause mis-operations and over tripping.

- Astor 138 kV Station has ground switch MOAB's on both 138/13 kV transformers. Ground switch MOABs cause intentional high side faults, which can damage nearby equipment.

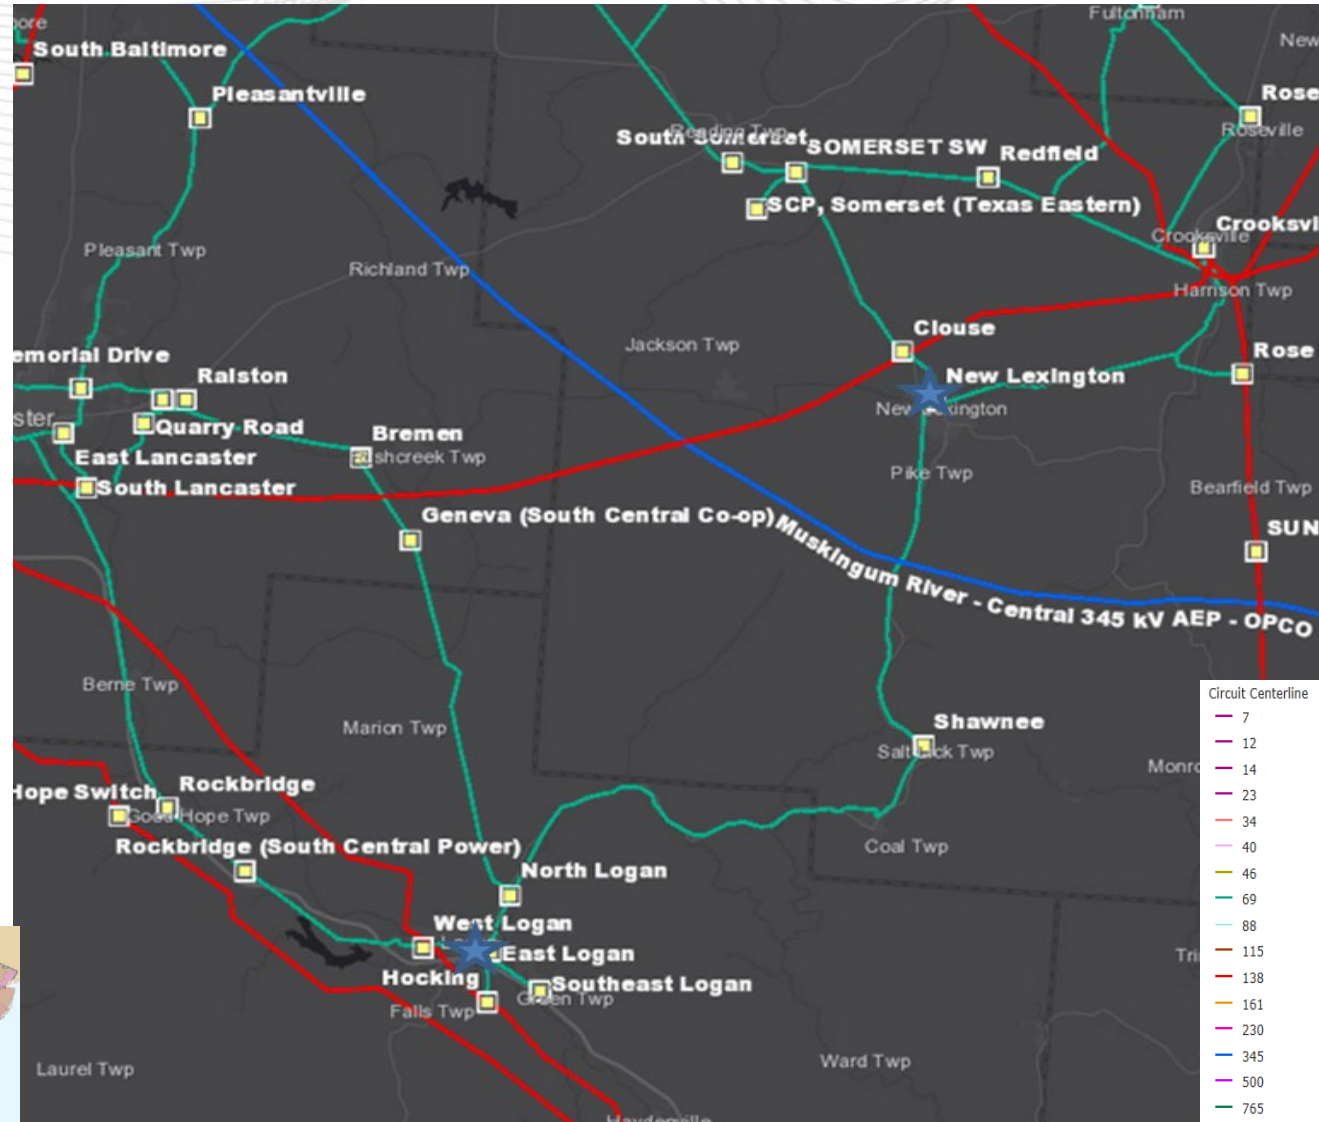
Need Number: AEP-2018-OH026

- The New Lexington – East Logan 22.3 mile 69 kV (vintage 1916) was built using wood pole structures with conductors ranging from #1 Copper 3 conductor (31 MVA rating) to 336.4 KCM ACSR 18/1 (73 MVA rating).
- There are 139 open A conditions on this line, including burnt/broken conductors, and broken structures. The New Lexington – East Logan 69 kV circuit has experienced over three million customer minutes of interruption in the past three years.

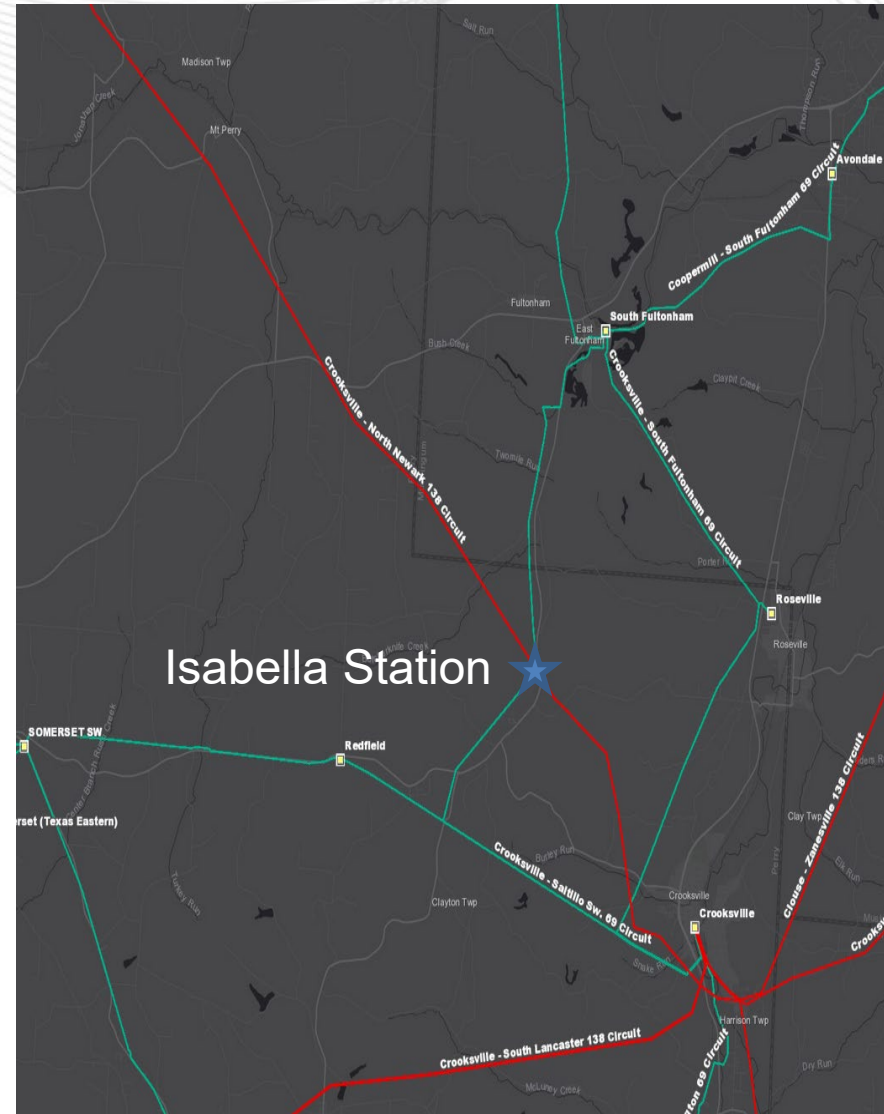
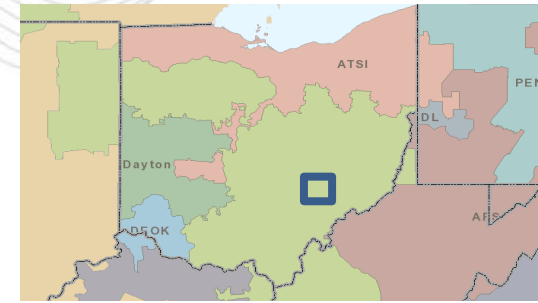
Need Number: AEP-2018-OH010

- **Customer Service #1:** AEP Ohio has requested a connection to the Crooksville – North Newark 138 kV circuit. Isabella station will replace their Redfield station. Redfield Distribution equipment is in need of rehab and it is distant from Distribution load centers. The starting load at Isabella will be 3.5 MVA and the ultimate load will be 10 MVA. Load will be transferred load from Redfield and South Fultonham. The existing Redfield 69kV Station has experienced 1,730,000 CMI over a three year period.
- ~~**Customer Service #2:** Roseville is still being evaluated.~~

- Build a new 138 kV in and out station with Moab switches to connect to the Crooksville – North Newark 138 kV circuit.
- Build a new 0.17 mile 138 kV extension to Isabella Station.

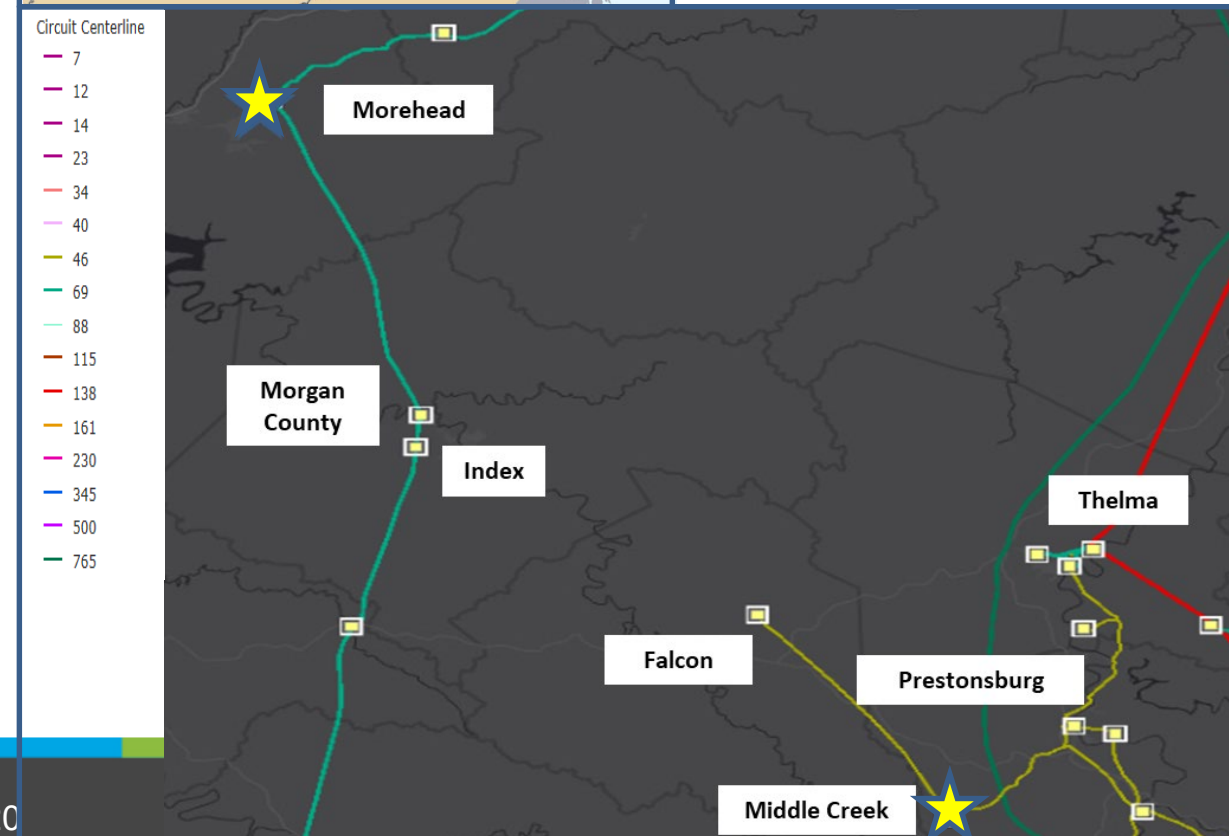
Need Number: AEP-2018-AP022

From 2013-2018 the Prestonsburg - Thelma 46 kV circuit (~ 16 miles) has experienced 22 momentary and permanent outages. The circuit has 34 category A open conditions associated with the structures that make up the line. These conditions include damaged/rotted poles and damaged guy wires, cross arms. The majority of this circuit utilizes 1960s wood structures and 336.4 ACSR conductor
