PJM Western Sub-Regional RTEP Committee AEP Supplemental Upgrades

May 20, 2019

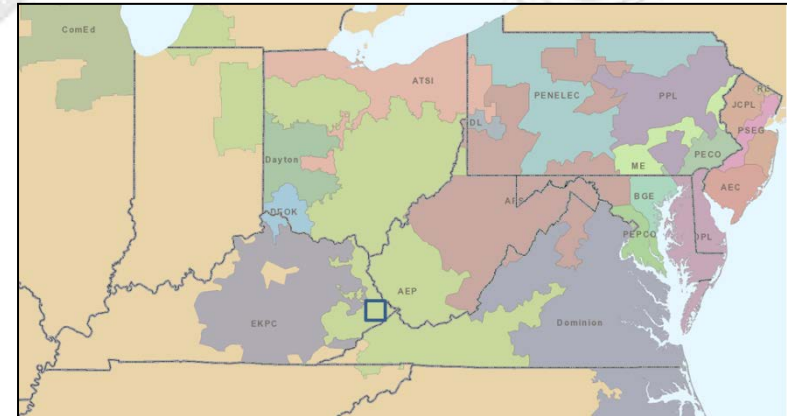
AEP Kentucky Power Distribution has requested a new distribution service out of the existing Cedar Creek Station located in Pikeville, Kentucky.

Winter projected load is 12.5 MVA.

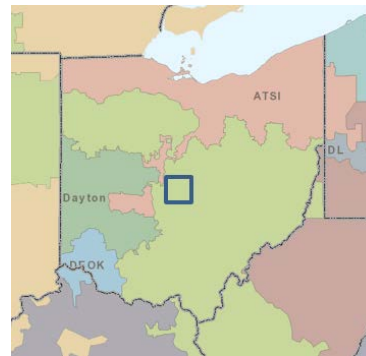
Transformation at the 34.5/13kV Sunbury station failed leading to the immediate need to install a 138/13kV skid station at Vassell station to continue serving customer load. AEP-Ohio has requested to remove the existing temporary skid station outside Vassell station and to replace it with a new 138kV delivery point installation at Vassell station.

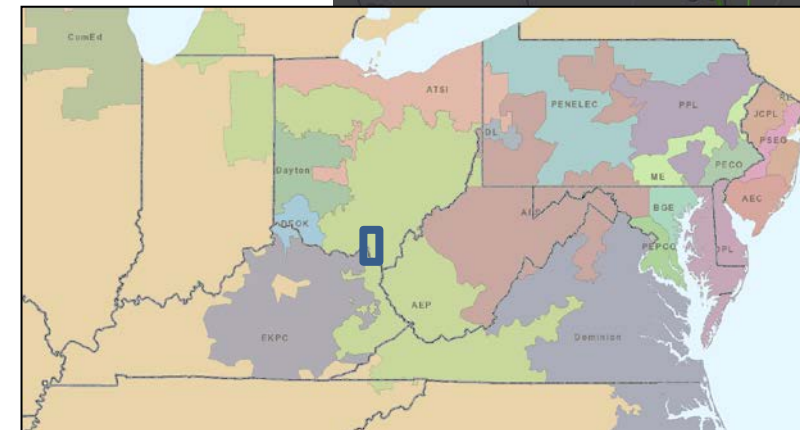
- The South Point – Portsmouth 138 kV double circuit is 34.7 miles and the Bellefonte 138 kV Extension is 4 miles in length.
- The conductor is primarily 397.5 ACSR (167 MVA).
- The South Point-Portsmouth line was originally constructed in 1929, with the majority of the structures and conductor being original.
- There are 45 open conditions on the line, including conductor issues, burnt/broken insulators, and loose/broken conductor hardware.
- Insulators of this vintage have shown heightened failure rates.

In general, several issues impact 1920 lattice tower lines:

- The steel conductor attachment plates have significant wear resulting in a loss of 50% of its strength.
- The cross arm hanger tension members are single mode of failure elements that are deteriorated and undersized due to the original design criteria.
- Lattice towers of this vintage do not meet current design requirements for wind and ice loading.
- Foundations are undersized for modern wind loading.
- Towers are beginning to show corrosion.

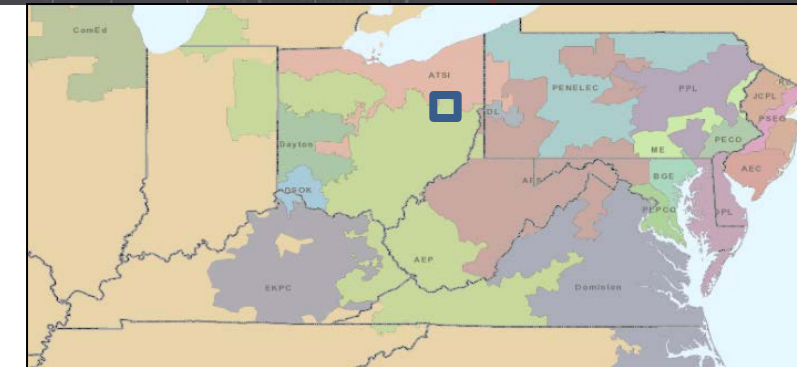
- The majority (94%) of the Sunnyside-Torrey 138 kV line (4.3 miles) is comprised of steel lattice towers built in 1918, with the remaining 6%, dating back to 1954.
- The conductor is original vintage (1918), consisting of 6-wired 200 MCM copper & 250 MCM copper.
- Note that the 0.3-mile customer tap was built in 2007 and is in adequate condition.

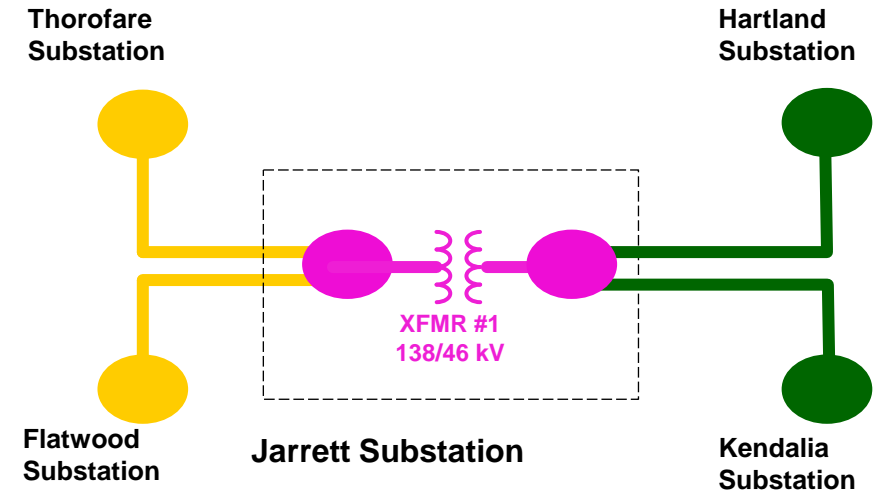
Replace the existing Clendenin Station with the new Jarrett Station, approximately 0.2 miles away from Clendenin Station, located outside of the flood plain. Install a new 138/46 kV 90 MVA XFR, with a high side circuit switcher. Install two 138 kV 40 kA CBs and three 46 kV 40 kA CBs. Install a 9.6 MVAR capacitor bank. Re-route the existing 138 kV and 46 kV transmission lines into the new station. Estimated Trans. Cost: \$21.3M
