SRRTEP Committee: Western AEP Supplemental Projects

June 17, 2019

AEP Transmission Zone: Supplemental Waverly-Adams-Seaman 138 kV Line Rebuild

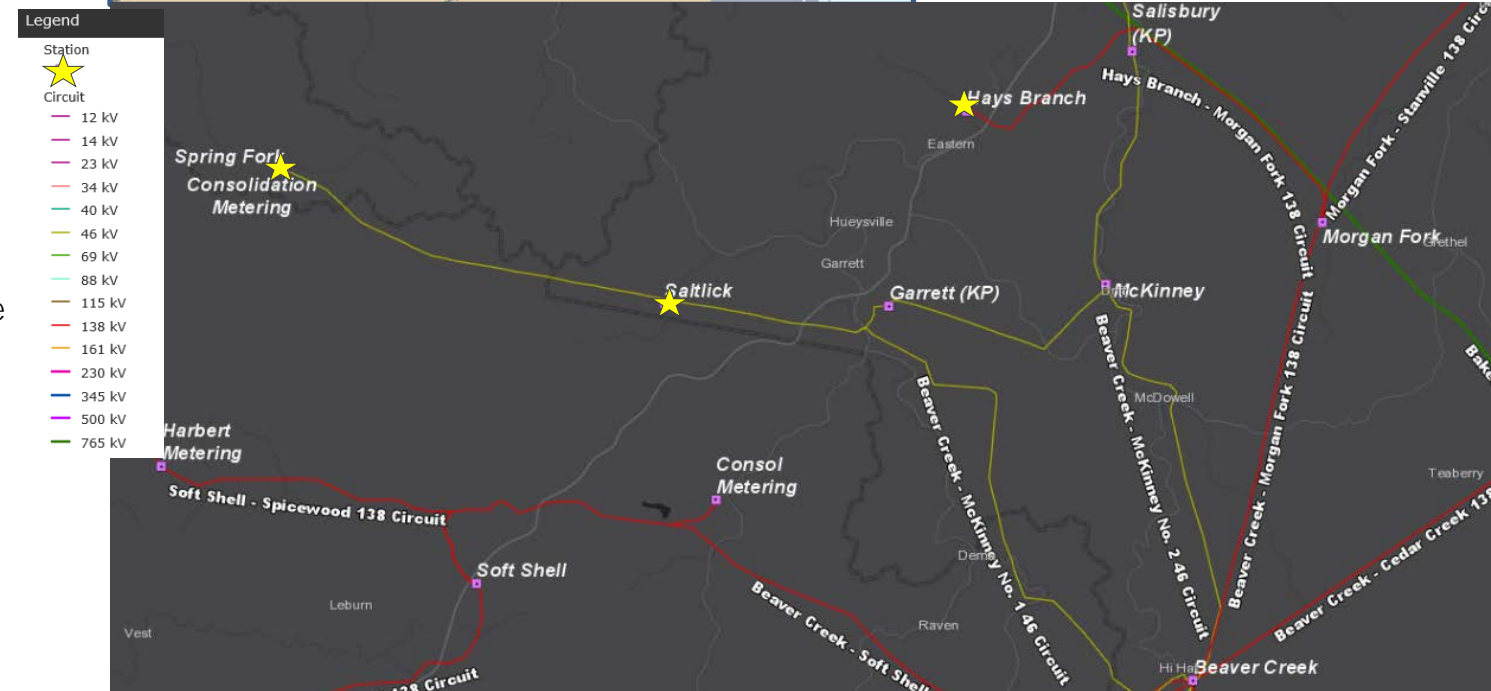
Saltlick Station

- From 2016-2018, the approximately 24.6 mile Beaver Creek – McKinney #1 46 kV circuit has experienced 22 outages.
- The circuit is comprised of 152 structures, the majority of which are wood structures dating back to 1929 (22/152, 14%) and 1949 (61/152, 40%).
- There are 142 open conditions along the 24.6 mile long line. These include damaged poles and cross-arms, conductor/shield wires, and guy anchor/knee/vee braces.

- Saltlick serves an EKPC co-op that is currently radially fed off the Beaver Creek – McKinney 46 kV circuit.

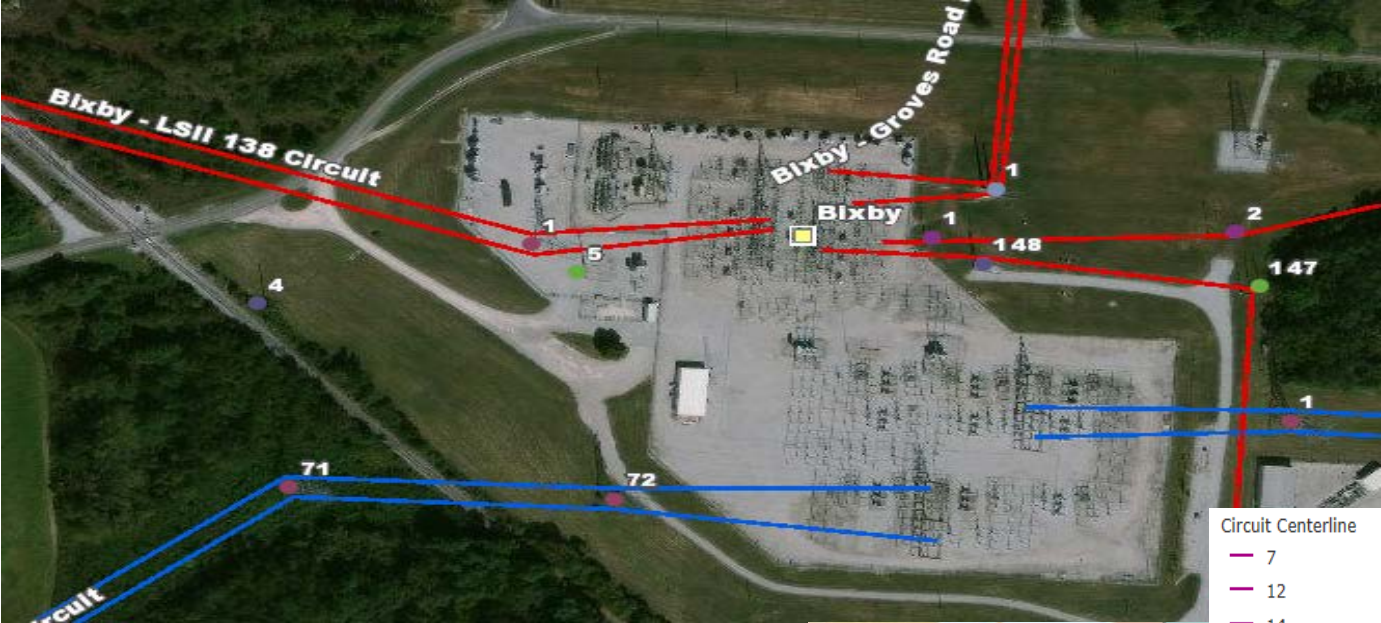
The 345/138kV, 675MVA transformer #1 failed and caught fire at Bixby station. The MOAB switch and risers cannot be repaired. A replacement is needed to support the load in the area.

At Bixby station, replace the failed transformer #1 with a 675MVA, 345/138kV transformer. Replace the damaged switches with 3000A switches. **Estimated Cost: \$4.5M**

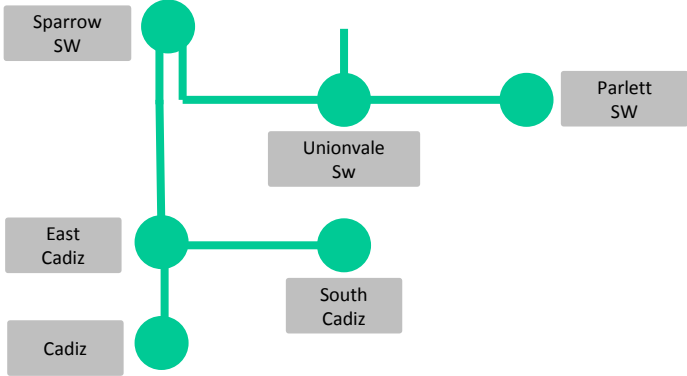
Existing:

- The Parlett-East Cadiz 69kV line, approximately 8 miles long, is comprised of deteriorated 1929 vintage wood structures and still has original 1/0 Cu and 4/0 ACSR conductor on it.

- The South Cadiz-East Cadiz 69kV line, approximately 2 miles long, is comprised of deteriorated 1954 vintage wood structures with the original 4/0 ACSR conductor on it.

- The Parlett-South Cadiz 69kV line has 190 open conditions.
- The Blackhawk – Miller Switch 69 kV line section, approximately 2.5 miles long, has some of the original 1918 conductor still on it (1/0 Cu). More than half of the wood pole structures on this sections are of pre-1980 vintage and are affected by heavy rot, woodpecker, & insect damage through the years. There are 22 open conditions on this circuit.

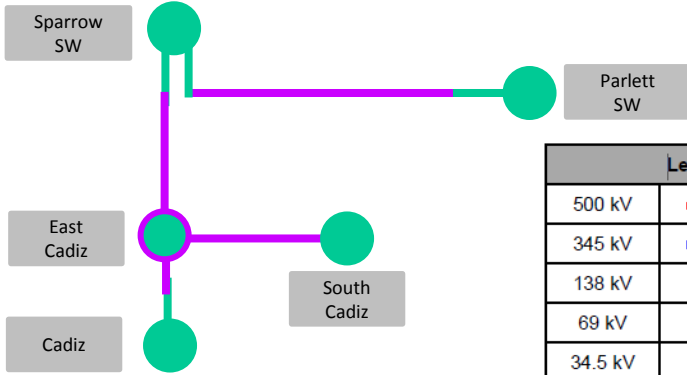
Proposed:

- Rebuild 9.65 miles of 69kV line as single circuit using 795 ACSR conductor, energized at 69kV. Install ADSS. **Cost: \$39.42M**
- Retire 0.41 miles radial, de-energized 69kV line that is routed west from Unionvale Switch. **Cost: \$0.76M**
- Retire Unionvale Switch **Cost: \$0.13M**
- Replace and relocate East Cadiz Switch with a three way POP Switch (2,000A) with MOAB's on each side. **Cost: \$0.72M**
- Remote relaying at South Cadiz, Parlett, & Sparrow. **Cost: \$0.5M**

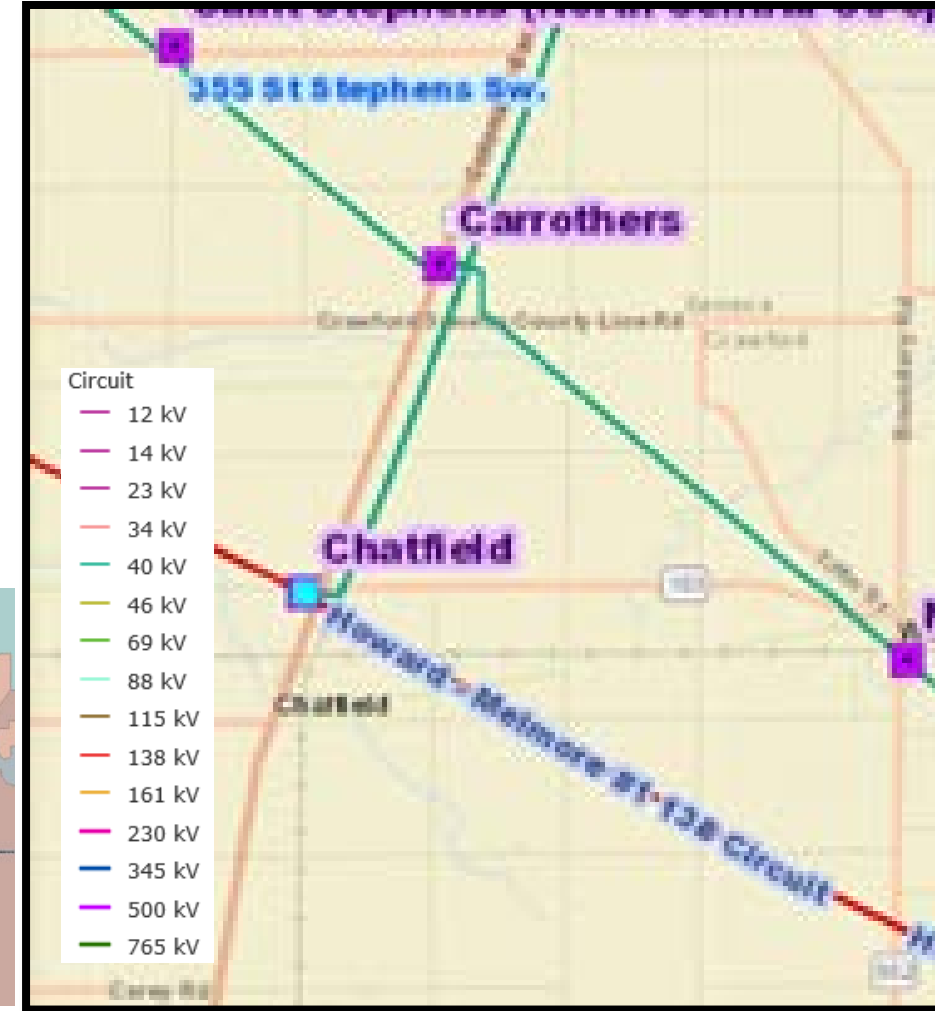
The Carrothers 69 kV Station has three dissimilar zones of protection (Bus, Transformer, and Line). Dissimilar zones of protection can cause mis-operations and over tripping.

At Carrothers 69kV station, replace line MOAB Y with a new 3000A 40 kA circuit breaker and replace/upgrade relaying at Carrothers and Chatfield stations to accommodate new breaker.
