# SRRTEP Committee: Western AEP Supplemental Projects

June 19, 2020

# AEP Transmission Zone M-3 Process Scottsville, VA Area

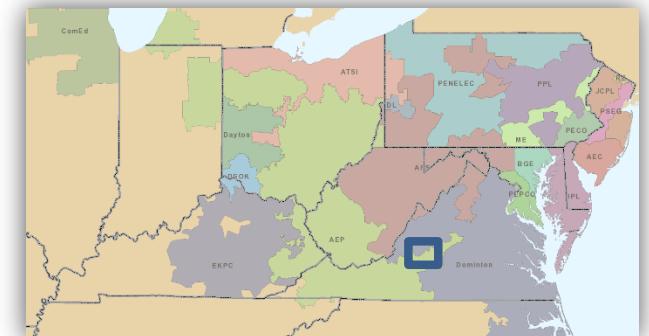
Scottsville Station:

- 138/46 kV Transformer #1 (connected in parallel with T2)
  - 1950 Vintage Transformer
  - Unit has low levels of dielectric strength, indicating an increase in particles within the oil which decreases the ability to withstand fault events, leading to damage to the paper insulation.

- Observed high oil power factor and low oil dielectric strength are strong indications of elevated moisture in the oil.
- 138/46 kV Transformer #2 (connected in parallel with T1)

- 1954 Vintage Transformer
  - Elevated levels of carbon dioxide and ethane indicate excessive decomposition of the paper insulating materials.
  - An upward trend in insulation power factor indicates an increase in particles within the oil and the dielectric strength of the insulation system (oil and paper) are in poor condition, impairing the unit's ability to withstand electrical faults.

- 138/46 kV Transformer #5
  - 1950 Vintage Transformer
  - The paper insulating material is deteriorating, reducing the ability of the transformer to withstand through fault events, which could potentially lead to catastrophic failure.

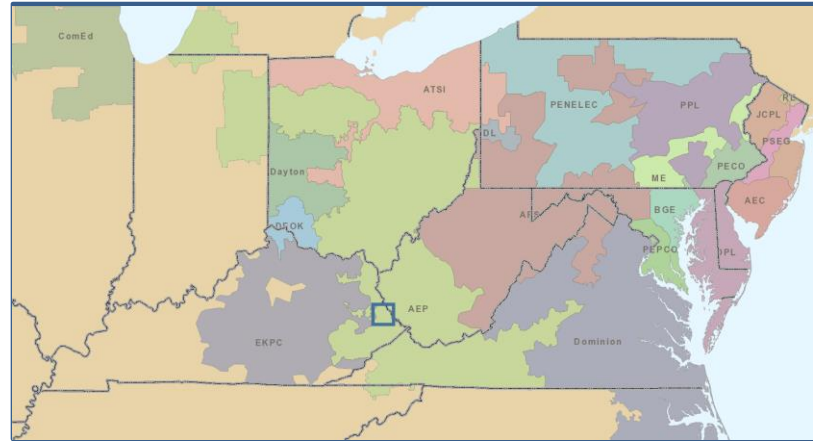
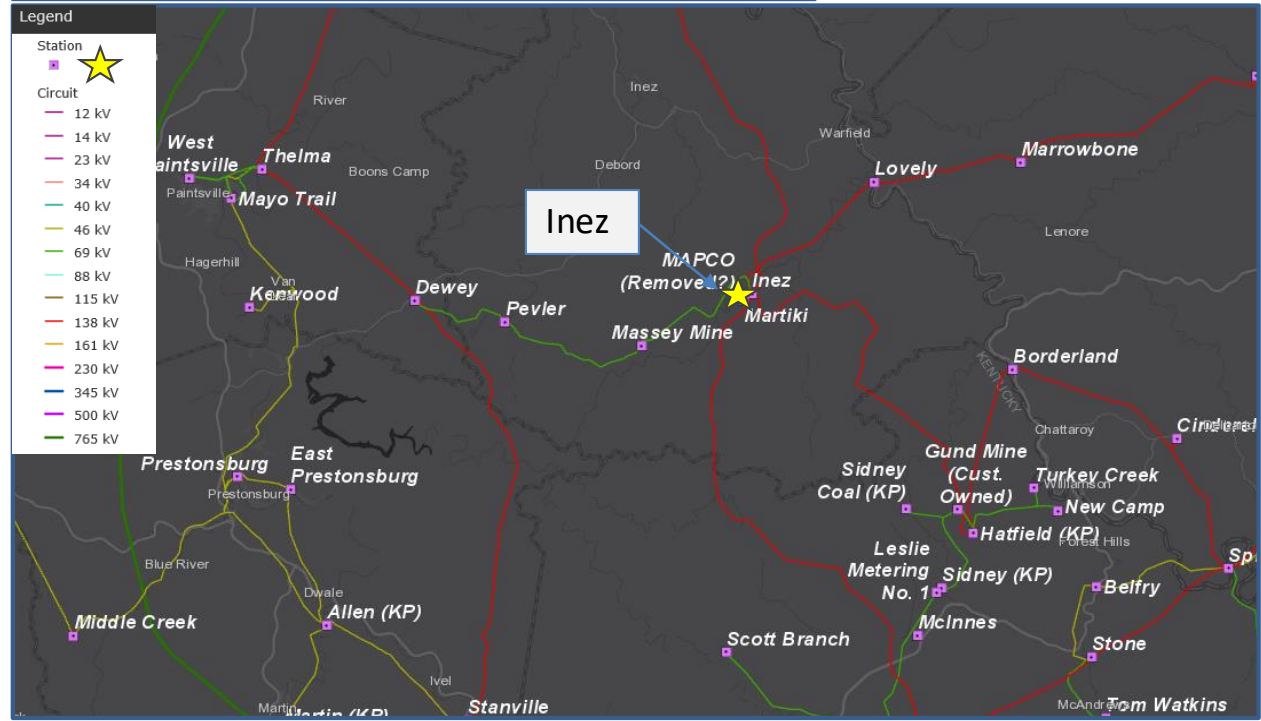
- The 138/69kV-13.09kV TR1 is 1967 vintage and has seen significant increases in moisture levels and power factor which indicate a rise in concentrations of harmful particles within the oil. The Short Circuit strength is decreased due to the age of this unit's insulating materials. As the insulating paper ages, it becomes brittle allowing for increased susceptibility to short circuit faults causing failure of the main tank. The transformer has numerous observed oil leaks including fluid leaking from the internal wiring.

- The four 138kV circuit breakers, B, B2, C and C1, are 1990's vintage SF6, **HVB145-40000-A** type breakers. The circuit breakers have experienced the following fault operations: CB B (38), B2 (22), C (99), and C1(70). CB-B had 52 leaks reported in malfunction records related to low SF6 gas levels. CB-B2 had 24 and CB-C1 had 10 reported SF6 leaks.

- Inez Substation currently deploys 105 relays to ensure the adequate protection and operation of the substation. Currently, 71 of the 105 relays (68% of all station relays) are in need of replacement due to obsolescence. 61 are of electromechanical type, six are static type, and four are discontinued microprocessor relays.

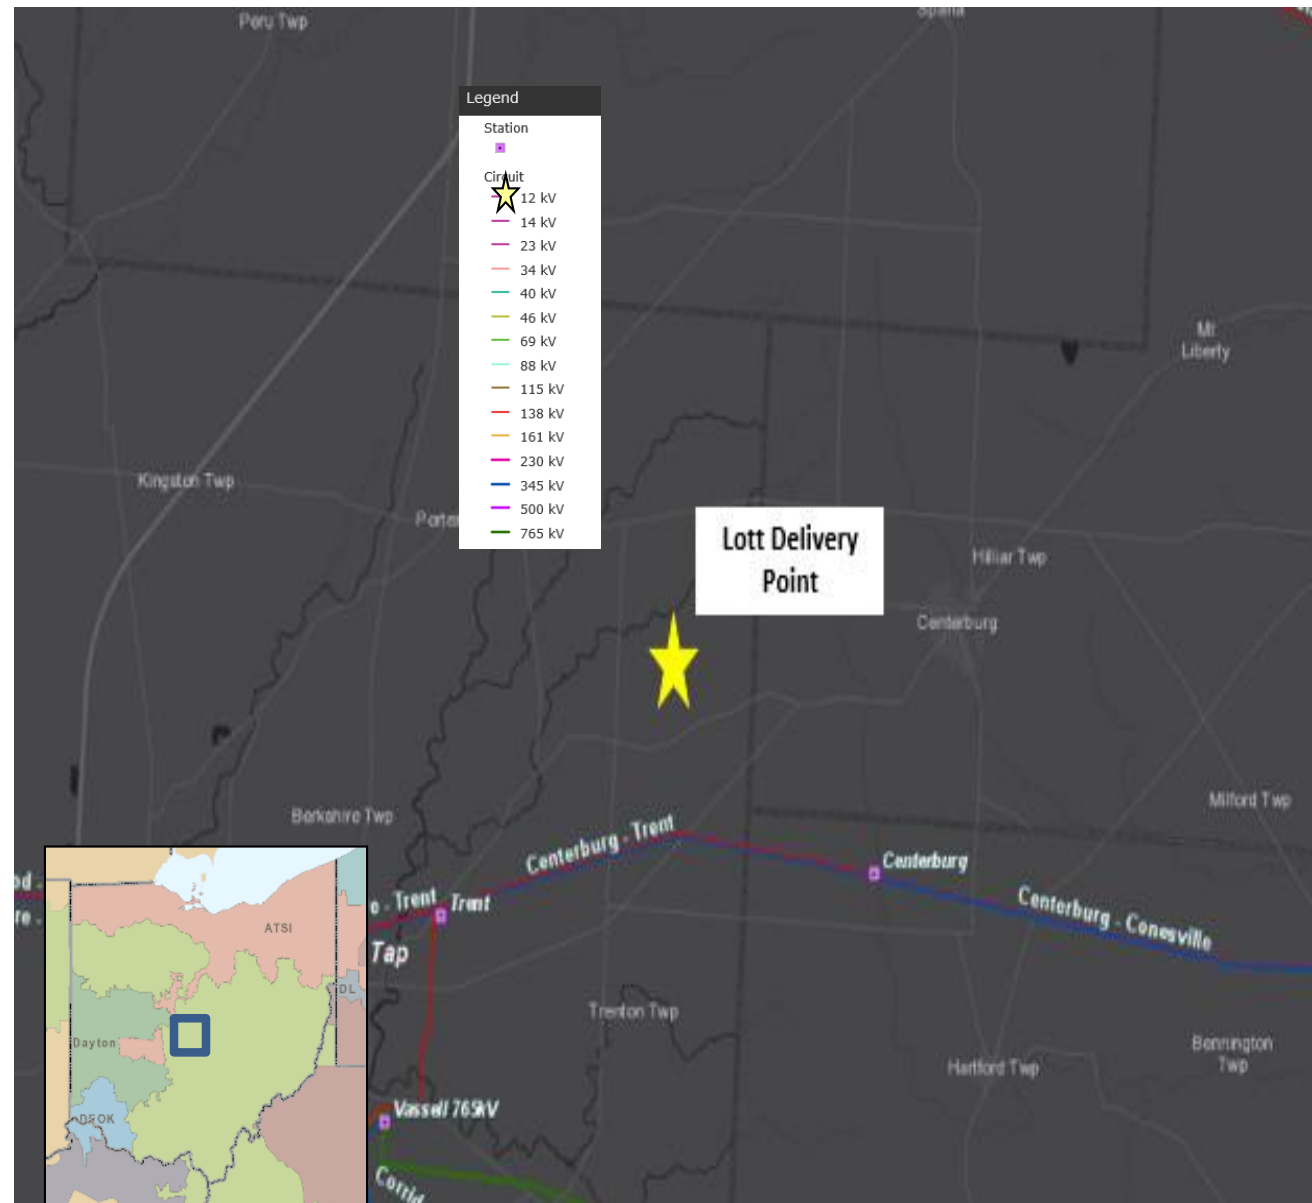
- Buckeye Power, on behalf of Consolidated Electric Cooperative, has requested transmission service in Delaware County west of Centerburg, Ohio.
- Consolidated Electric Cooperative customers are currently connected to a radial 34.5 kV distribution line from AEP Ohio's Trent station.
- The delivery point has consistently been identified as having poor reliability by Buckeye.
- Consolidated Electric Cooperative has reported approximately 700 thousand customer-outage minutes (CMI) over a three year period (2015-2020).

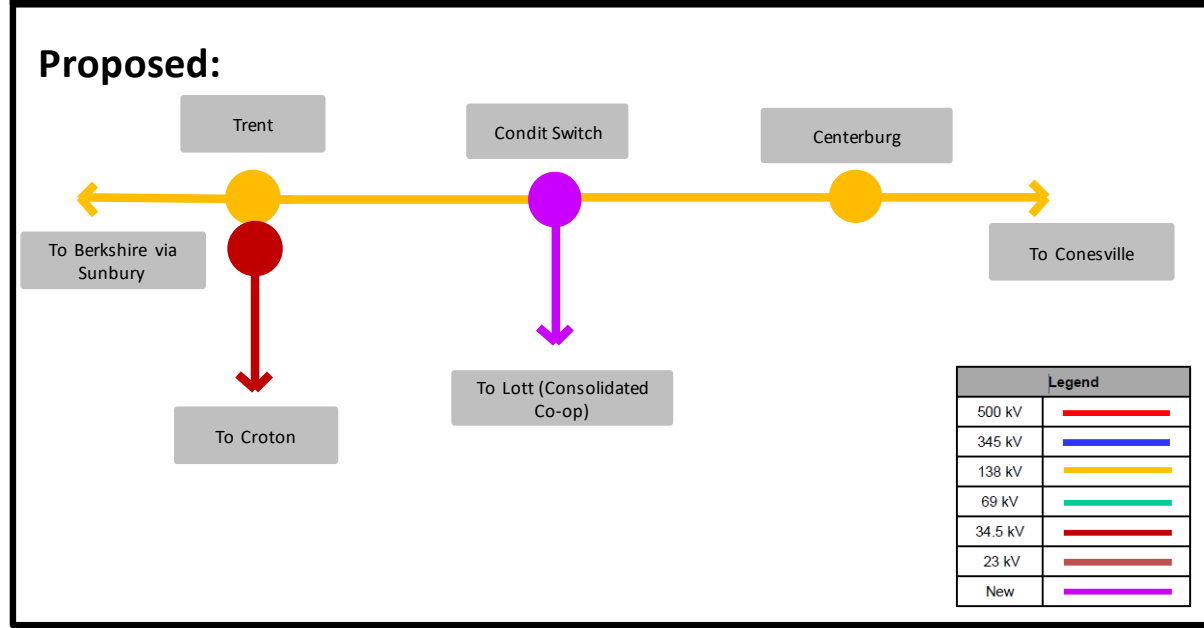
- Build ~ 3.75 miles of single circuit 138kV transmission line from new Condit 3-way MOAB Switch (tapping the Centerburg– Trent 138kV circuit) to Lott station (Consolidated Co-op). **Estimated Cost: \$9.86M**
- Build Condit 3-way MOAB 138kV switch **Estimated Cost: \$ 0.78M**

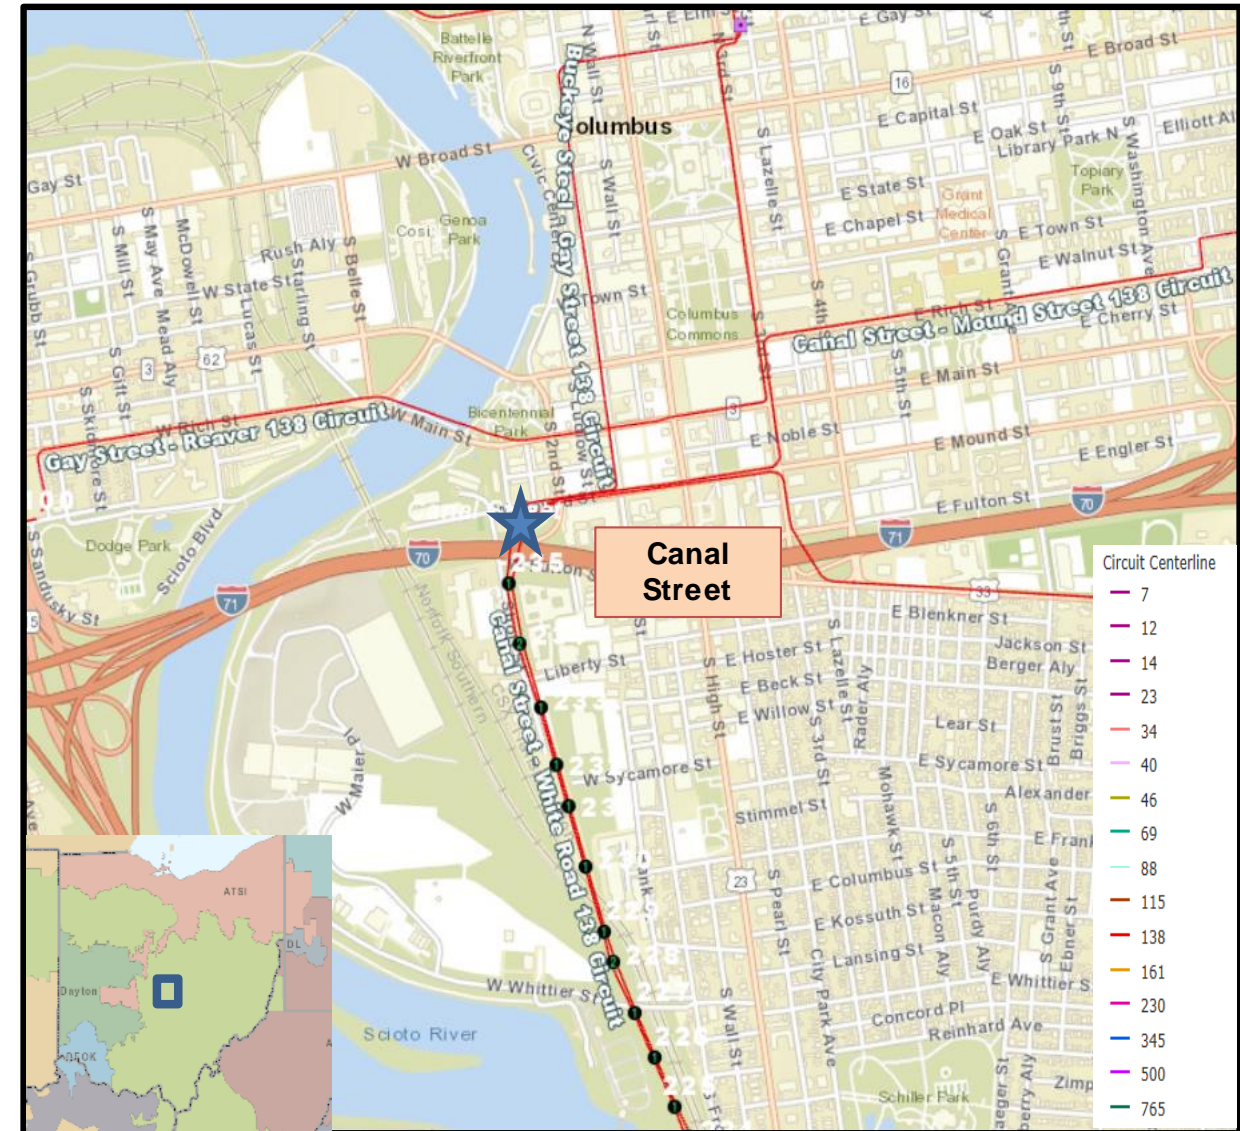
Circuit Breaker (4):

- Install Date: 1969
- Interrupting Medium: Oil
- Additional Information:
  - Interrupting Capability: 37kA
  - Fault Operations:
    - Number of Fault Operations: 15
    - Manufacturer recommended Number of Operations: 10
  - Oil breaker maintenance has become more difficult due to the oil handling required to maintain them. Oil spills are frequent with breaker failures and routine maintenance and can become an environmental hazard. This is the last remaining oil breaker at Canal Street station.
