Subregional RTEP Committee – Western FirstEnergy Supplemental Projects

August 14, 2020

Needs

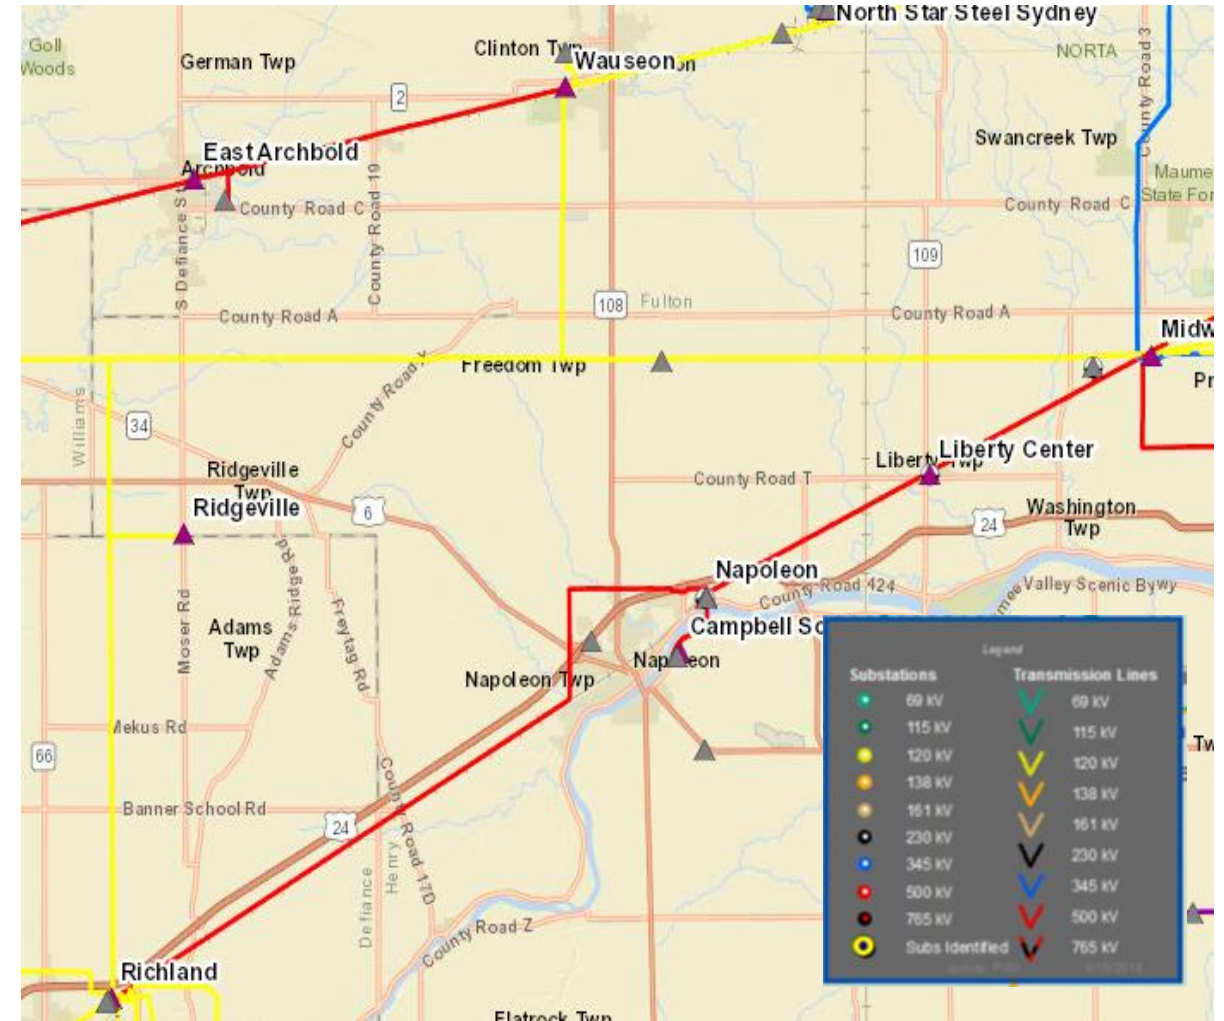
Midway-Richland-Wauseon 138kV (~33.5 miles) Transmission Line:

- Existing 336.4 ACSR has a history of failure due to conductor vibration resulting in thermal overload and corrosion of steel core.
- Original porcelain insulators from 1948 construction are aged and exhibiting wear.
- Comprehensive aerial inspection was completed in 2020 and shows a rising negative trend in required maintenance with 160 structures that presently require repair for structure damage, static wire damage, broken insulators, and broken or overheated conductor.
- Growing trend in unscheduled interruptions on this line with five (5) equipment caused outages in the past 10 years.
- Condition of static wire is deteriorating which may be contributing to rise in lightning caused outages.

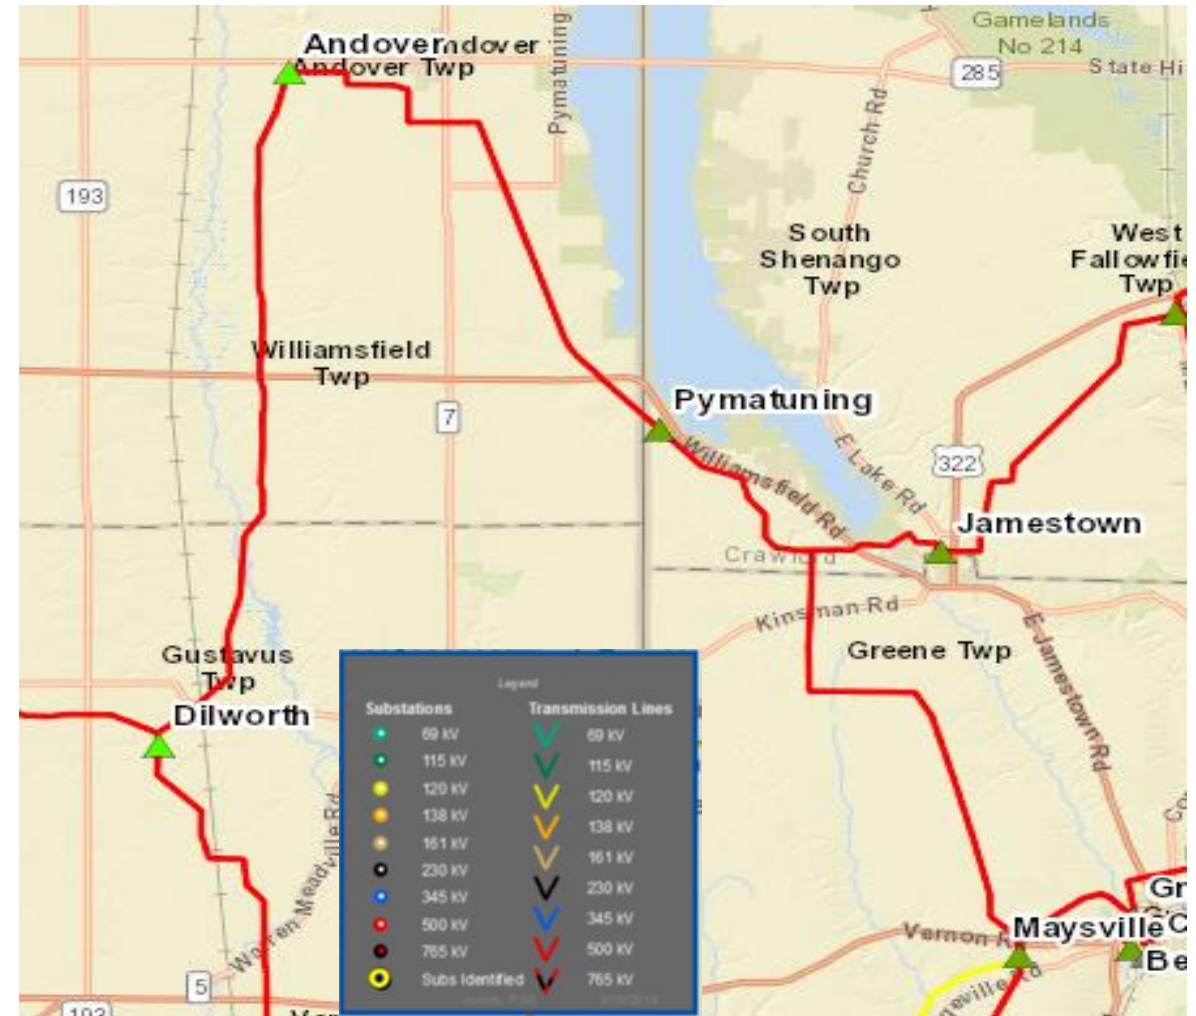
Dilworth-Maysville 69kV (~11.4 miles) Transmission Line:

- Line was originally constructed in 1947. The average age of structures on this line are 58 years old. FirstEnergy has historically experienced an average age of reject for wood poles to be 48.7 years.
- Line survey in 2019 showed a structure reject rate of 57% (166 of 293). The primary reasons for reject were wood pole deterioration, broken static wire, woodpecker holes, broken conductor strands.
- Existing 336.4 ACSR has a history of failure due to conductor vibration resulting in thermal overload and corrosion of steel core.
- Environmental conditions on ROW causes difficulties for routine maintenance, vegetation management, and outage restoration.
- Growing trend in unscheduled interruptions with 10 outages in the past two years with approximately 15,000 customers impacted in the area.
- Obsolete line switch (A-212 N.O.) is no longer supported by the manufacturer.
