Sub Regional RTEP Committee: Western AEP Supplemental Projects

September 11, 2020

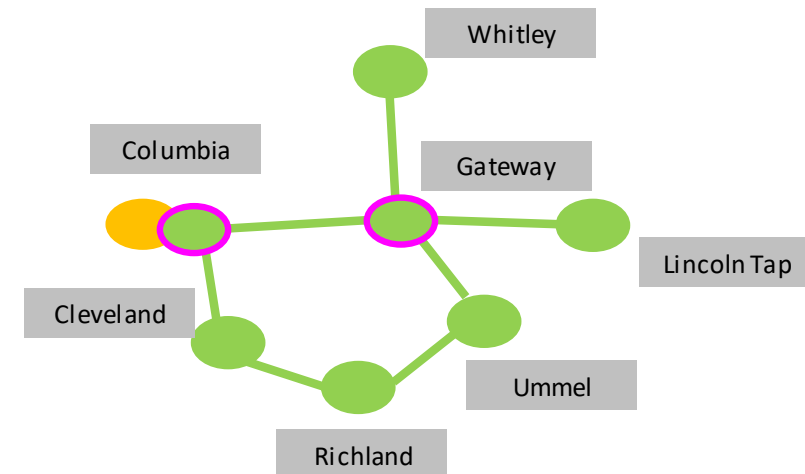
Proposed Solution:

Replace 69kV CB “E” at Gateway station with a 3000A 40kA CB

Replace 69kV CB “J” at Columbia station with a 3000A 40kA CB

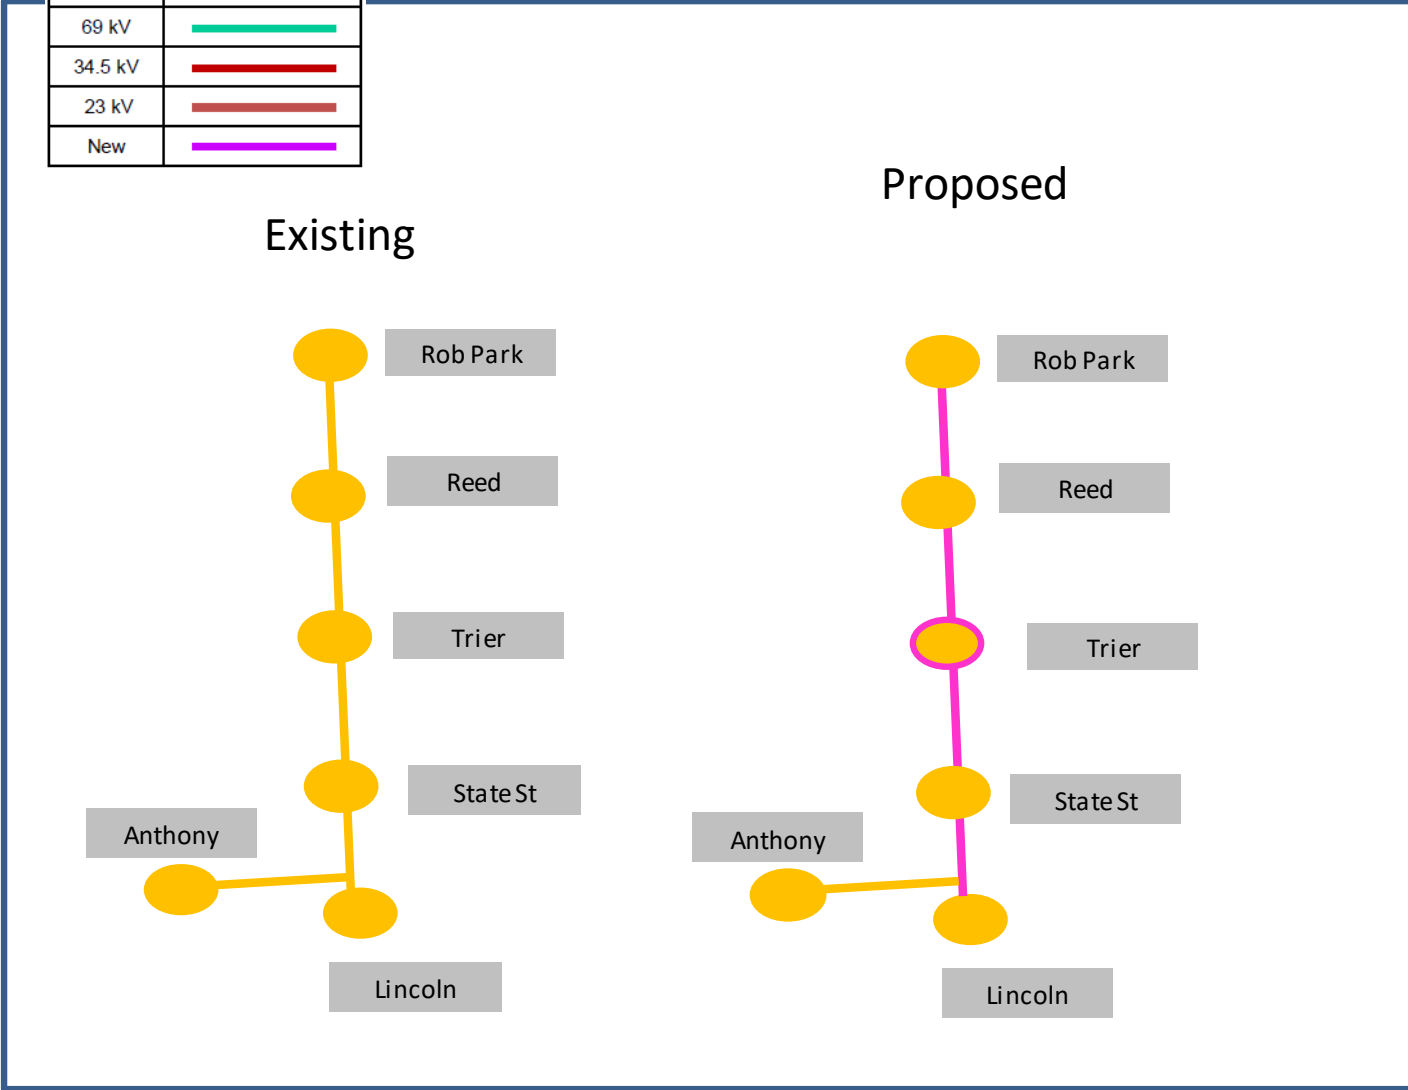
Proposed Solution:

Rebuild the ~7.8 mile 138kV Rob Park – Lincoln line using Drake 795 ACSR (SN/SE/WN/WE: 257/360/325/404MVA).

Add a 3000A bus tie CB at 138kV Trier station to separate the 4 MOAB's in series. **Estimated Cost: \$1.2M**
