Western Sub Regional RTEP: AEP Supplemental Projects

July 21, 2023

Need Number: AEP-2023-AP017

Need Number: AEP-2023-AP018

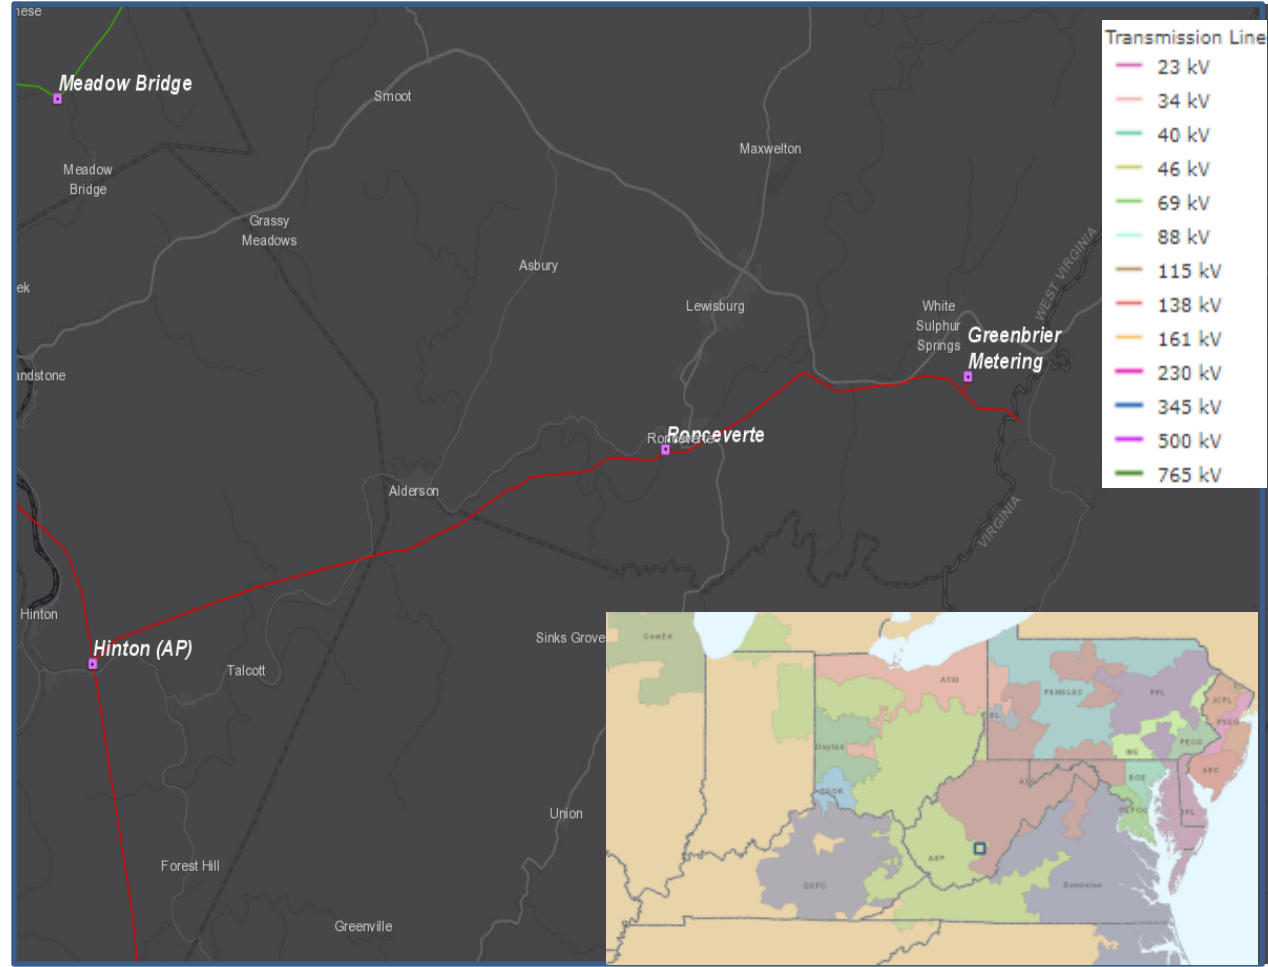
Hinton Station

- 138 kV circuit breakers A, B, C
 - HVB145-4000 type, SF6 filled breakers
 - The HVB145 model family has the propensity to mechanically pump closed instead of locking open as it awaits an electrical close command from the relaying. This presents a high mis-operation risk on the system. The HVB breakers have had some failures due to slow tripping with the breakers not reclosing faster than 20 cycles. Also, this model family has a high occurrence of SF6 gas leaks with 215 recorded malfunction records. This is an environmental concern since SF6 is a potent greenhouse gas with a high global warming potential, and its concentration in the earth's atmosphere is rapidly increasing. In addition, low SF6 causes operational issues with the breaker which can lead to excessive maintenance of closing contacts or failure. CBs A and C have active SF6 leaks.

- Hinton Station ties with Allegheny Power Services (APS), which is connected to the 138kV Bus at Hinton with no circuit breaker. This lack of sectionalizing creates a scenario where a fault on this tie outages the entire bus at Hinton and contains more than two zones of overlapping protection.

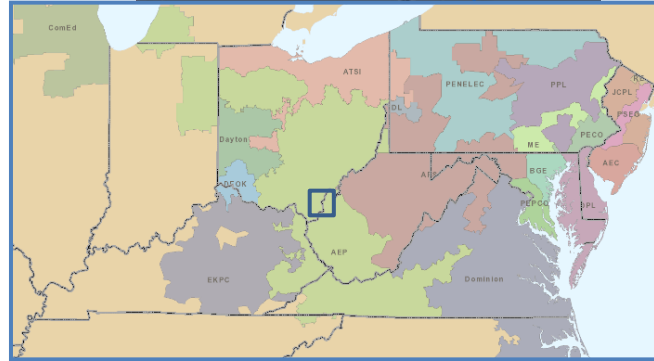
Beale Station

- 69 kV MOAB W has a broken arc horn on the middle phase.
- 69 kV MOAB/Ground switch that is an outdated design.
- 69/12 kV TR-1 067 is 1978 vintage and has experienced excessive decomposition of the paper insulation materials, overheating, high moisture content, low and declining dielectric strength indicative of increasing particle concentrations in the oil and decreasing ability of the oil to withstand future fault events.
- 12 kV Circuit Breaker A is oil filled and a Westinghouse PR Type.
- There are also 4 transmission and 10 electromechanical relays that need to be replaced.
- The distribution DOS RTU is currently not in service.

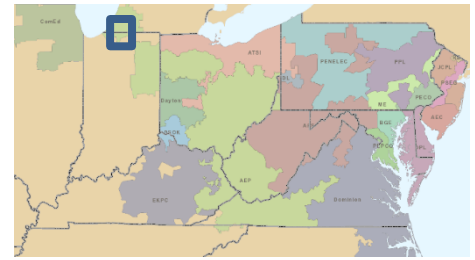
- Twin Branch – Borley 34.5kV Line:**
- Line is 2.74 miles long installed in 1969 with a mix of wood poles with cross arms or horizontal post construction
 - 4/0 copper conductor exists on structure ranges 1 – 16 and 35 – 75
 - Structures fail 2017 NESC Grade B, AEP structural strength, and ASCE structural strength requirements
 - Mostly insulated with a mixture of 34.5kV and 69kV insulators, which do not meet AEP standards for CIFO and minimum leakage distance requirements
 - There are 10 structures with open conditions (13% of line). These conditions are structure related including bowed crossarm, rot heart, rot top, and split conditions
 - Approximately 30% of the wood poles have some level of decay or woodpecker damage
 - Approximately 20% of all crossarms are cracked and/or have visible decay

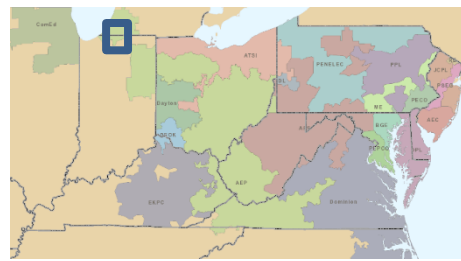
- Lawton Park- Lawton Switch 34.5kV line is 2.59 miles long that was originally installed in 1956 and mostly consists of single wood poles
- Structures fail to meet NESC Grade B and AEP structural strength requirements

- The grounding method utilizes butt wraps on every other structure, which is inadequate for current AEP Standards.
- The shield angle on a typical tangent structure is measured at 45 degrees, which is inadequate for current AEP shield angle requirements and can lead to poor lightning performance

- Most poles have decayed tops, crossarms have light to moderate decay, crossarm braces have advanced decay and insect damage

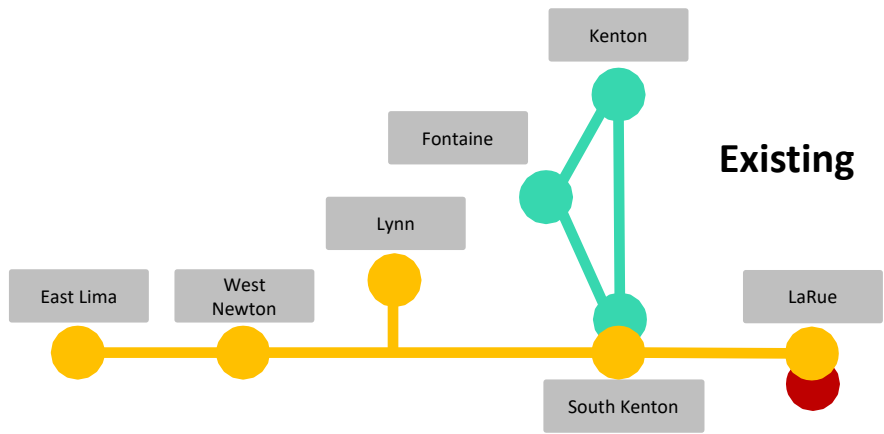
- **South Kenton.** Rebuild the 138kV bay as a four breaker ring bus using 3000A 40kA breakers. Replace transformers two and three with a single 90MVA unit. Install a DICM and replace the EM relays. Replace the 69kV bus and breakers C and E.
Estimated Cost \$12.7M
 - Re-terminate the East Lima - South Kenton 138 kV and South Kenton - Larue 138kV circuits into the new South Kenton ring bus. **Estimated Cost \$3.64M**
 - Re-terminate the South Kenton - Kenton #1 69kV and South Kenton - Kenton #2 69kV circuits into the station. Install fiber between South Kenton and Kenton, retire the pilot wire scheme **Estimated Cost \$1.45 M**
 - At Kenton station, replace MOABS X,Z with 69kV 3000A 40kA breakers. Install a DICM **Estimated Cost \$3.80M**
 - Upgrade telecom equipment at Rangeline and Gunn Road stations **Estimated cost \$94.4K**
- Total Estimated Transmission Cost: \$21.70M**

- Consideration was given to keeping the existing MOAB line sectionalizing scheme at Kenton. In order to replace the pilot wire scheme between the stations, a custom protection scheme would be required. Installing line breakers allows a much simpler protection and control scheme while also providing ancillary benefits that MOABs do not.
- South Kenton is an important source for the NW Ohio 69kV network. Retiring transformers two and three without replacement is not a viable option. Installing only one transformer to replace the parallel does not reduce the area's reliability because the banks could not be sectionalized.
