# Transmission Expansion Advisory Committee FirstEnergy Supplemental Projects

January 9, 2024

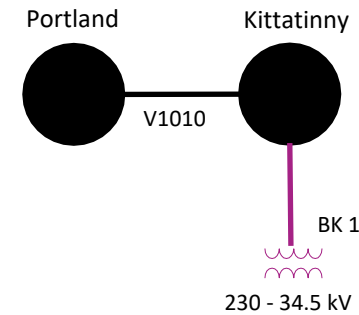
**Need Number:** JCPL-2023-049

- Replace the 230-34.5 kV No. 1 Transformer at Kittatinny Substation with a 90 MVA unit.
- Replace high side switch with a circuit breaker.
- Upgrade transformer relaying

- Kittatinny 230-34.5 kV No. 1 Transformer:
  - Before Proposed Solution: 60/63/76/77 MVA (SN/SLTE/WN/WLTE)
  - After Proposed Solution: 123/142/148/166 MVA (SN/SE/WN/WLTE)

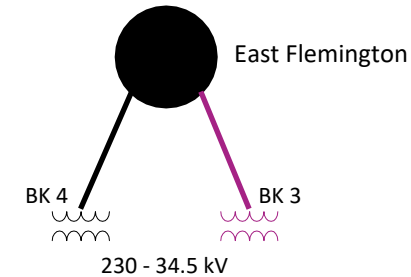
**Need Number:** JCPL-2023-051

- Replace the 230-34.5 kV No. 3 Transformer at East Flemington Substation with a 125 MVA unit.
- Install a 34.5 kV breaker with SCADA control
- Upgrade transformer relaying

- East Flemington 230-34.5 kV No. 3 Transformer:
  - Before Proposed Solution: 77/81/97/99 MVA (SN/SLTE/WN/WLTE)
  - After Proposed Solution: 162/169/209/214 MVA (SN/SE/WN/WLTE)

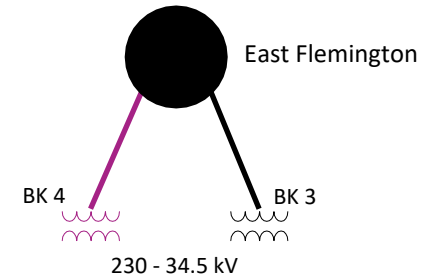
**Need Number:** JCPL-2023-052

- Replace the 230-34.5 kV No. 4 Transformer at East Flemington Substation with a 125 MVA unit.
- Install a 34.5 kV breaker with SCADA control
- Upgrade transformer relaying

- East Flemington 230-34.5 kV No. 4 Transformer:
  - Before Proposed Solution: 76/81/97/99 MVA (SN/SLTE/WN/WLTE)
  - After Proposed Solution: 162/169/209/214 MVA (SN/SE/WN/WLTE)

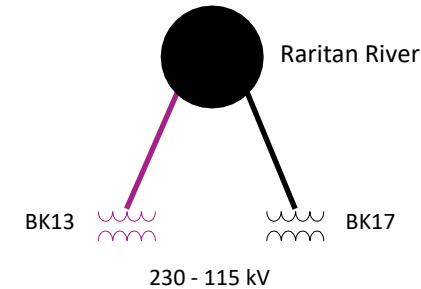
**Need Number:** JCPL-2023-060

- Replace the 230-115 kV No. 13 Transformer at Raritan River Substation with a 224 MVA unit.
- Replace high side switch with a circuit breaker
- Upgrade transformer relaying
